-- *Fyfeshire Pond Dam* --  
**PHASE II**  
INVESTIGATIONS REPORT

Dam Name: Fyfeshire Pond Dam  
State Dam ID#: 3-14-34-2  
NID#: MA01512  
Owner: Town of Bolton Conservation Commission  
Owner Type: Municipal  
Town: Bolton  
Consultant: Fuss & O'Neill  
Date of Completion: October 30, 2009

FYFESHIRE POND DAM PHASE II INVESTIGATIONS  
Town of Bolton Conservation Commission

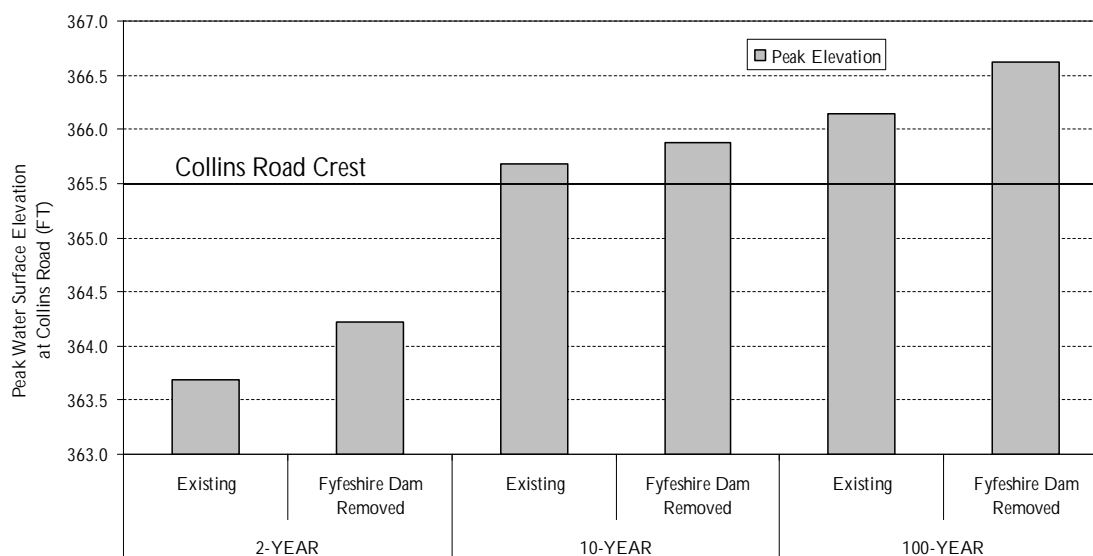
### Impacts of Dam Removal on Collins Road

predicted peak storm elevations at Collins Road with and without the dam in-place. It is important to note that, in general, the increases in peak flow resulting from dam removal can be acceptable to stream ecology since they often approximate natural conditions; it is the artificial structures in the stream system that are more likely to be adversely impacted from dam removal projects.

The peak flow increases would result in increased water surface elevation in the wetland upstream of Collins Road, increasing the depth of overtopping of Collins Road by approximately 0.5 feet.
