--TOWN OF BOLTON--
FYFESHIRE POND DAM
PHASE I
INSPECTION / EVALUATION REPORT

Dam Name: Fyfeshire Dam, also known as Fish Pond Dam
State Dam ID#: 3-14-34-2
NID ID#: MA01512
Owner: Town of Bolton Conservation Commission
Owner Type: Bolton, MA
Town: Municipal
Consultant: AMEC Earth & Environmental Inc.
Date of Inspection: 7/17/2008

EXECUTIVE SUMMARY

- *Fyfeshire Dam (AKA Fish Pond Dam), Bolton, MA*
- *July 17, 2008*
- *AMEC Earth & Environmental, Inc.*
- *Dam Condition: Unsafe*
- *Major Deficiencies: Failing Spillway, Bulging Embankment, Lack of Documentation.*

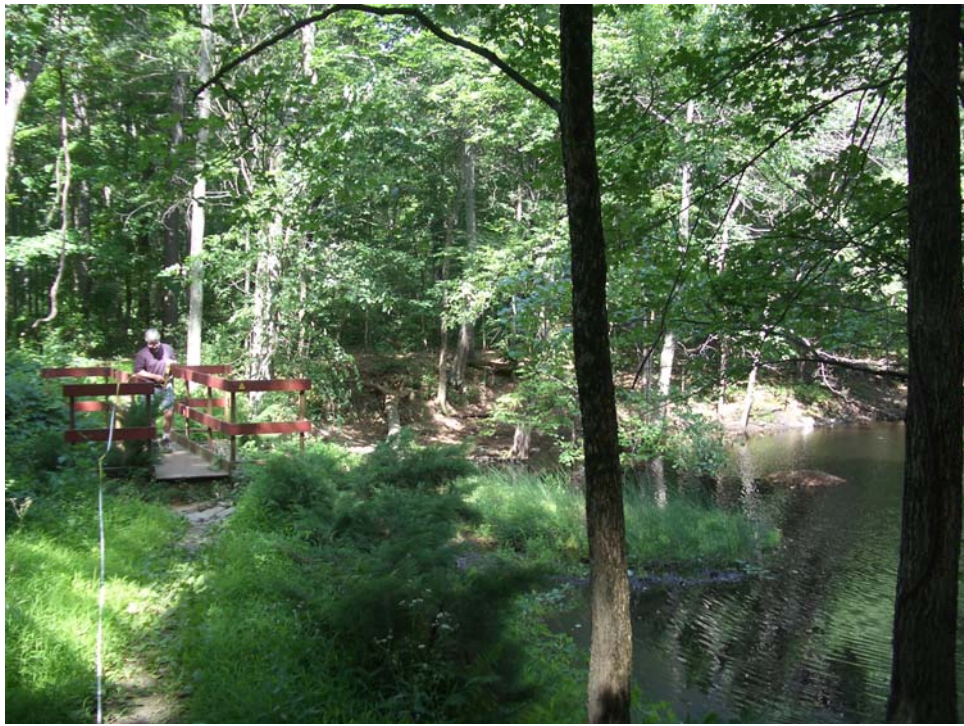
The crest of the dam is currently part of a walking path in the conservation area. Both sides of the path are grass-covered. The left side of the dam has juniper bushes planted on the upstream side of the crest. Evidence of significant erosion is found on the left side of the dam at the point where the spillway wall and the earth dam structure meet. The area was recently repaired with small 2-foot tall, cast-in-place concrete walls, retaining the soil within the walking path. The right side of the crest appears in better condition, with no sign of notable erosion, and only grass along the crest. See Photos 1 & 2.

Photo #1: Taken from the left abutment (east facing west) facing dam, and cove upstream

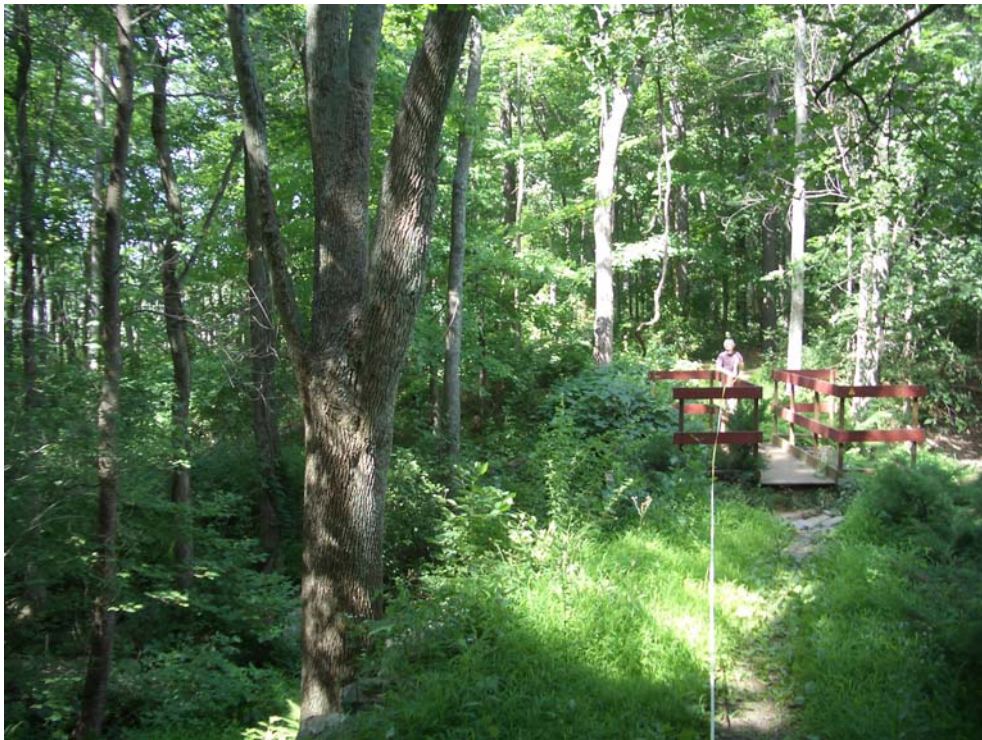
Photo #2: Taken from left abutment (east facing west) of dam and downstream.

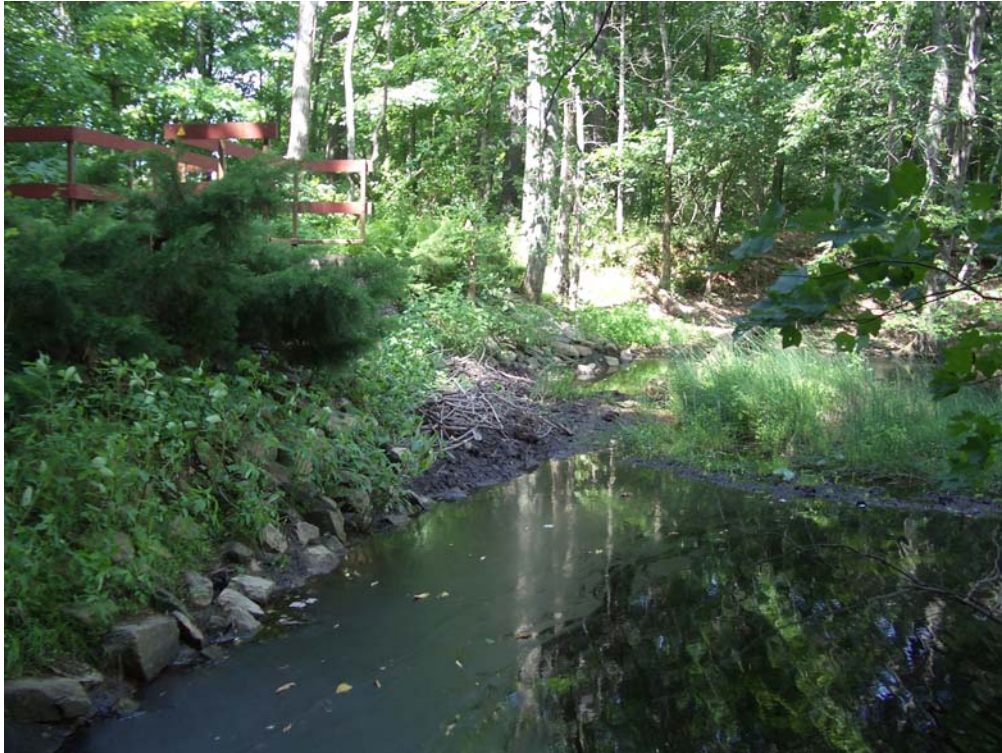
Photo #3 Upstream face of dam taken at left abutment (east facing west)

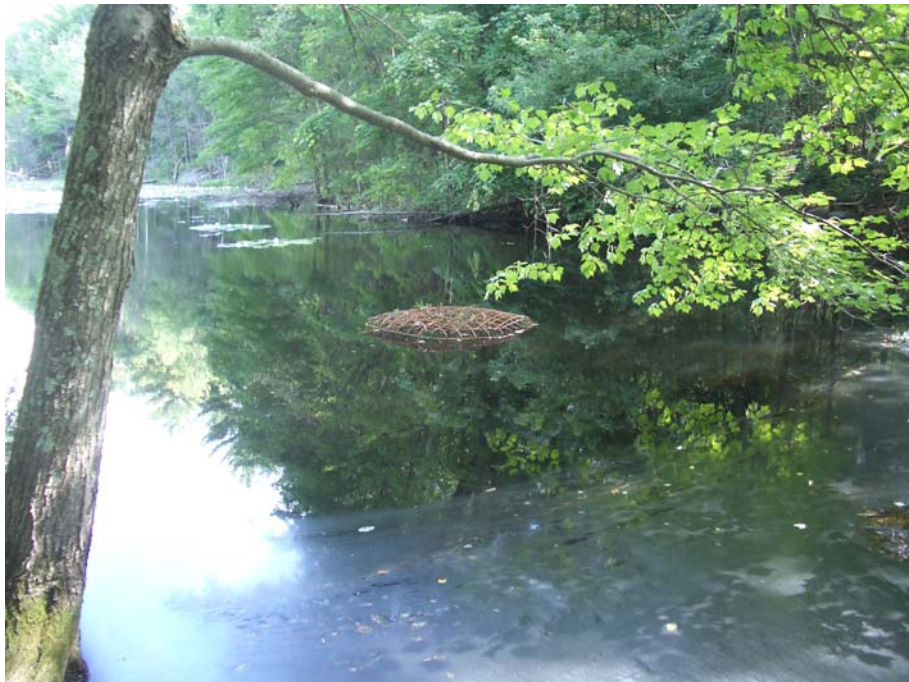
Photo #4: Screened inlet for spillway outlet pipe.

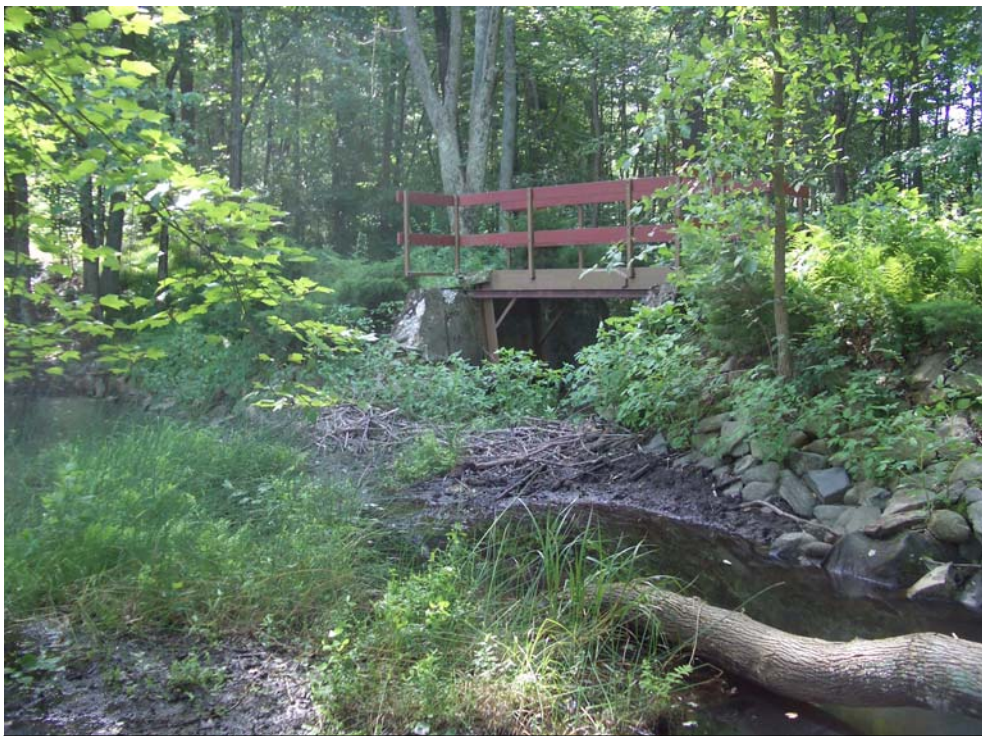
Photo #5: Upstream face, spillway and footbridge taken from right embankment.

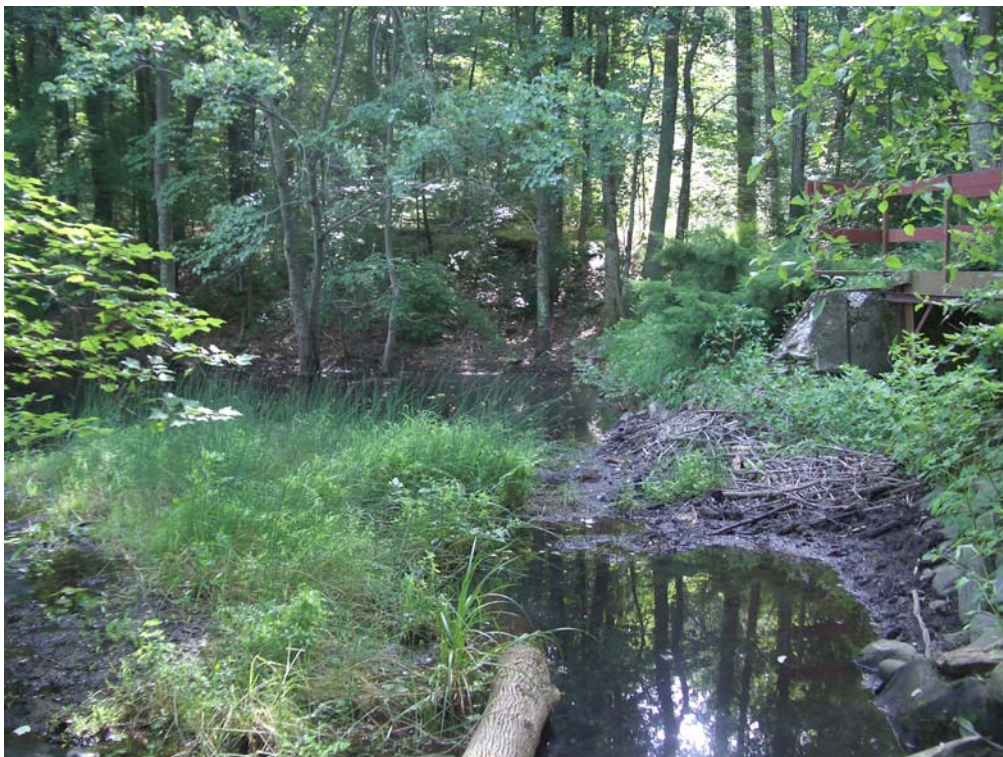
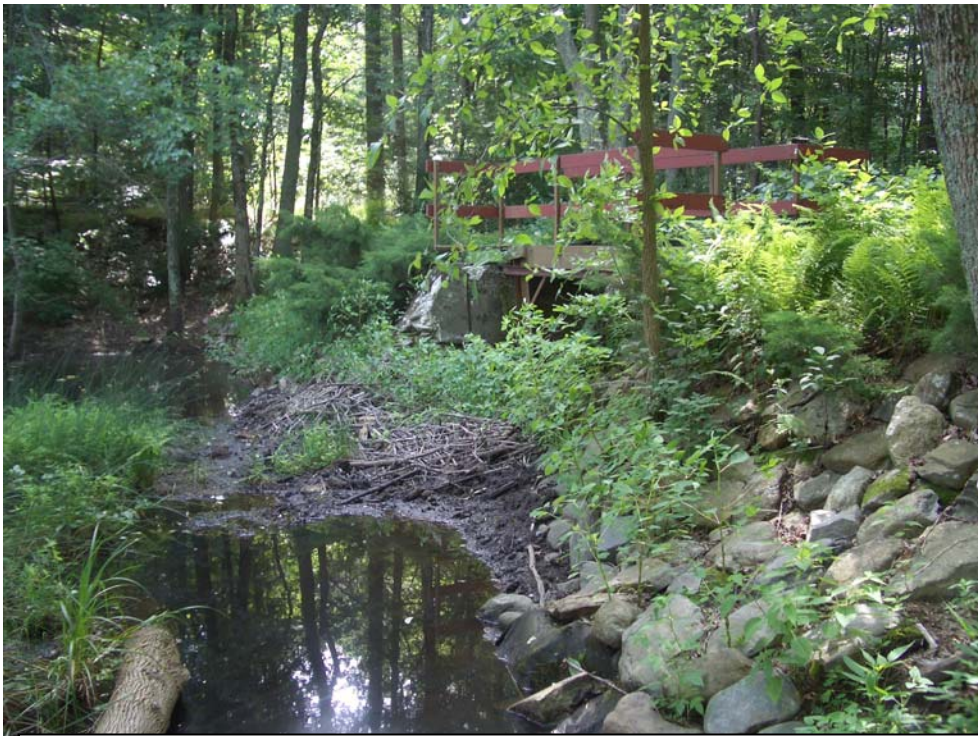
The spillway is partially clogged with branches and mud that appear to have accumulated due to storm flows. In the past, the pond has been home to beavers; however, there is little fresh sign of beaver activity. A 15-inch diameter corrugated polyethylene pipe and screened inlet was installed from the pool in front of the dam extending slightly past the spillway, atop the concrete sill, to bypass the accumulated debris or beaver dam. The pipe and inlet were installed within the last three years according to the limited records.

Photo #6: Debris dam and sedimentation in upstream pool.

At a minimum, the spillway should be checked for accumulated debris, wood, mud, etc., and cleaned as needed. That should be done at least quarterly (every three months) and after every significant storm event. Other recommendations will require further study.

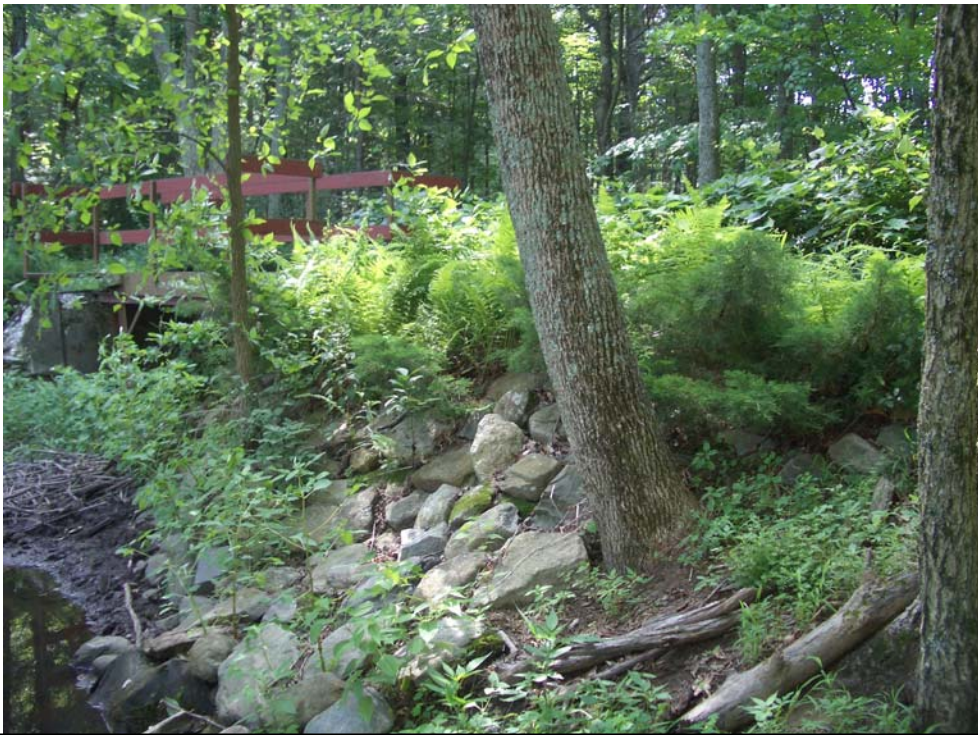
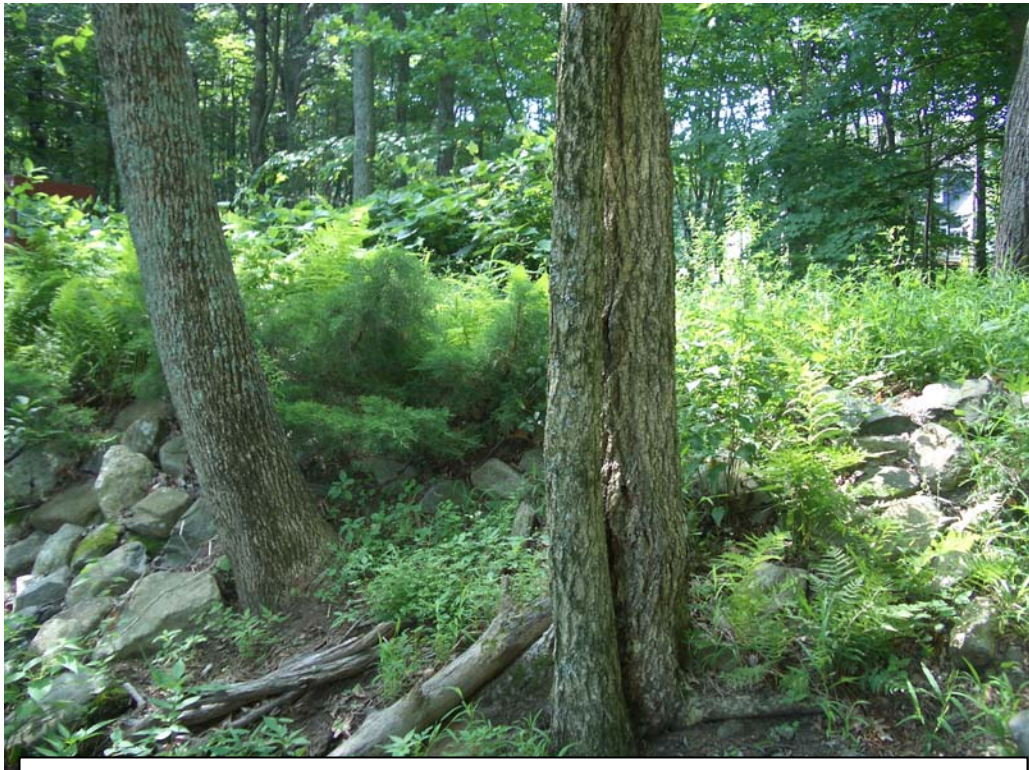
The upstream face of the dam consists of a battered (sloped) wall of smooth flat rocks. The rock face of the dam is in satisfactory condition with little observable erosion or wear. Trees are present on the right side face. See Photos 8 & 9. The pond appears stagnant and the pool directly in front of the dam is heavily silted in. Therefore, the visual inspection can only verify the condition of the face of the dam to the mud line. At the time of the inspection the mud line was completely visible and only partially submerged.

Photo #8: Trees in upstream face (right side)

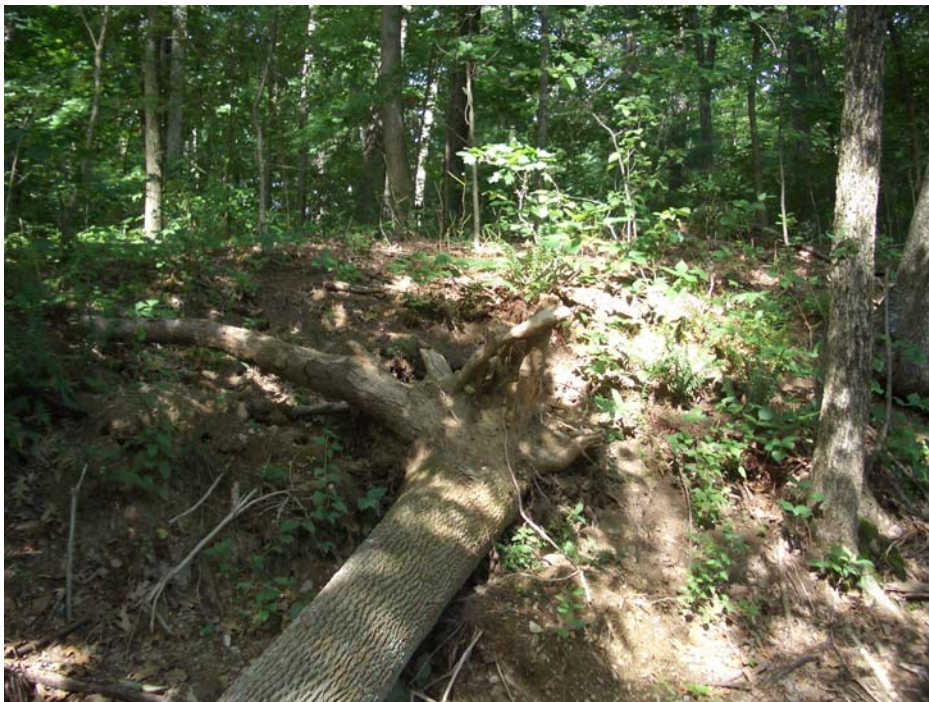
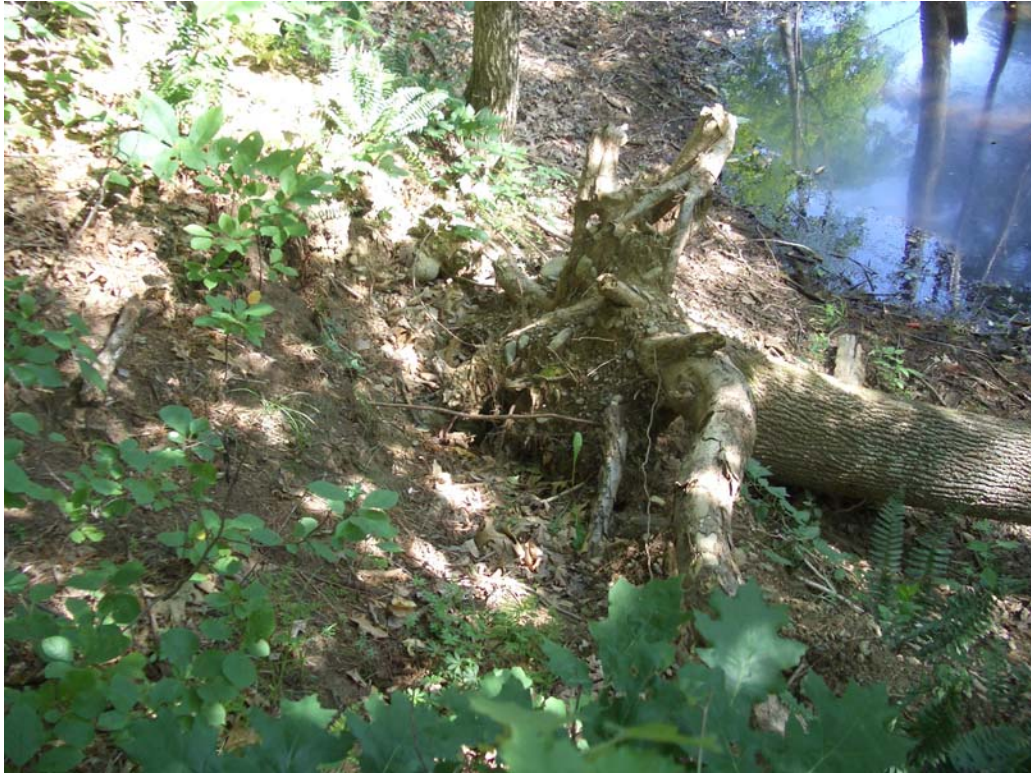
The abutments on both the left and right sides of the dam appear to be solid and dry. There is thick grass along the top of abutments and crest of the dam and only a few trees nearby on either side. At the corner of the right abutment, a tree has fallen over, removing the root ball and exposing a spherical volume within the pond embankment. This area doesn't appear to have weakened the dam abutment, but could be a cause for concern with erosion. See Photos 10 & 11.

Photo #10: Fallen tree upstream of the right side of abutment (view south).

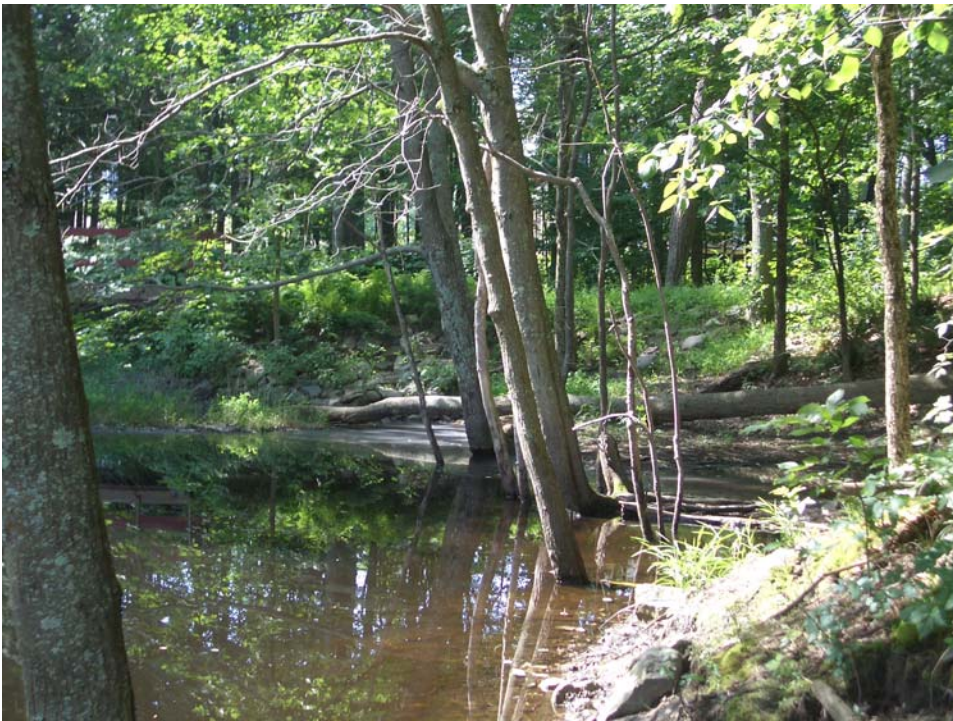
Photo #12: Right side upsteraam face, abutment and cove embankment

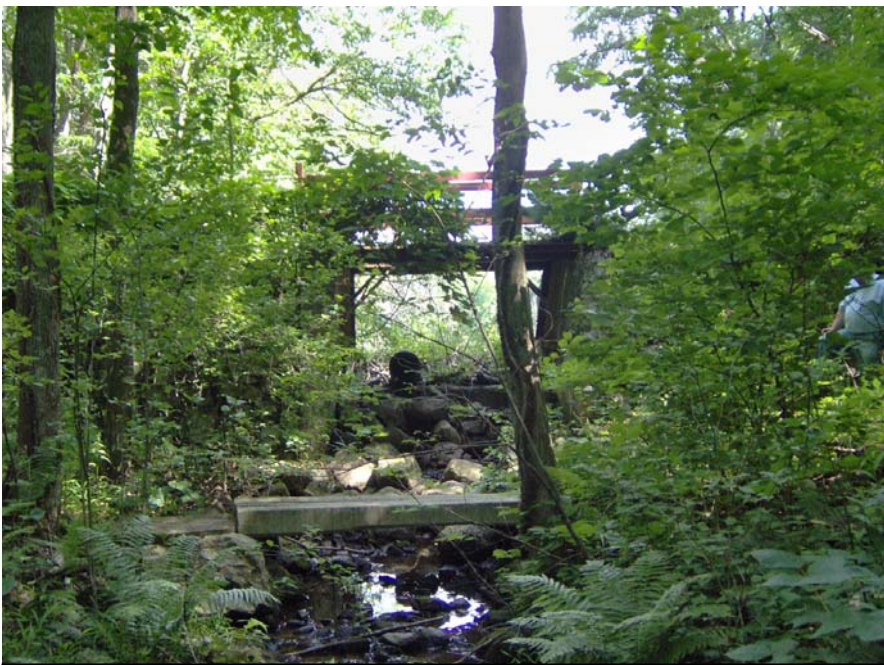
Photo #17: Downstream of spillway

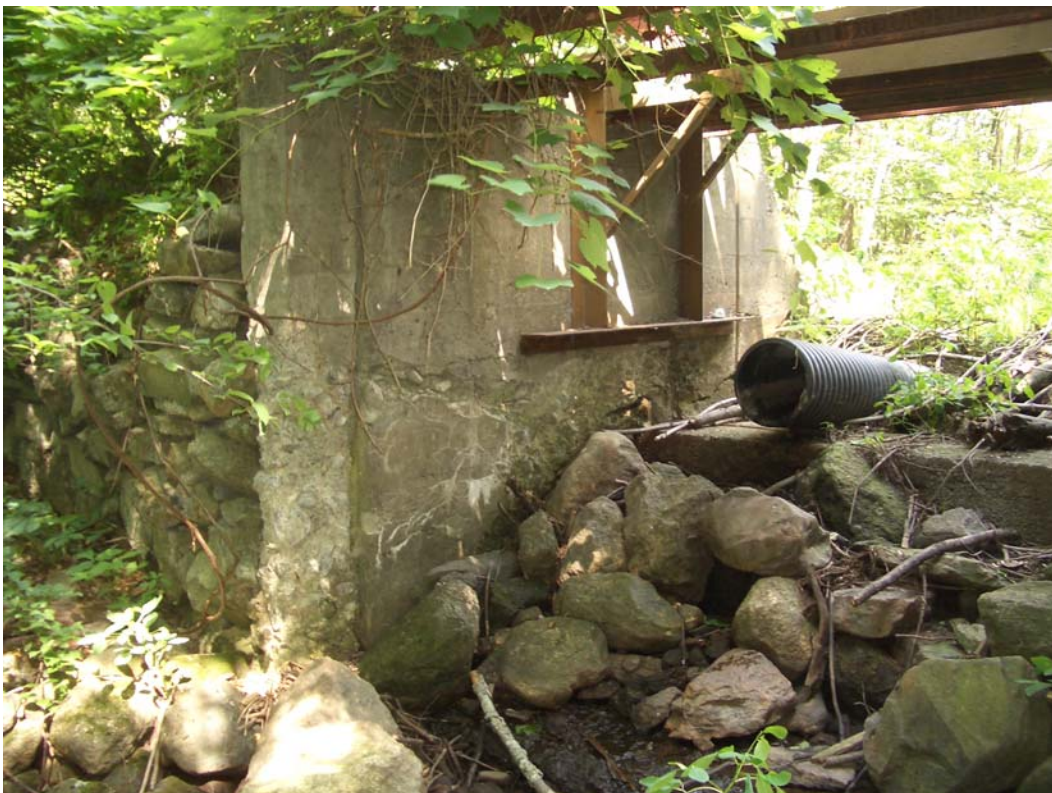
The spillway walls are made of concrete with aggregate sizes as large as approximately 6 inches in diameter. The concrete is consistent with the concrete produced in the late 19th century. The right (west) wall appears to be straight and vertical with a horizontal crack extending from upstream to downstream. The left (east) wall of the spillway has a large horizontal crack, which appears to penetrate completely through the thickness of the wall and extends from upstream to downstream. The left wall of the spillway appears to be bulged or folded such that the horizontal crack projects toward the center of the spillway many inches and the portion above and below the crack is leaning significantly (estimated 10 degrees) away from the center of the spillway. See Photos 18 through 25 in Appendix A for the spillway walls.

Photo #18: Downstream of spillway facing the right (west) spillway wall and dam wall

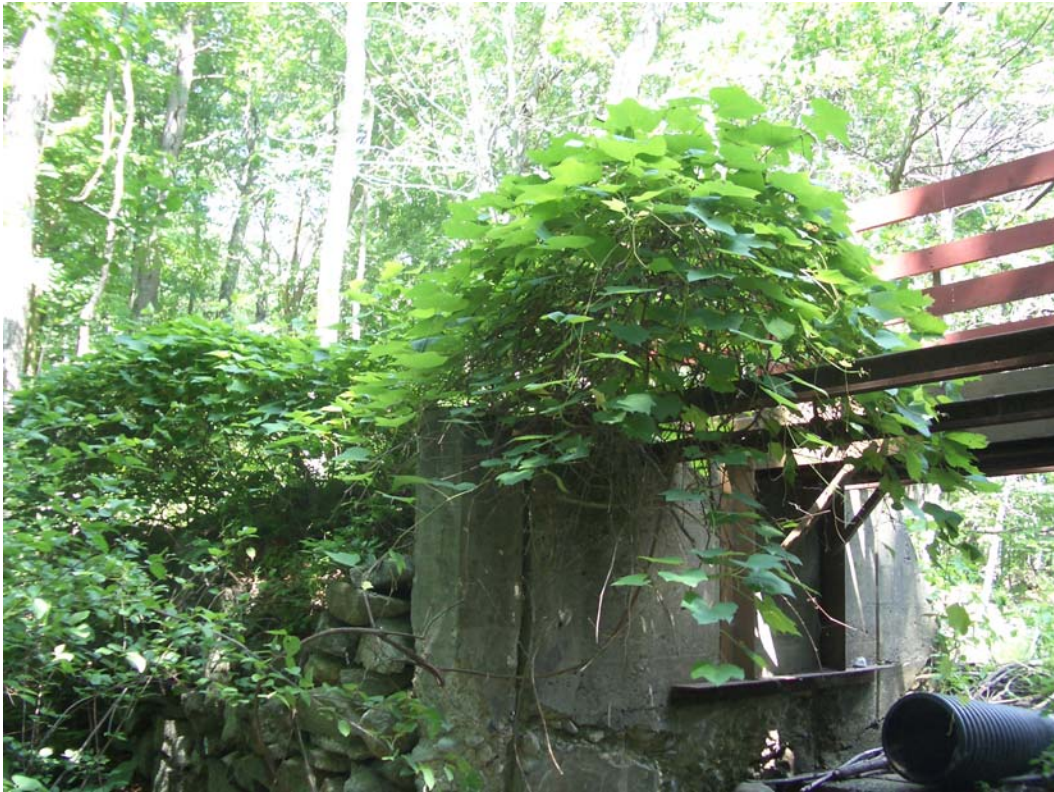
Photo #19: Downstream of spillway facing the right (west) spillway wall and dam wall with grape vine

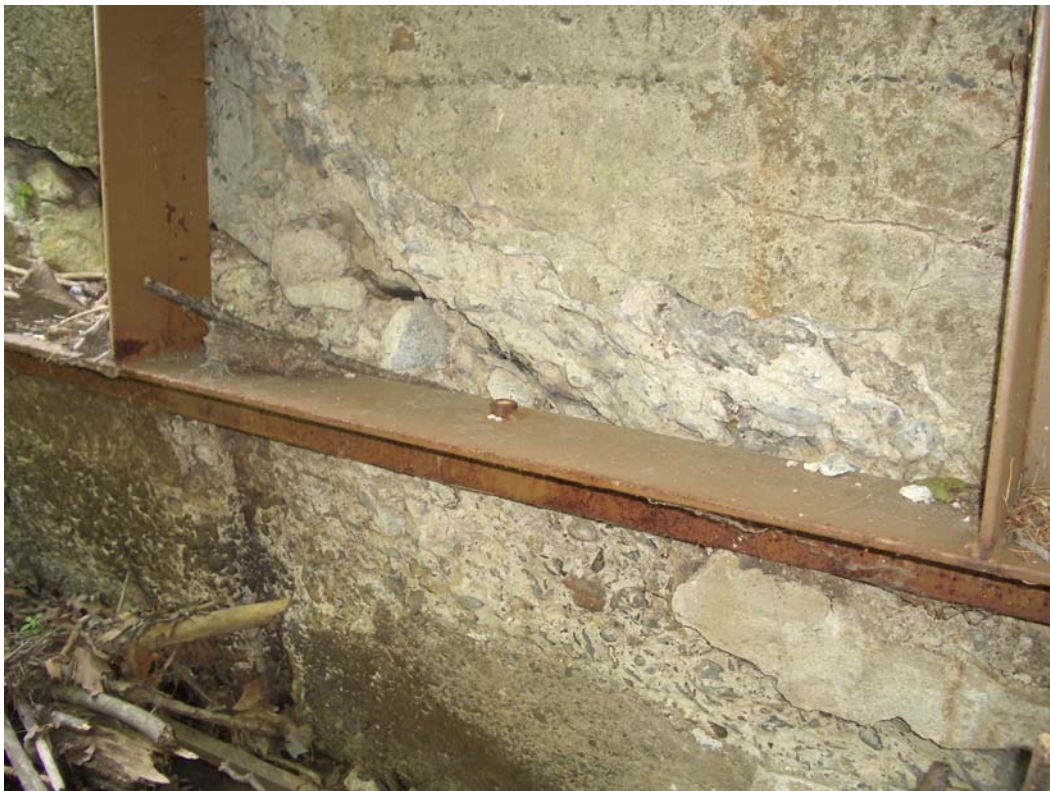
The structural stability of the Fyfeshire Dam appears to be in unsafe condition based upon the visual inspection. In particular, the downstream face on the right side and the cracked and broken left wall of the spillway contribute to the "Unsafe" designation. These two walls appear to be of concern and could have significant impacts to the entire structure if they fail.

Photo #20: Major crack in left spillway wall and steel bracing

The spillway and embankments will require immediate replacement or significant repairs to remain in service.

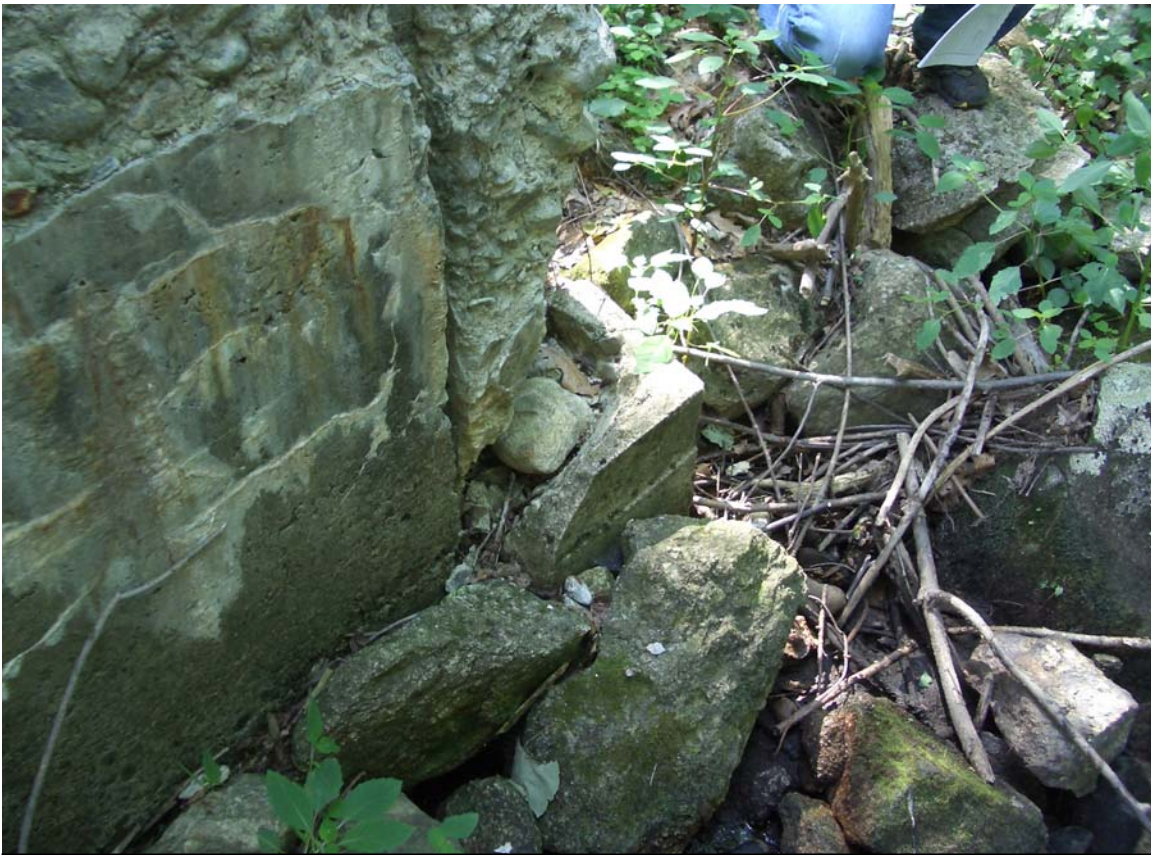
Photo #21: Deterioration of left, downstream spillway wall

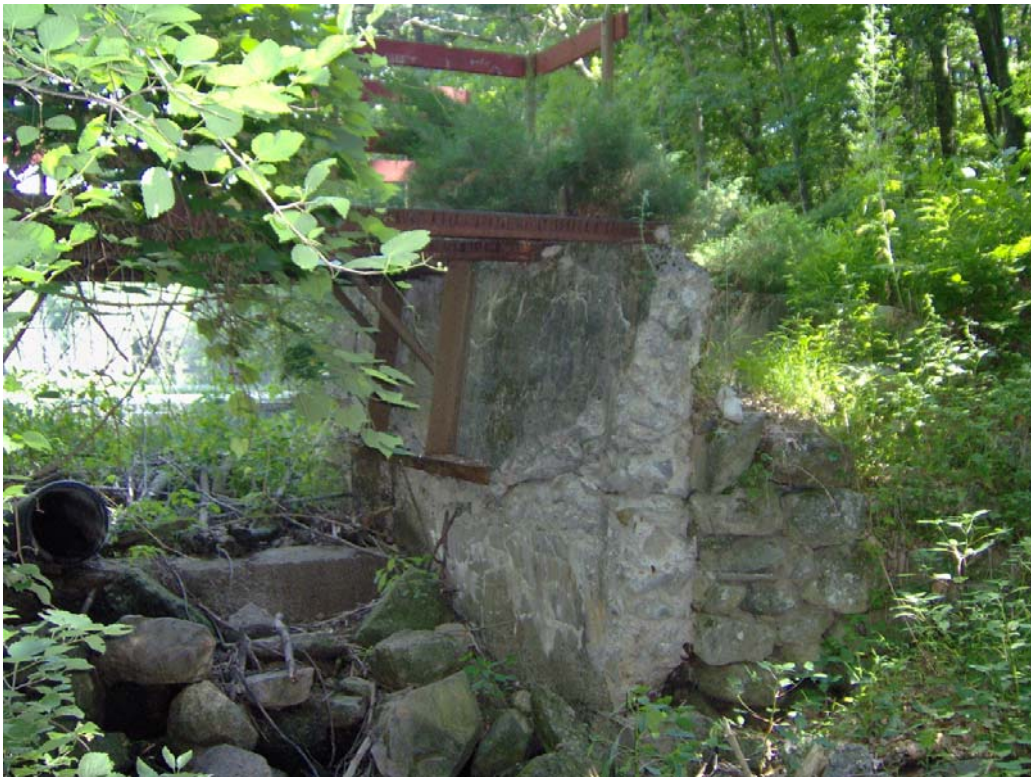
Photo #22: Left side of spillway.

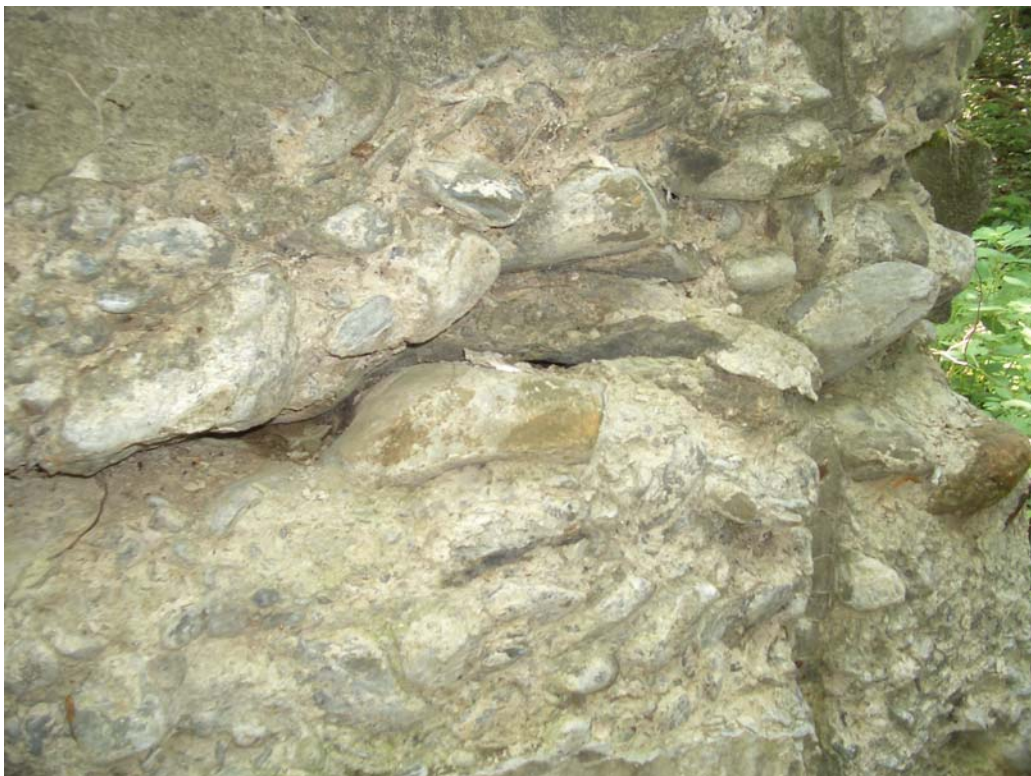
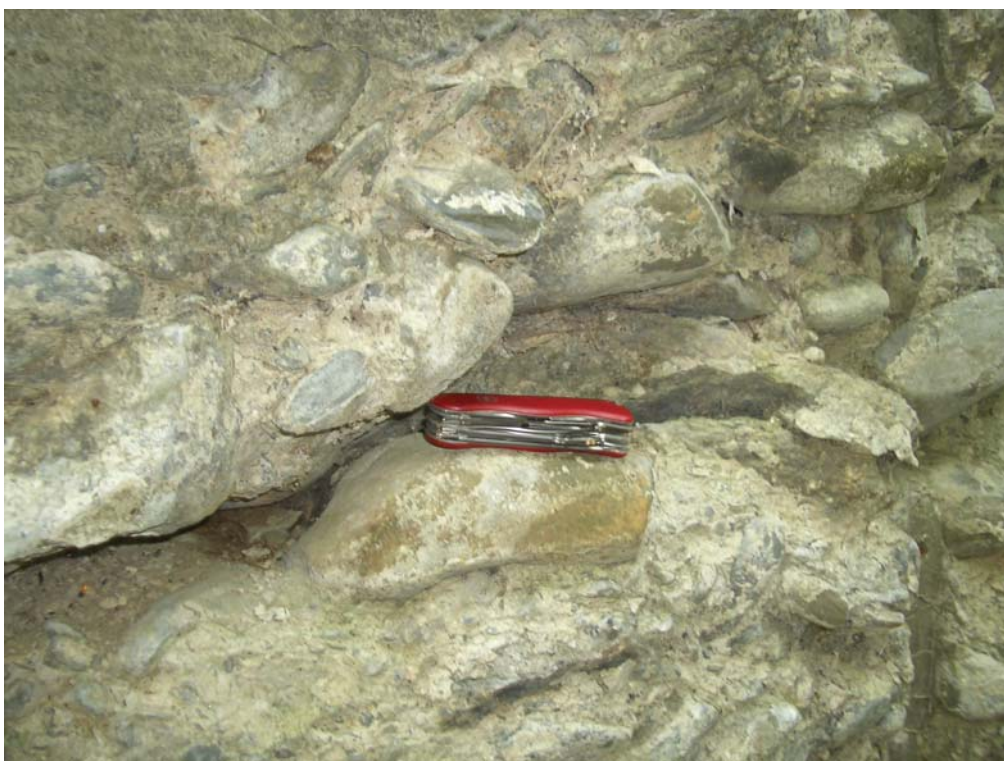
Photo #23: Major crack in the left spillwaywall downstream

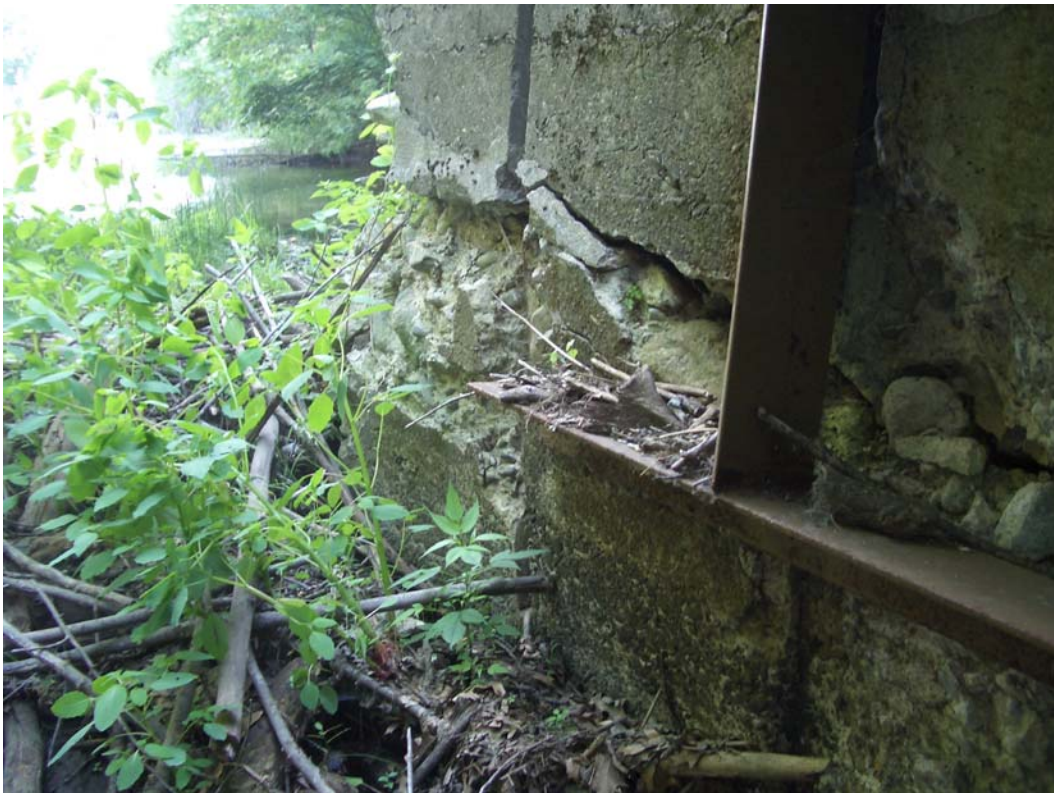
Photo #25: Major crack in left spillway wall ,upstream

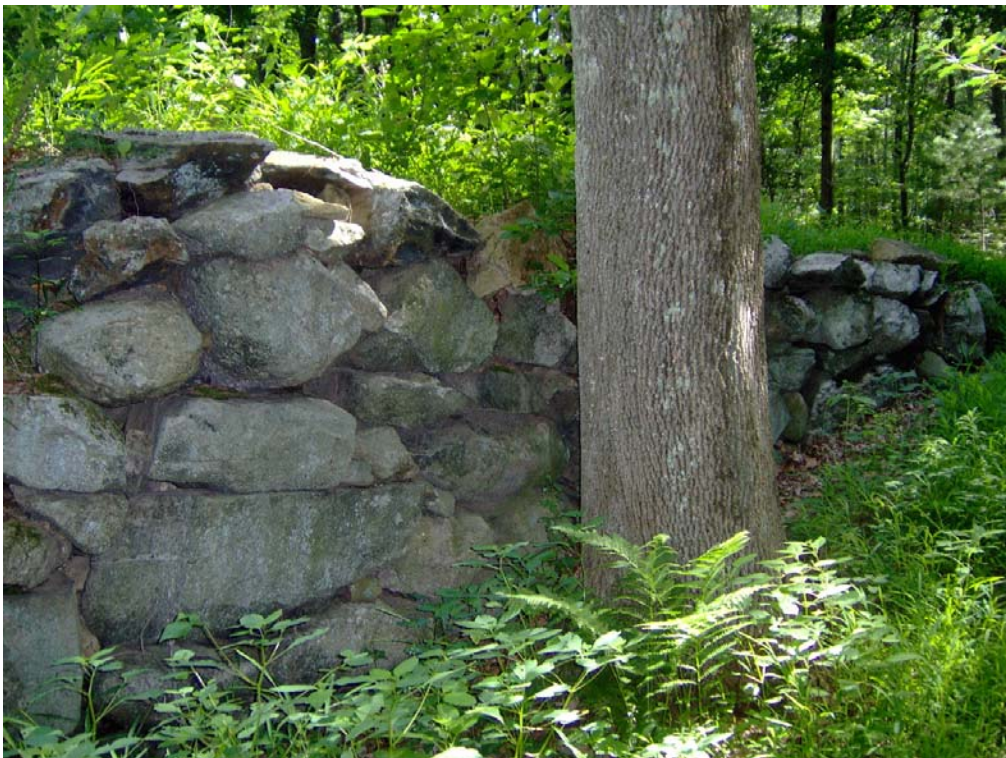
Photo #26: Downstream face, left side

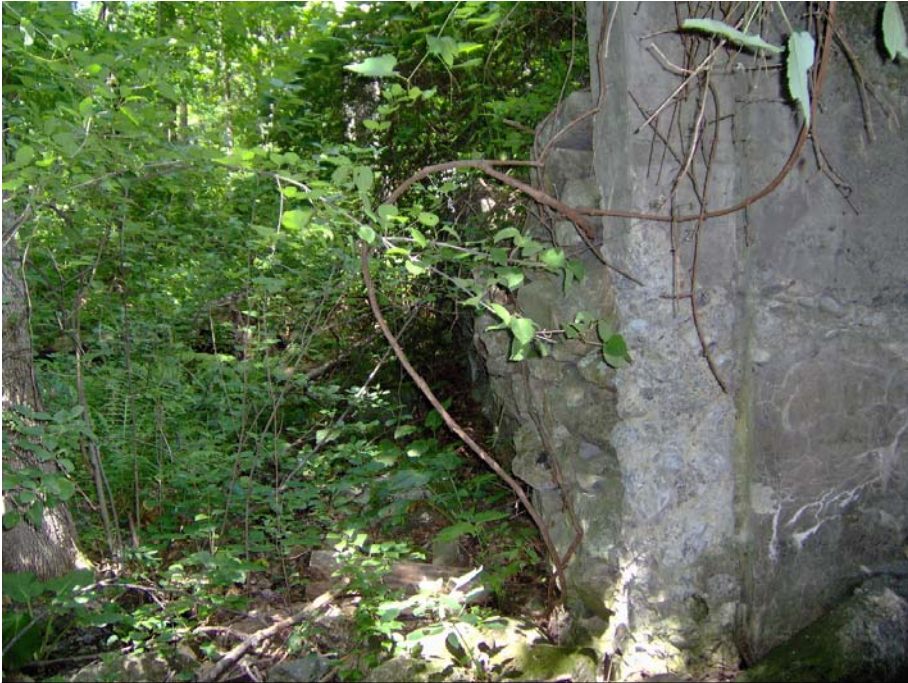
Photo #27: Downstream face, right side

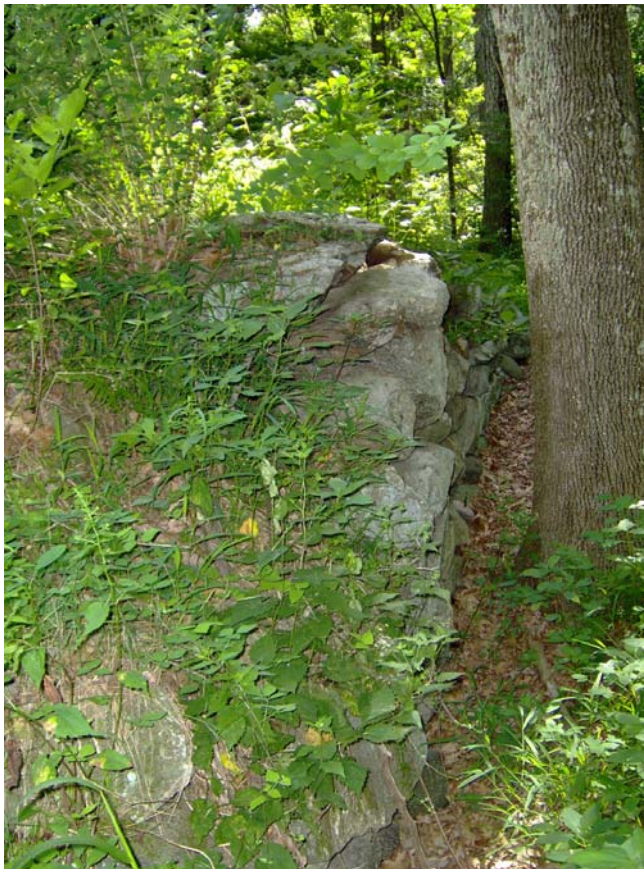
Photo #28: Downstream face left side.

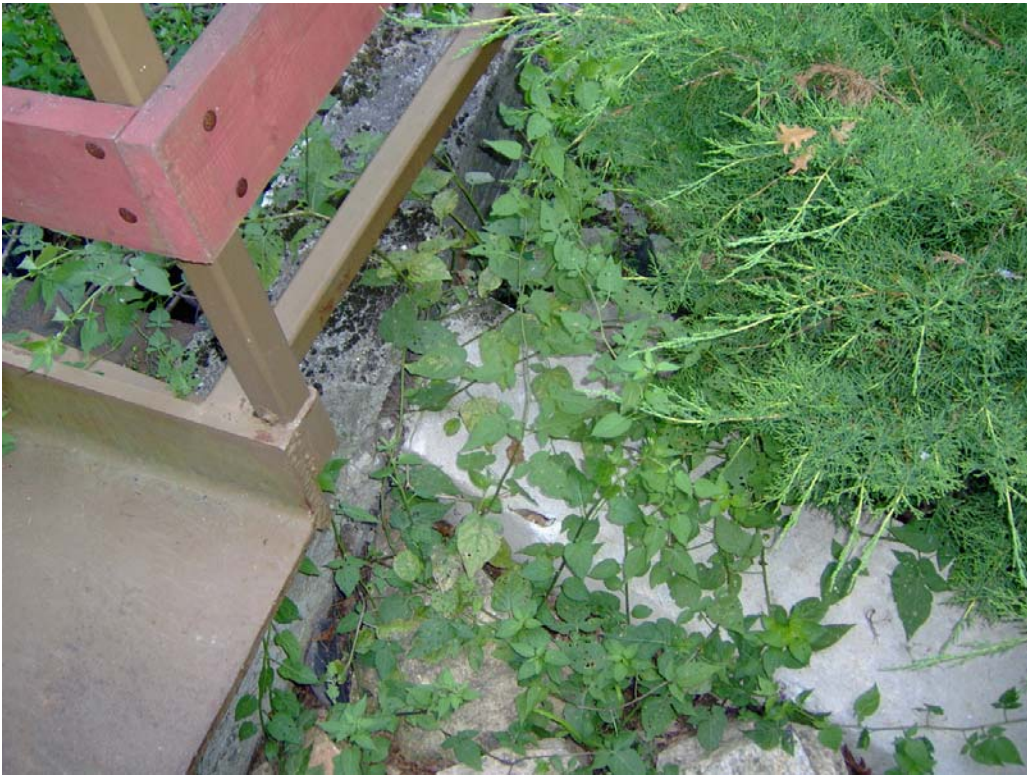
Photo #29: Repair section on left side of spillway

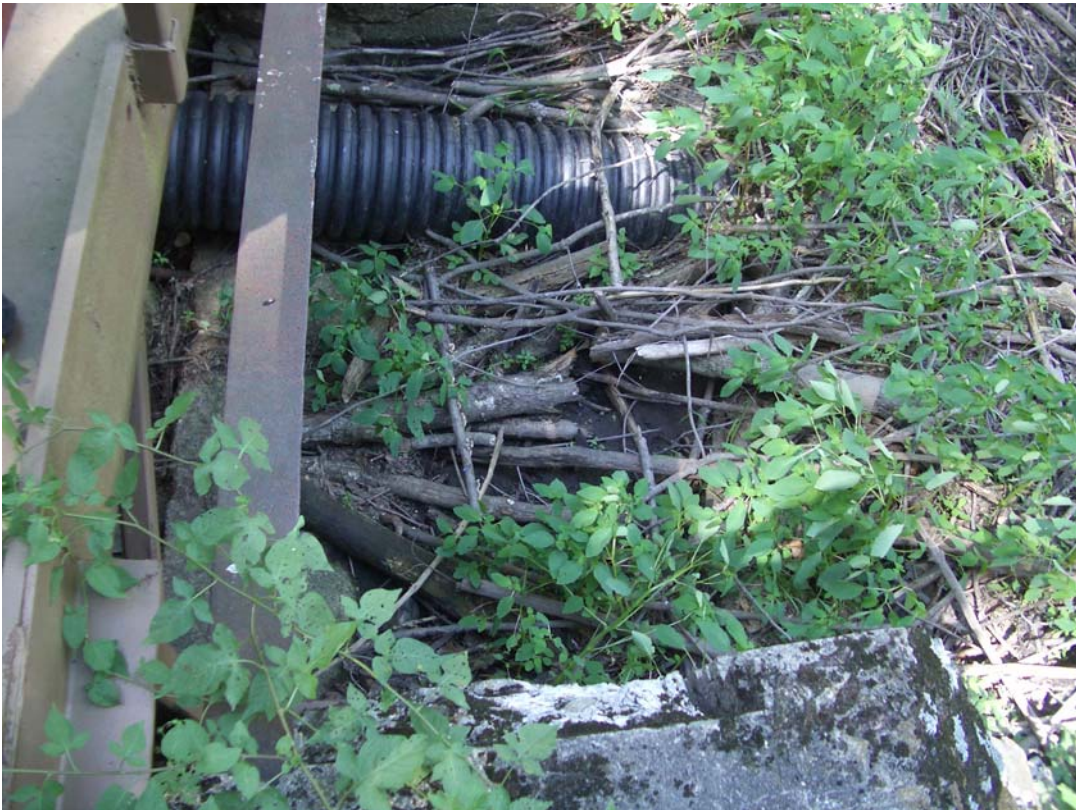
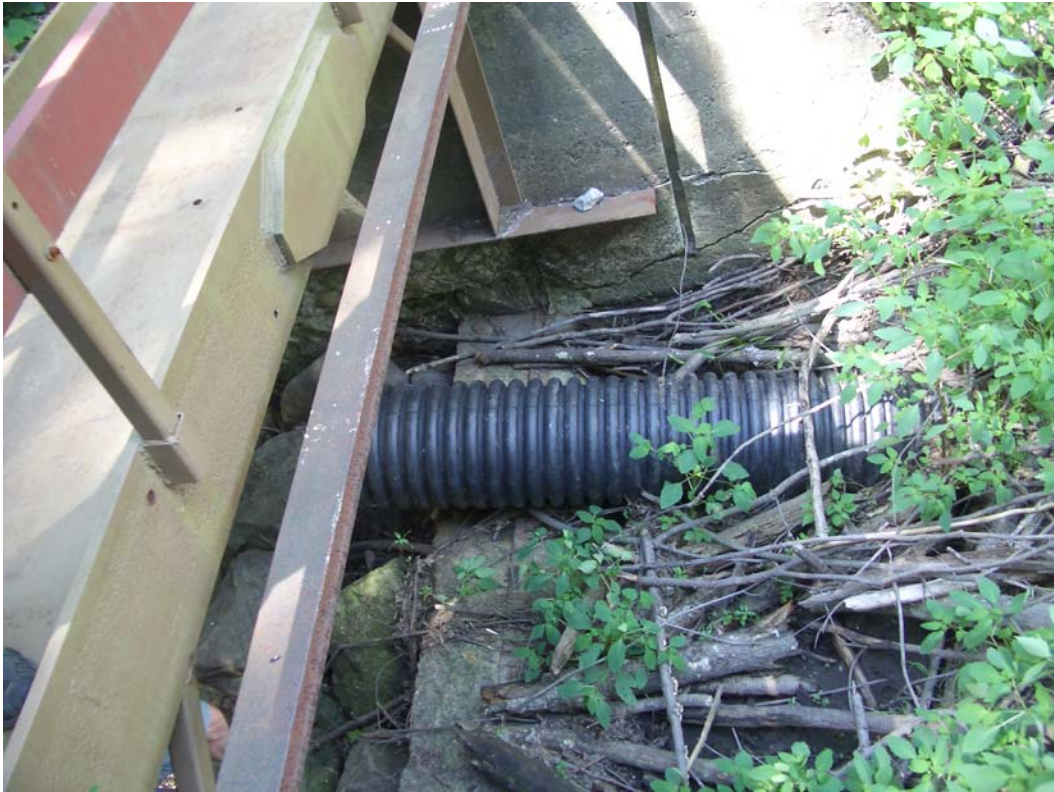
Photo #30: Debris dam at the spillway and pipe outlet.

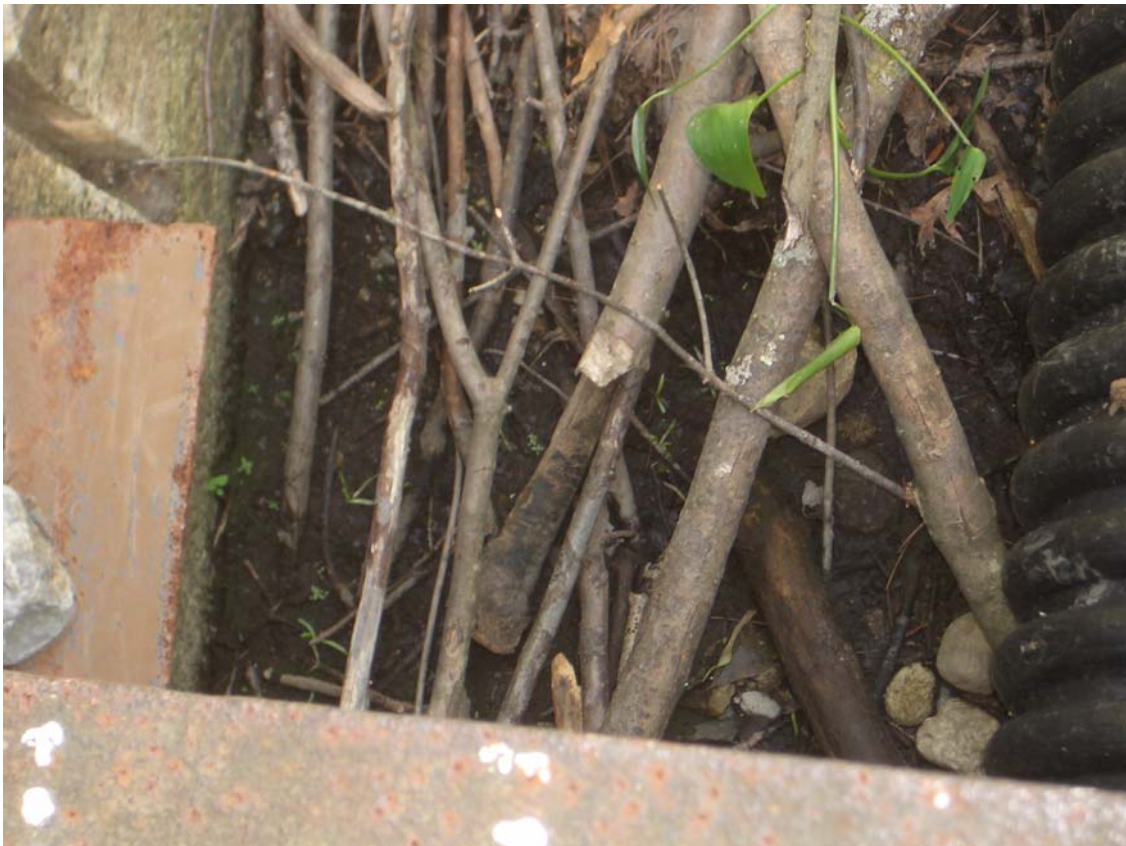
Photo #32: Evidence of old beaver activity
