## Town of Bolton, MA Old Fire House Structural Evaluation - Final

**TO:** Randy Heglin, DPW Director  
**FROM:** Trent Guihan; Craig French, PE, Principal Structural Engineer  
**COPY:** Daniel Roop, PE; Peter Valinski, PE  
**DATE:** June 10, 2022

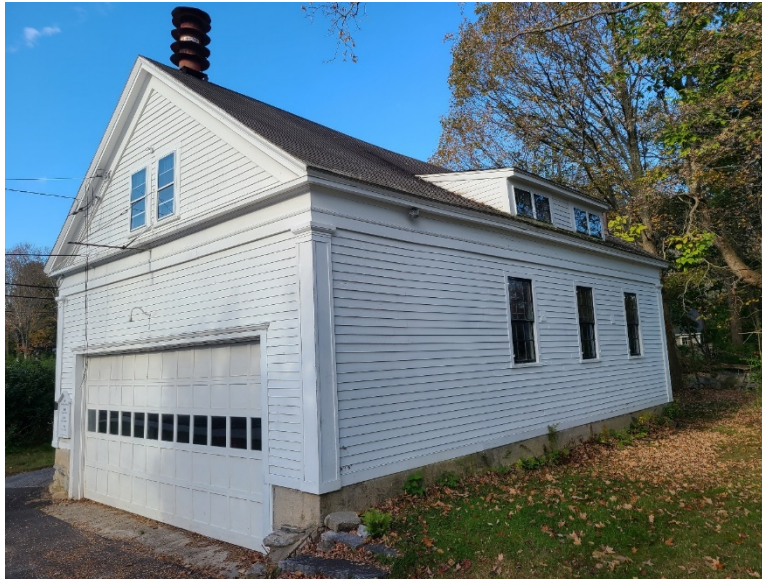
Overall, the wood siding, corner boards, soffit and gable trim are generally in good condition (painted ~10 years ago according to maintenance staff). Patch work of siding is evident at the access door by the garage door as well as trim replacement around the door frame. It is likely that the door was replaced, and new trim was installed during this work (**Photo 1**).

Photo 1 – Old Fire House Southeast Exterior looking Northwest

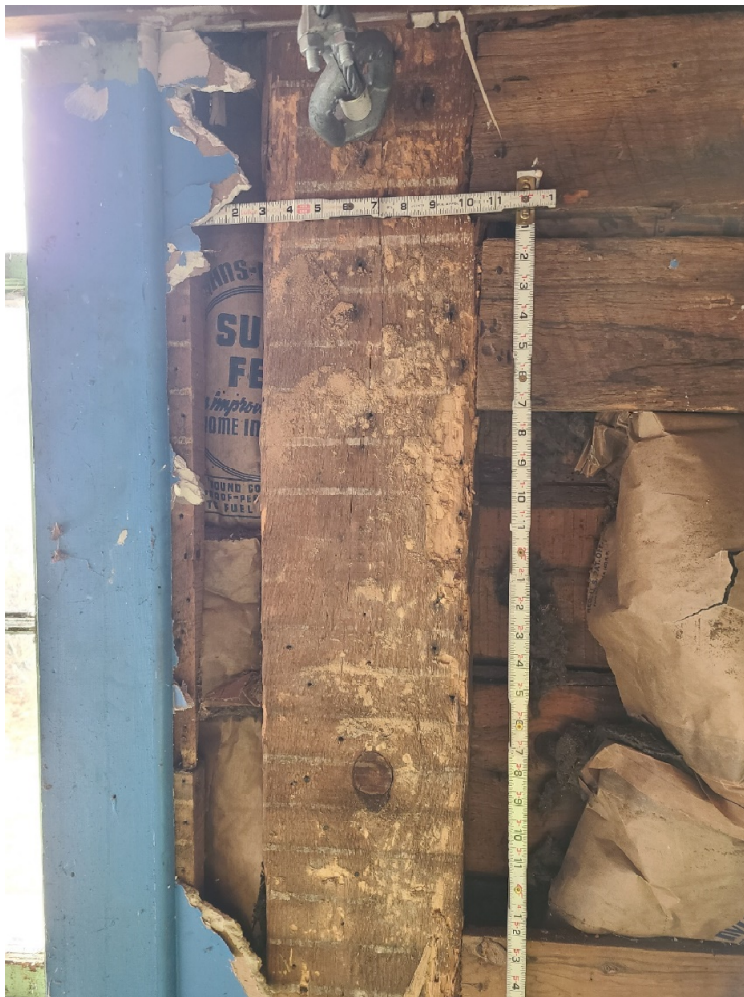
Photo 2 – Column A3 before, note evidence of BID on exterior of column

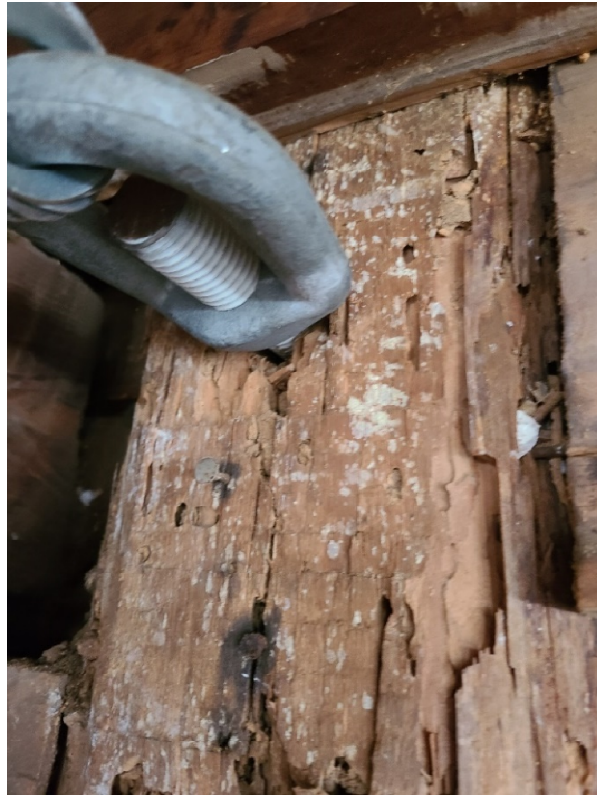
Photo 3 – Column B4 as observed after selective demo, extreme BID evident without removal of material.

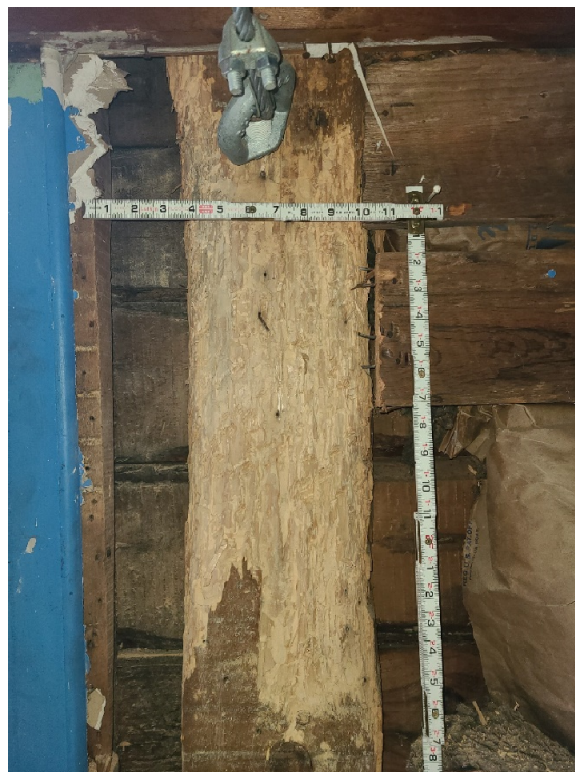
Photo 4 – Column A3 after scraping to remove surficial BID, note damage continues into member beyond loose material removal.

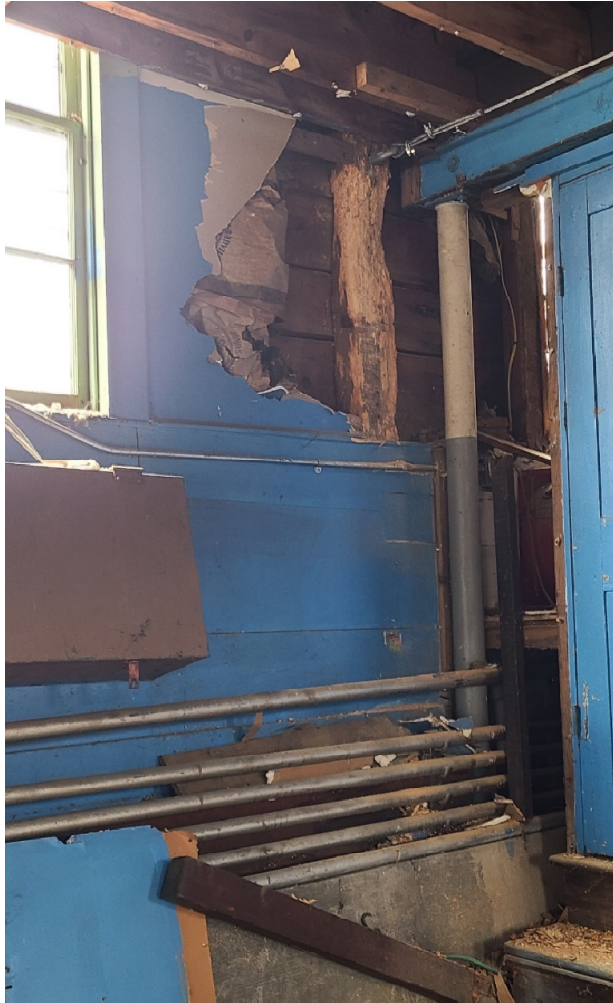
Photo 5 – Column A4 after scraping to remove surficial BID, note damage continues into member beyond loose material removal.

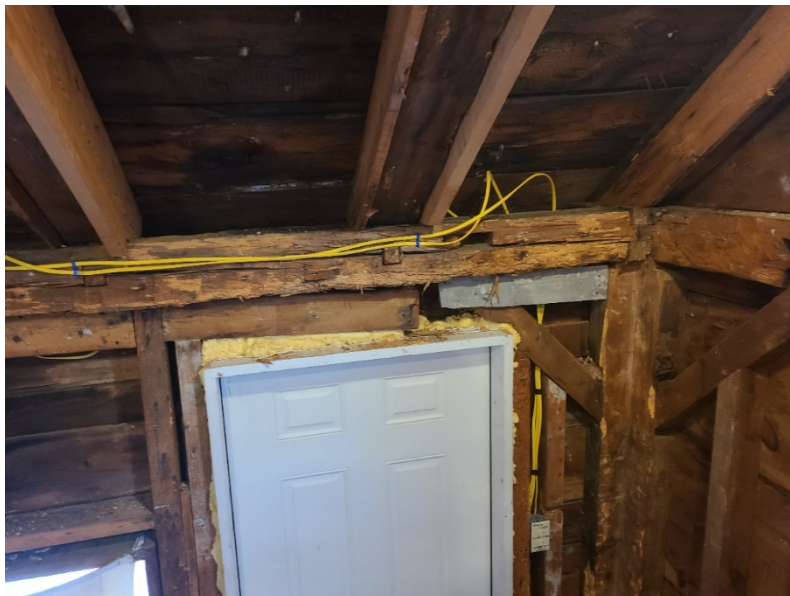
Moving up the stairs to the second floor, evidence of BID in the original structural members is prevalent in almost every visible original timber member. A flathead screwdriver was used to inspect the integrity of a select number of members including the top plate along column line A and corner column A5 at the stair landing (**Photo 6**). Column A5 had extensive BID on both interior faces of the column to a depth of about 3/4" +/- 1/4", though the center mass of the member appears to be sound when poked with the screwdriver insect boring holes are evident within the remaining portion.

Photo 6 – Observed BID in top plate along Column Line A and in Corner Column A5

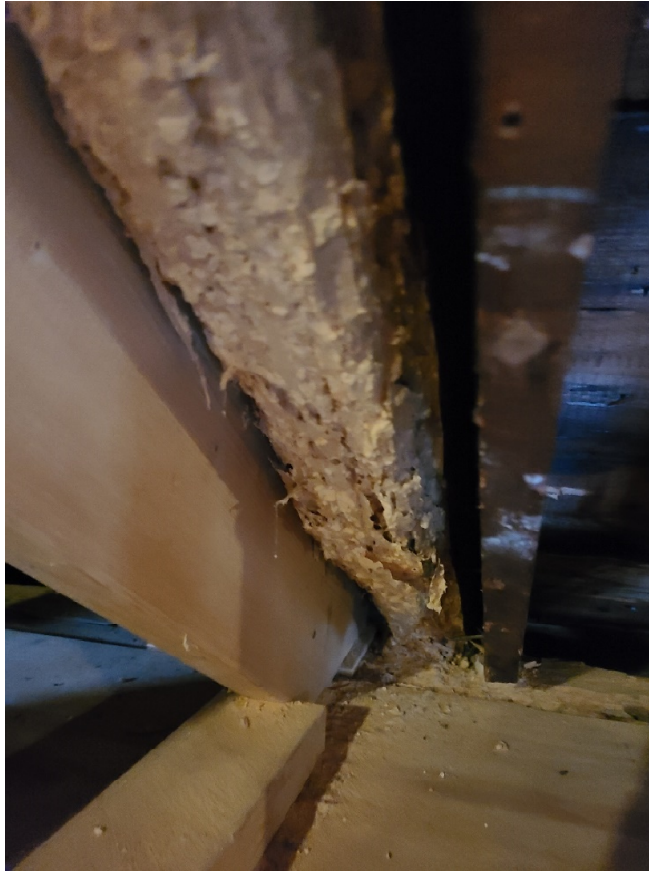
Standing on the second floor observing the exposed roof beams and sheathing, evidence of BID is apparent on every original roof beam with varying degrees of extent. In some members, BID appears to be localized in a small area while others have significant visual section loss throughout its length (**Photo 7**). Dimensional lumber has been sistered to these original roof members in an effort to repair the roof framing (**Photo 8**). Carrying beams have been installed across the shed dormer roof line perpendicular to their sistered rafters intended to transfer some of the roof load away from the side bearing walls and into the steel beams and columns below. See **Figures 2 & 3**, lidar scan renderings, showing the roof framing conditions. Speaking with town maintenance staff, this work was completed around a similar time as the cable ties. This repair does not appear to be an engineered system. The members are simply nailed to the original members with a minimal nailing pattern and no connections to the supporting members below. For the time being, this assembly may assist the damaged members in supporting roof gravity loads, but it does not appear adequate to resist all applicable design loads, nor provide a code compliant construction for continued occupancy.

Photo 7 – Roof rafter with extreme BID along Column Line B Above Column B4

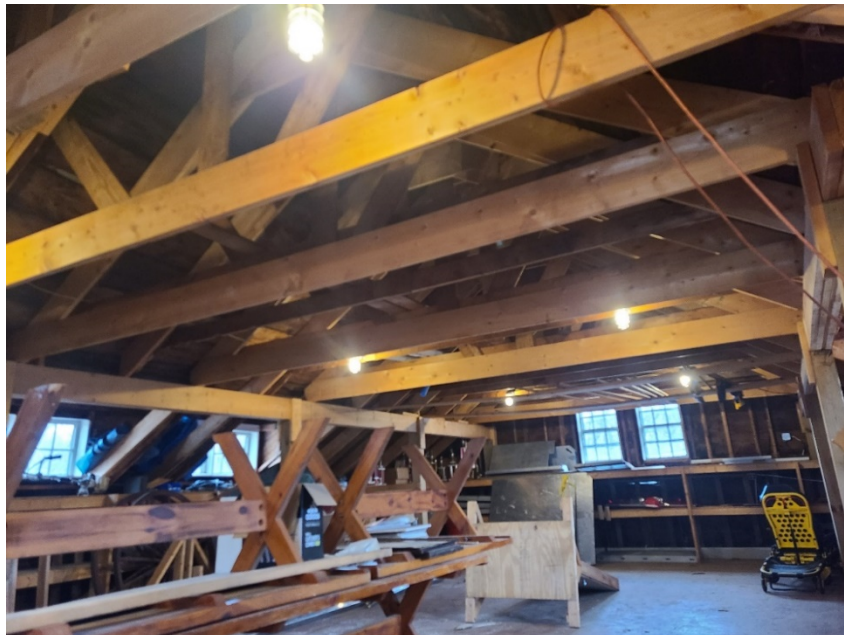
Photo 8 – Typical supplementary roof framing seen from second story floor. Note carrying beams background left and foreground right.

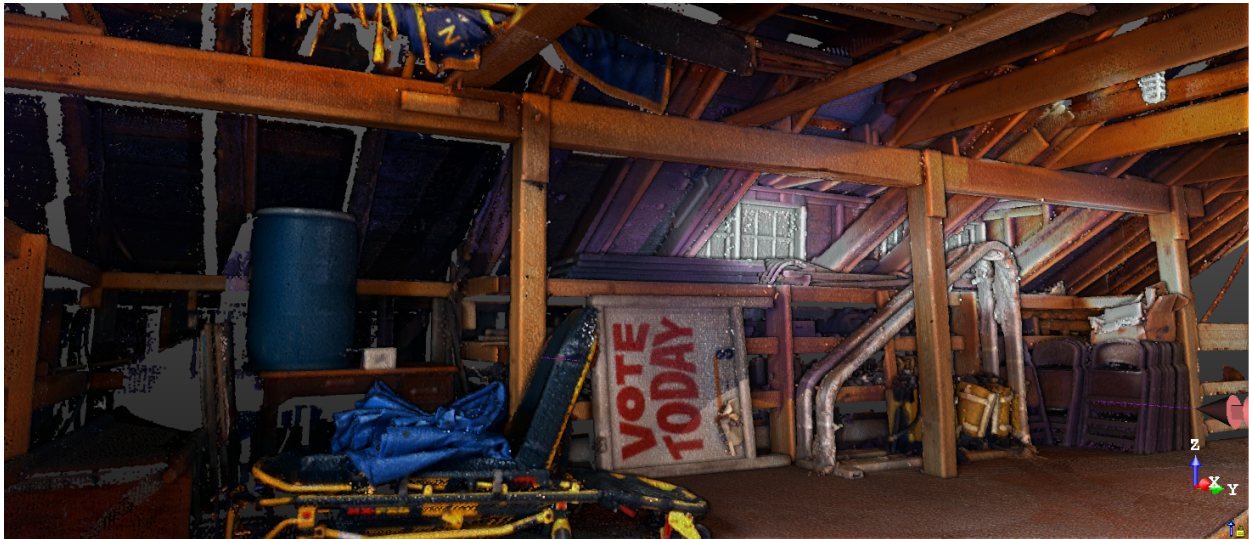
Figure 2 – Carrying beam along west side of roof framing

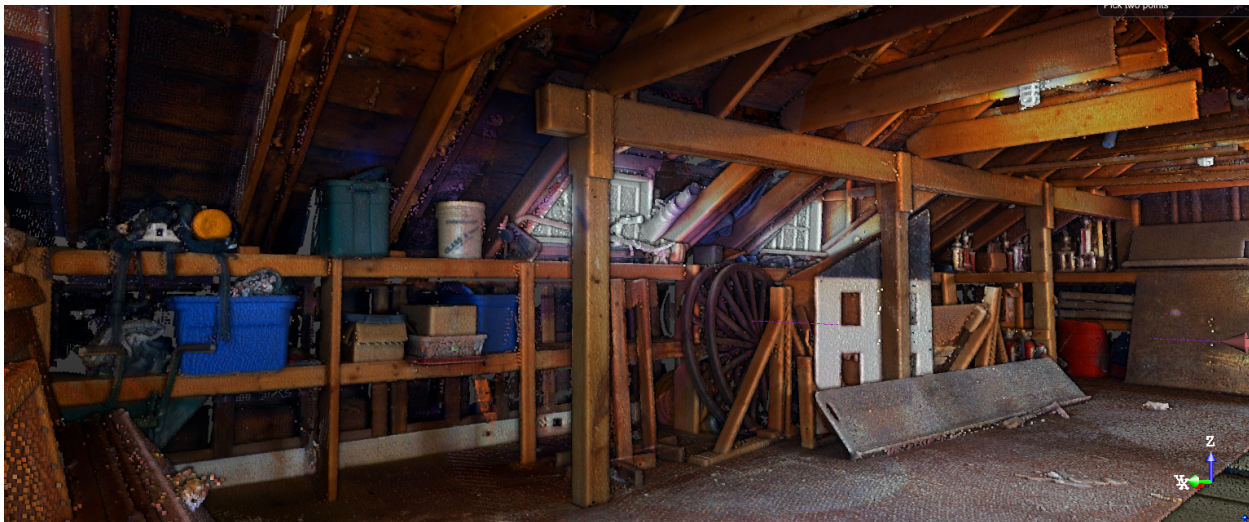
Figure 3 – Carrying beam along east side of roof framing.

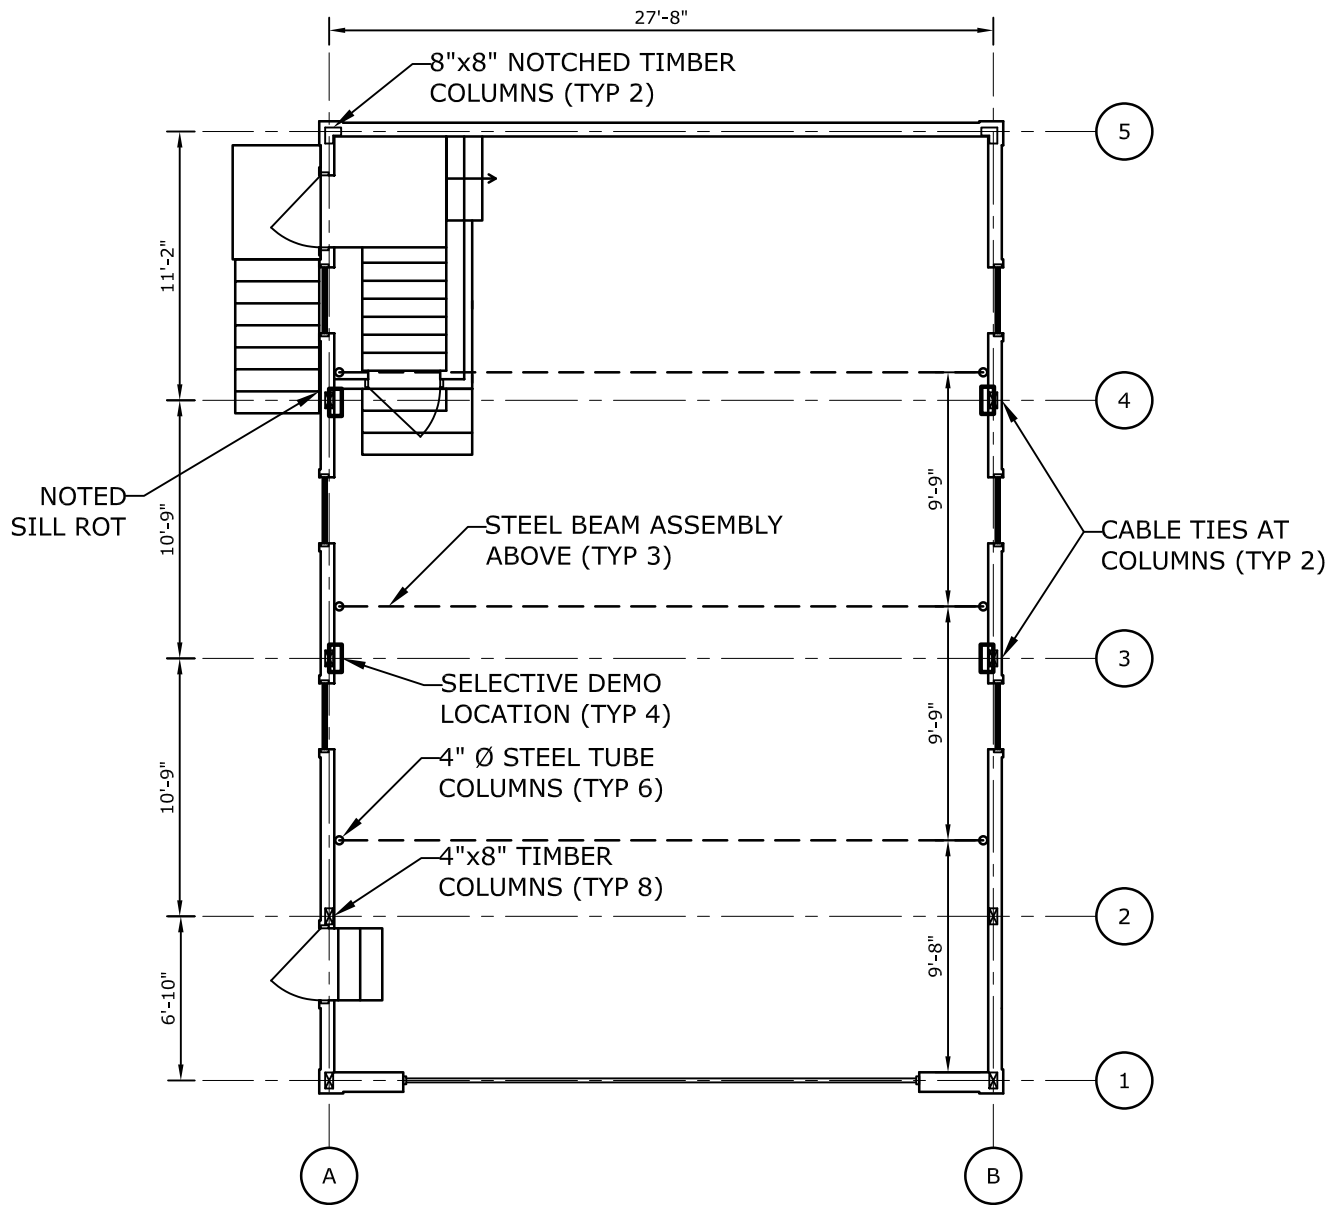
FIGURE 1

The ground level garage walls are mostly covered with interior finishes. Selective demo was done in four locations at the cable system connections to the columns to observe the structural condition of the building within these areas (Columns A3, A4, B3 & B4). See **Figure 1** for Floor Plan of lower level and column grid. The drywall and batt insulation were removed at these areas to expose the wood framing (**Photos 2 & 3**). Once the drywall and batt insulation were removed, the columns were scraped with light hand force using the back end of a hammer to remove BID. Note material that has been digested by wood boring insects will be powdery and what remains on the surface is paper thin, very little effort is needed to expose these areas (**Photos 4 & 5**). Three of the four columns (A3, A4 & B4) inspected had section loss of 1" or more +/- 1/2" due to BID. The fourth column (B3) also had evidence of BID, however, it was mostly sound and not significantly damaged in the area observed. While the columns observed on the ground floor had evidence of BID as described above, the partition wall framing and wide plank paneling appears to be in fair condition with little to no BID based on the limited view of these selectively demolished areas.
