Bolton, Massachusetts

MUNICIPAL BUILDING CONDITIONS ASSESSMENT REPORT

Town of Bolton

June 2022

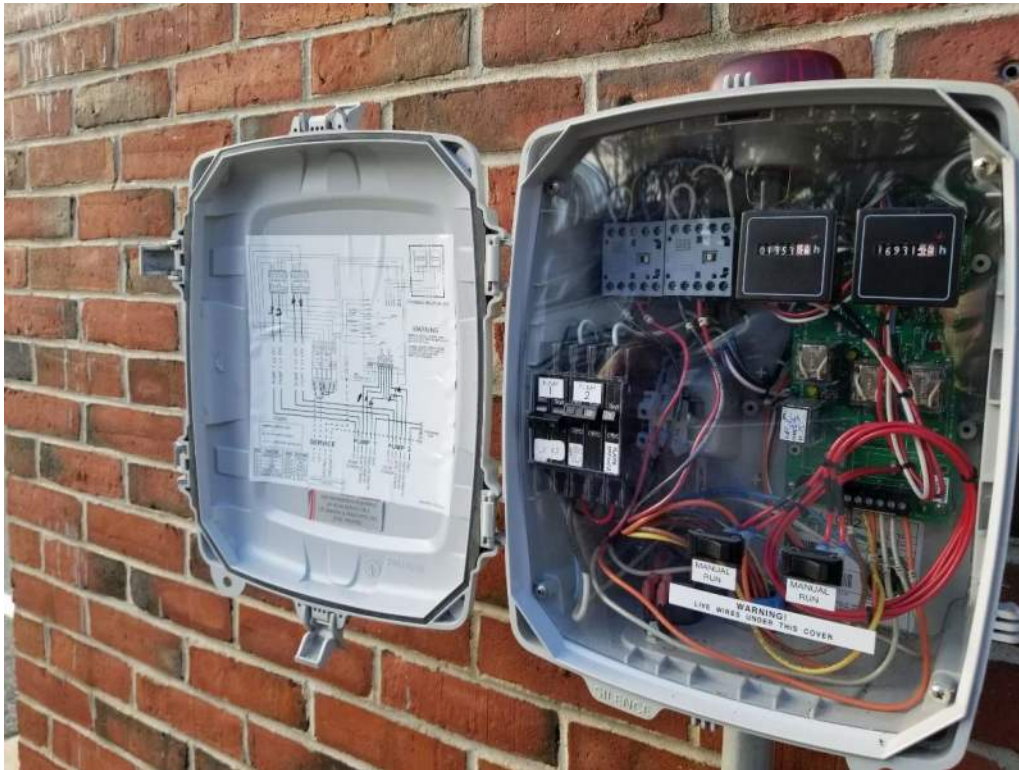
Photo C1: Photo of E-One Grinder Pump Control Panel. Power wiring and the control panel need replacement.

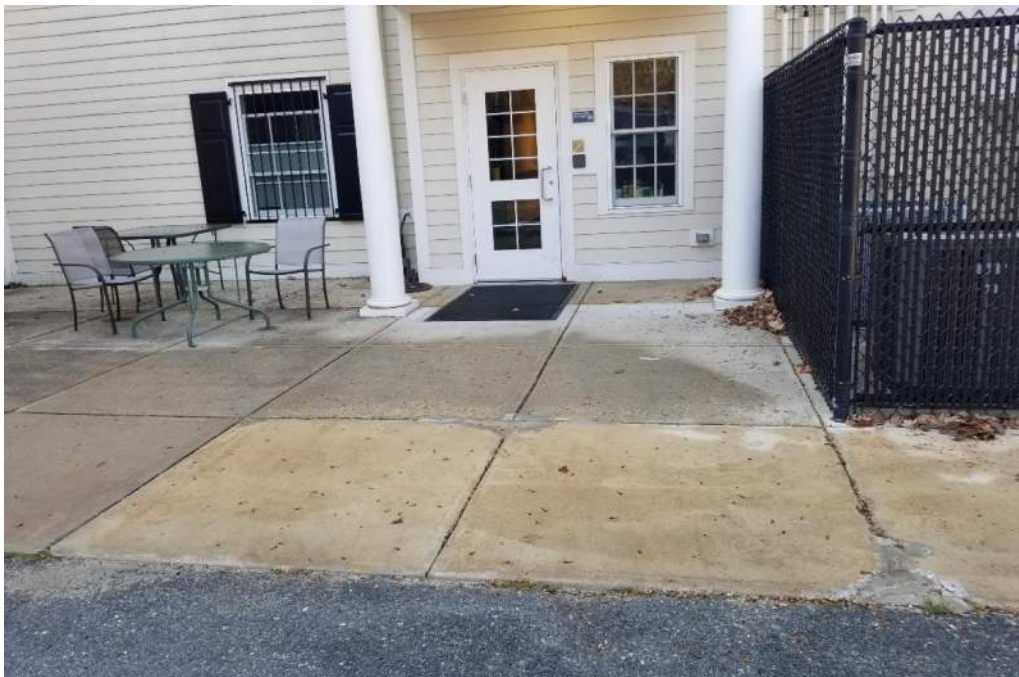
Photo C2: Compromised side entryway sidewalk damage in need of repair.

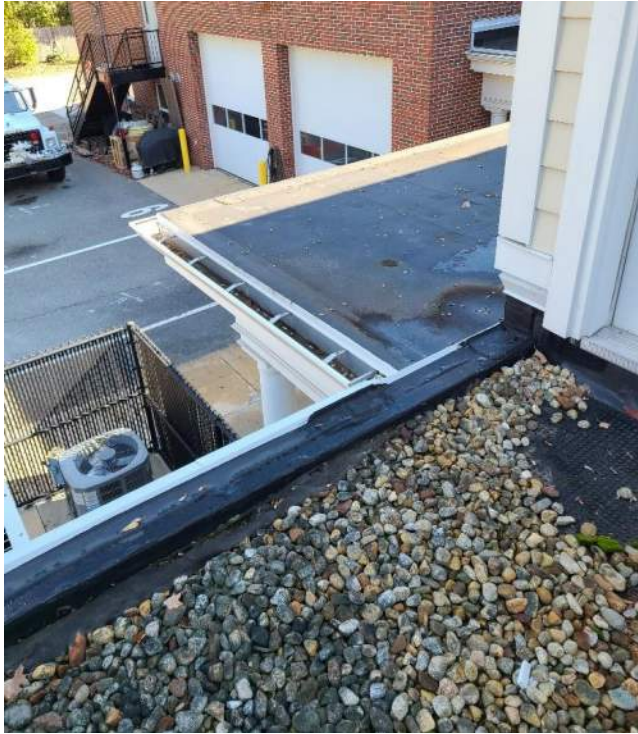
Photo S1: Guardrails needed on roof. Door too close to edge without fall protection.

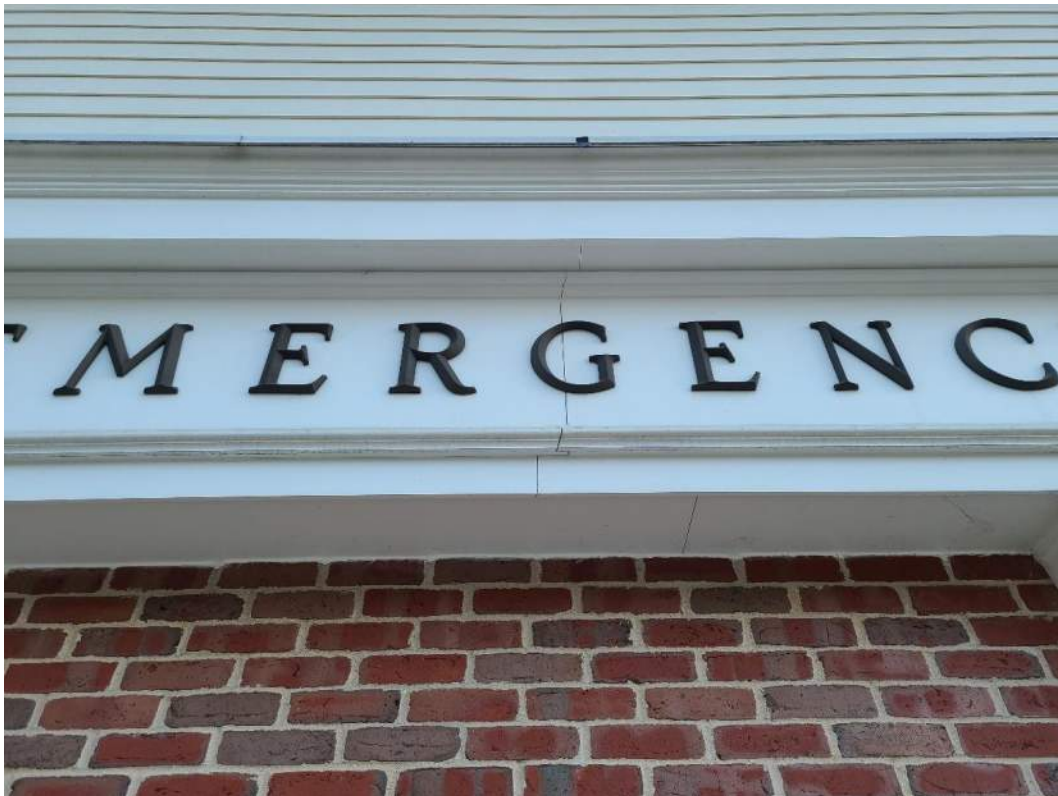
Photo S2: Trim joints to be caulked and repainted.

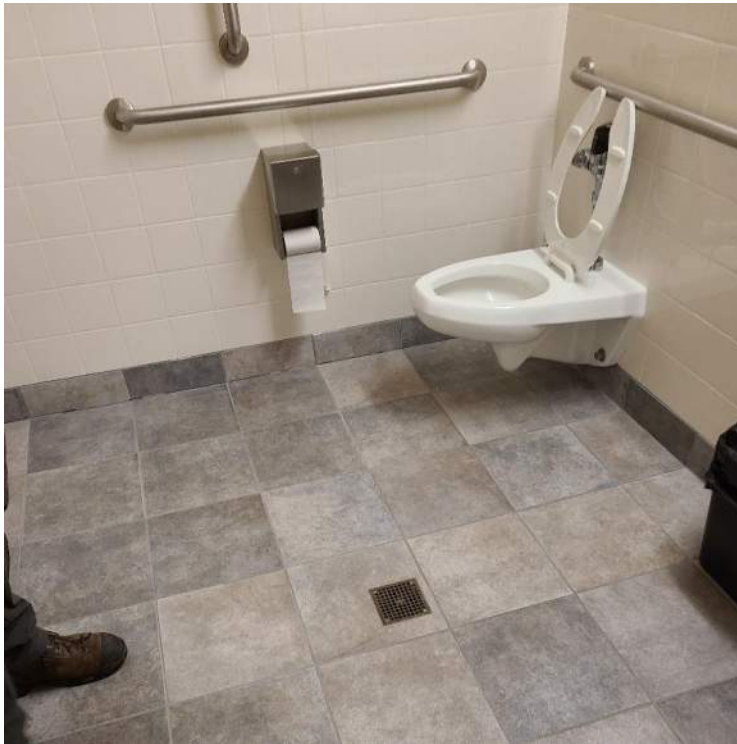
Photo S3: RegROUT bathroom tiles in Police Station bathrooms.

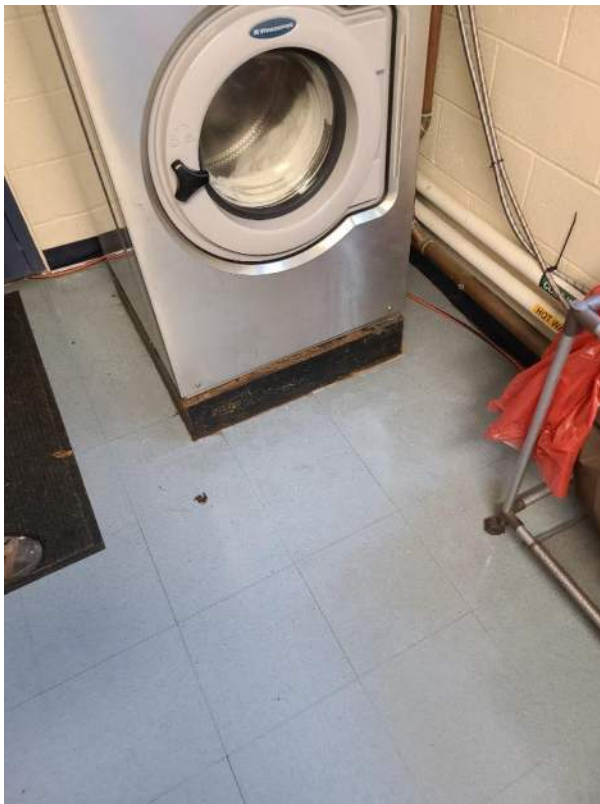
Photo S4: Delamination on Fire Station Side floor in laundry / boiler room.

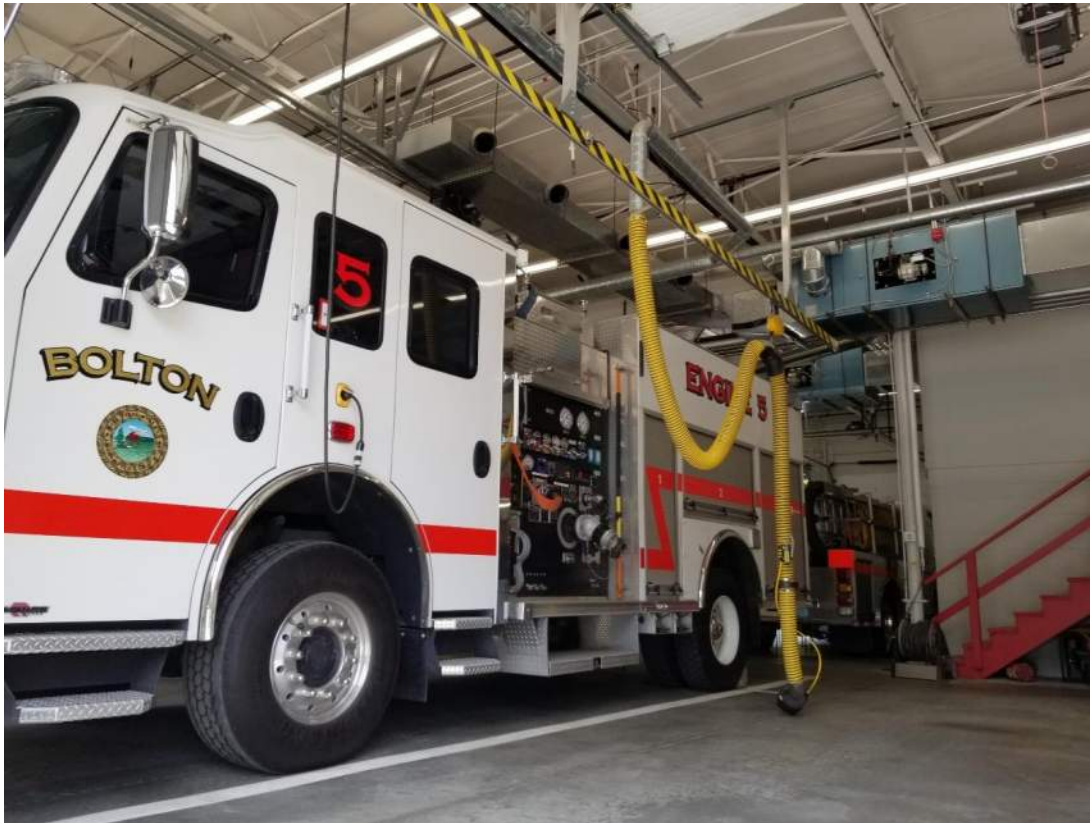
Photo H1: Gas detection for NO₂ and CO is needed in garage. Upgrade ventilation controls based on gas level.

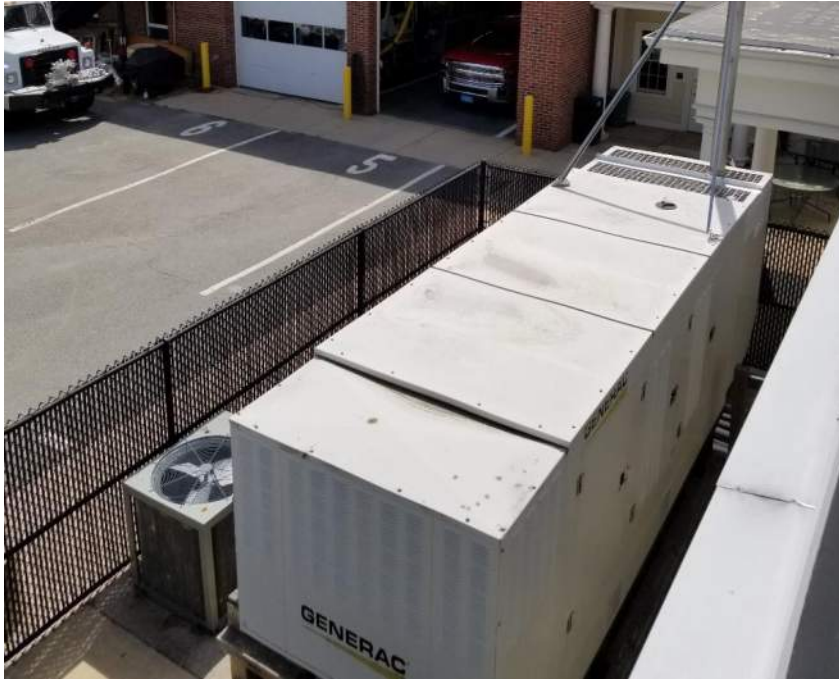
Interior and exterior lighting levels are sufficient, but fixtures are inefficient. As fixtures are replaced in the future, efficient LED fixtures should be installed. The generator has known mechanical issues and does not function correctly despite numerous repair attempts by the Town. It is recommended that the generator be replaced (PS-E-7 at \$138,000). There are no labels indicating an arc flash study has been performed at this station. Given the size of the service and type of equipment, an arc flash study is recommended if there is a possibility of energized work per NFPA 70E (2021). The following issues are code violations and/or safety concerns, and should be addressed:

Photo E1: Backup generator is having mechanical issues and will likely require replacement in the next 5 years.

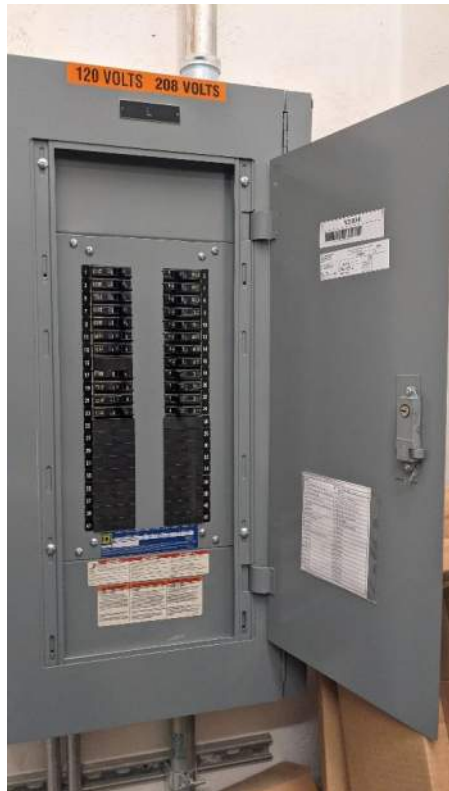
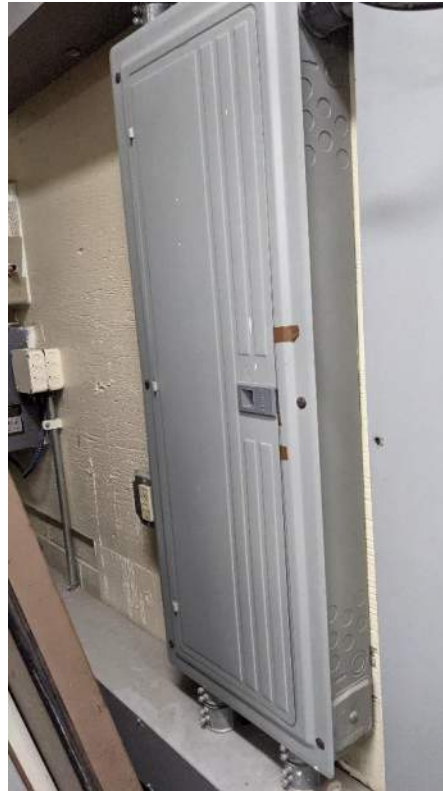
- Insufficient battery powered emergency lighting. Emergency battery-powered LED lighting should be installed where required by code.
- There are a number of locations with working space code violations due to equipment storage on or near the electrical equipment. Code required working space (36-inches deep by 30-inches wide minimum) should be established in front of all applicable electrical equipment. Energized work should be prohibited on electrical equipment until code required electrical working space can be established.

Photo E2,E3: Electrical panels. Ensure stored items cleared from front of panelboards to avoid working space code violation.

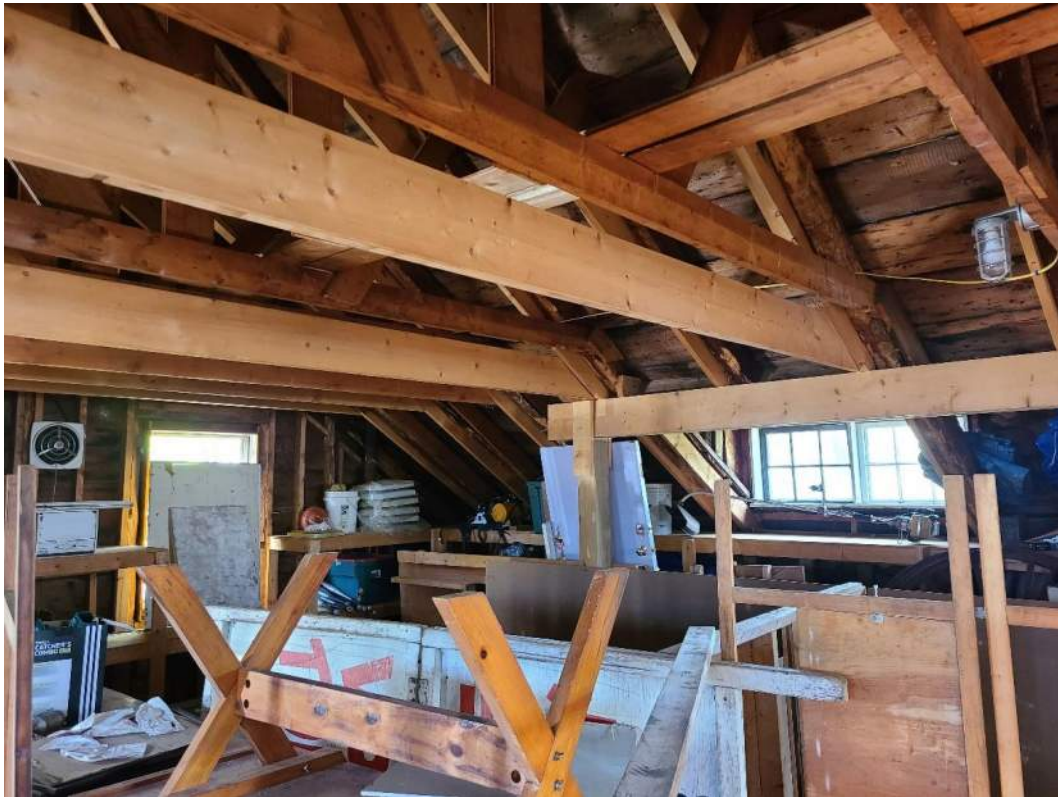
Photo S1: Patched and sistered structural framing in compromised old Fire Station.

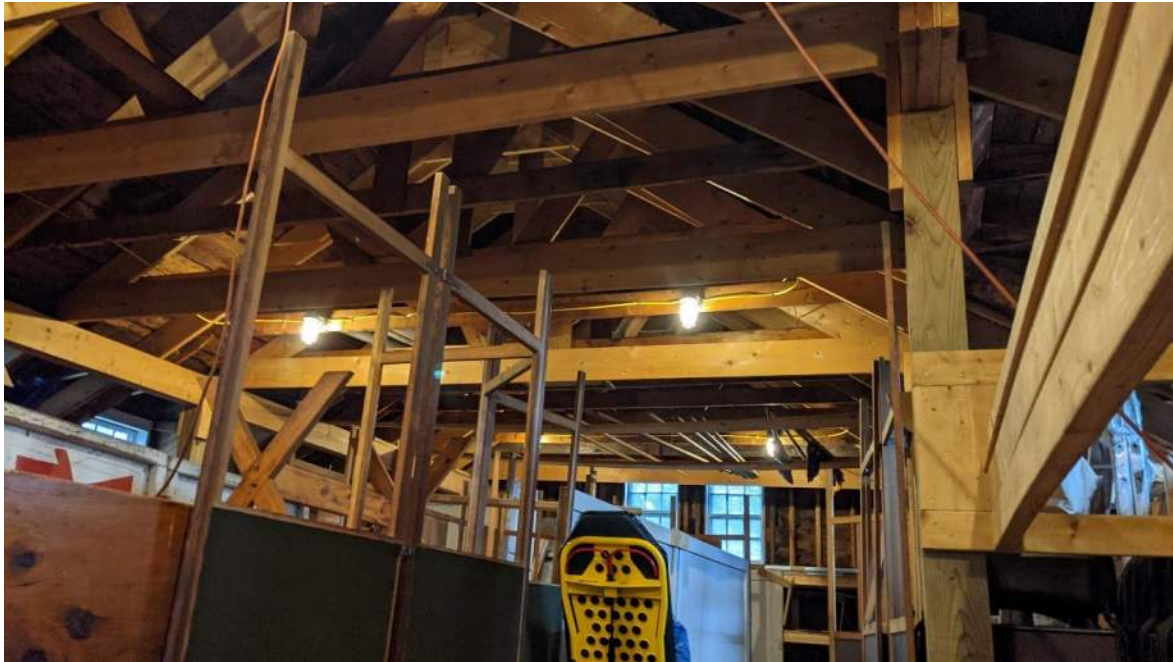
Photo E1: Second floor lighting. Building is lacking illuminated exit signs and emergency lightening, which are code violations.

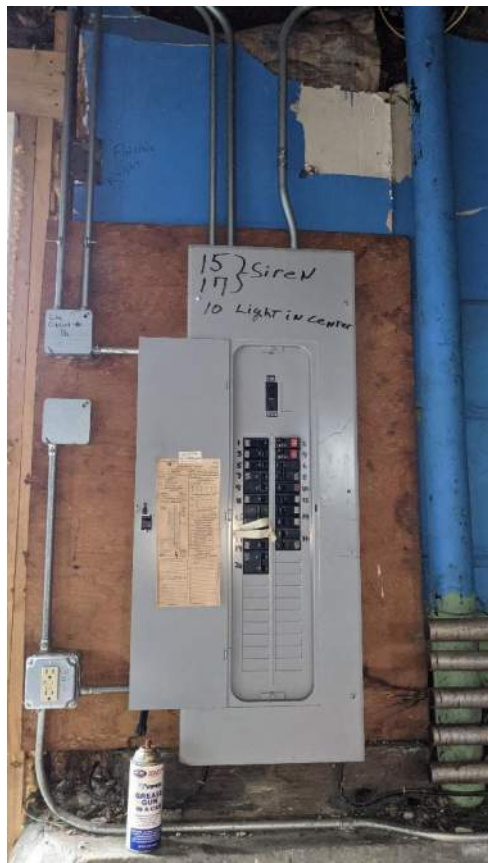
Photo E2: Electric panel. Install surge protection, code violation.

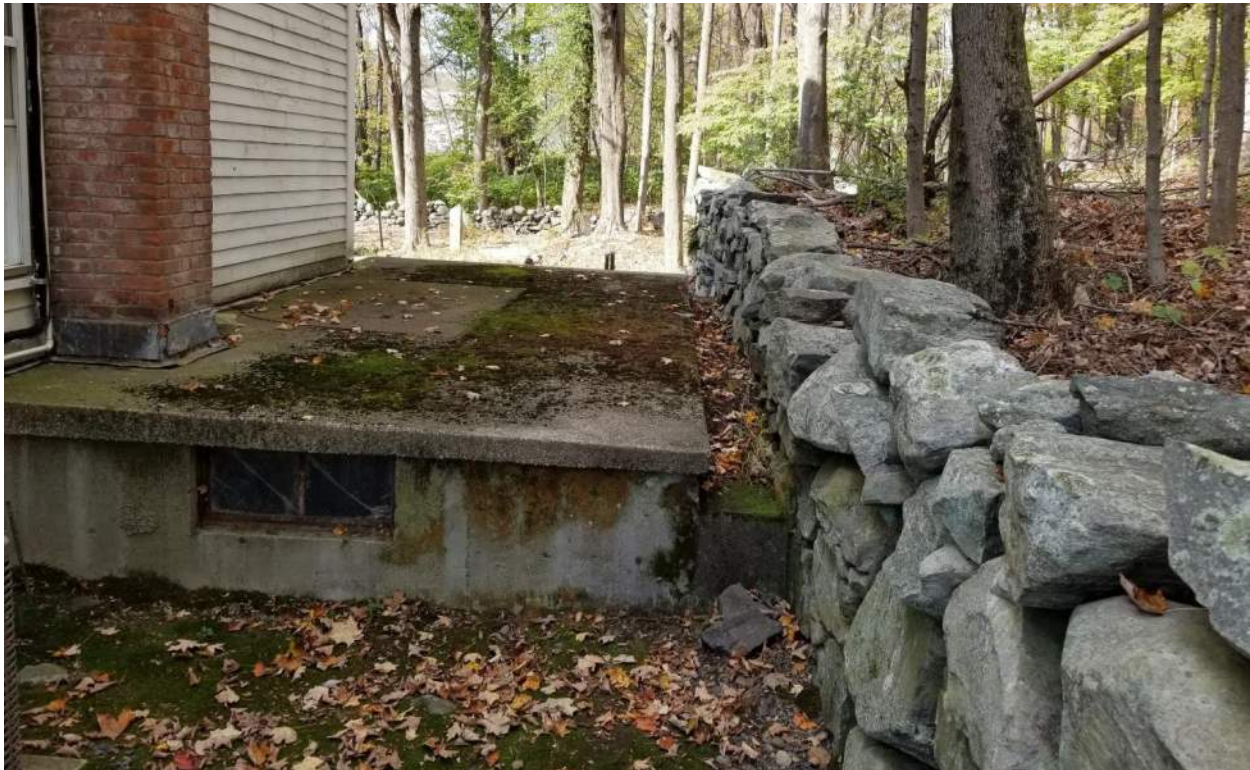
Photo C1: View of boiler room and stone wall behind building. Water weeps into building at this point. Investigate installation of either a drainage system installed behind wall to direct flow around building or an interior or exterior cutoff drain below boiler room floor elevation.

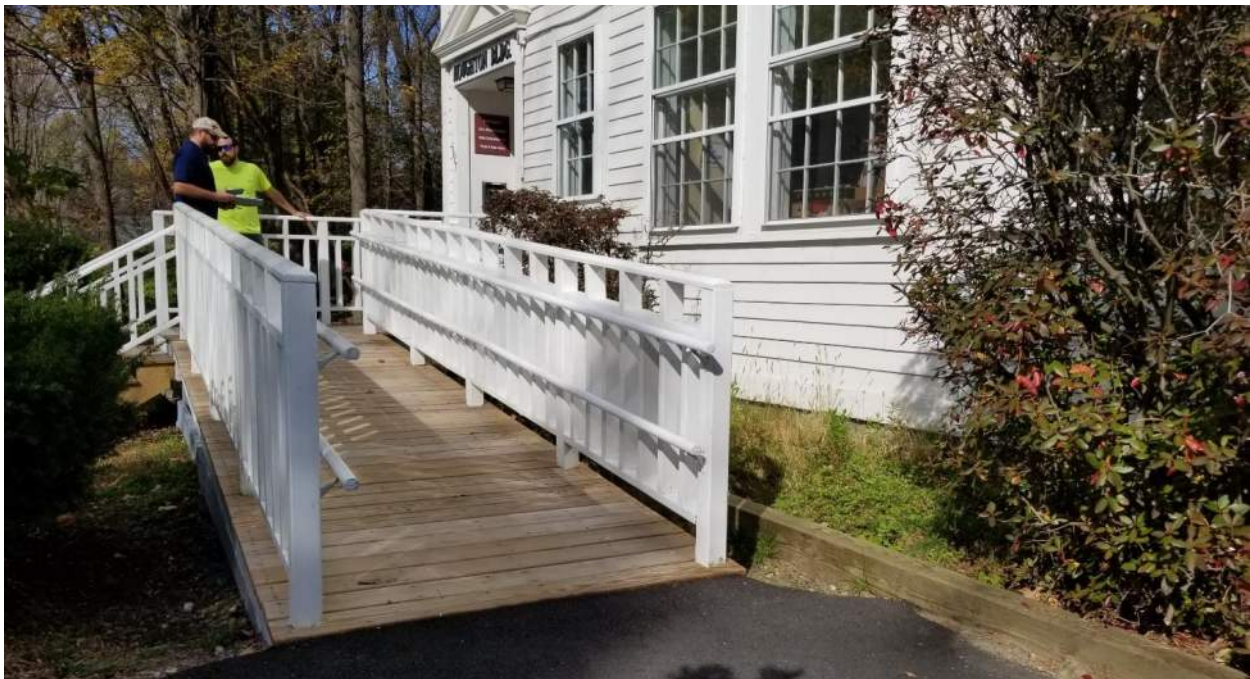
Photo C2: Entry ramp is not ADA compliant. Too steep ($>8.3\%$), no handrail extensions, lacks landing (60" level required).

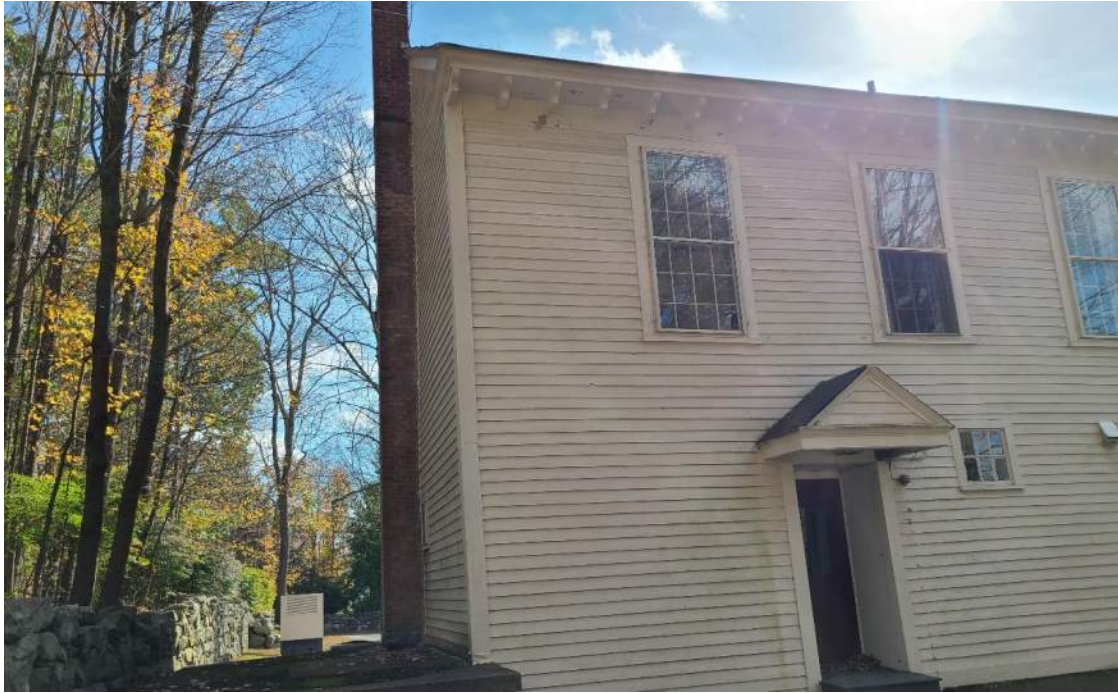
Photo S1: Eave and siding paint chipping.

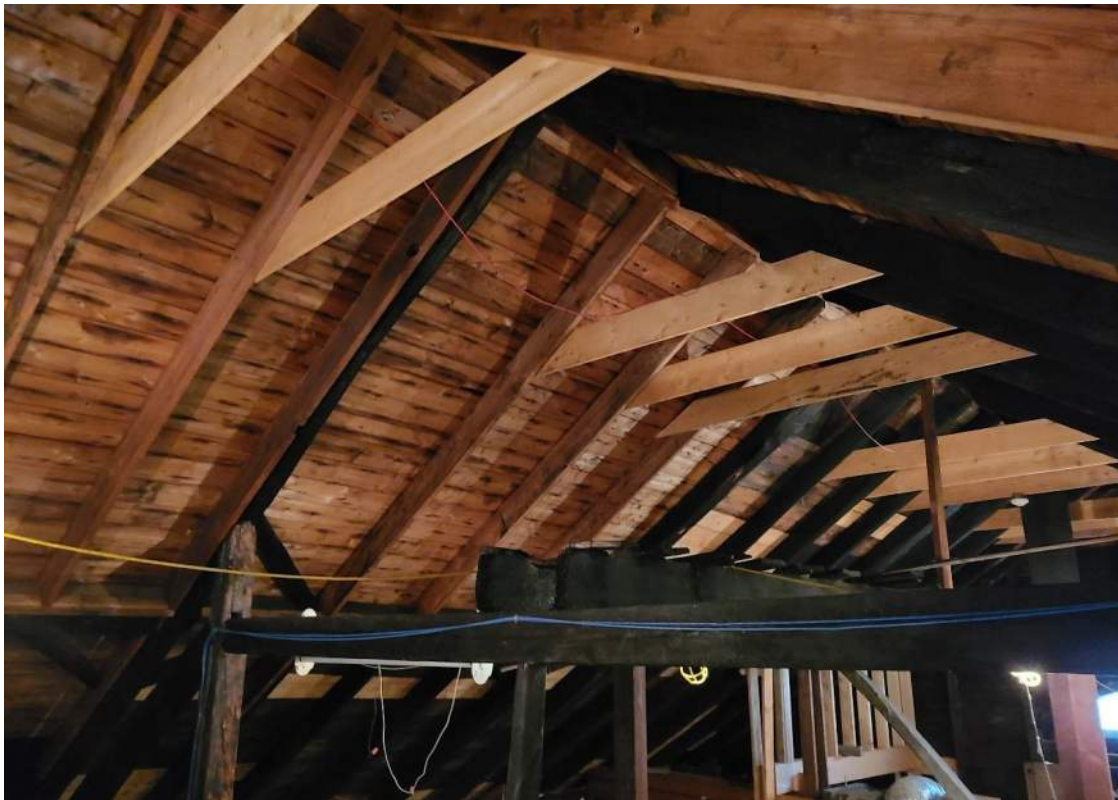
Photo S2: Rebuilt roof rafter and decking after fire.

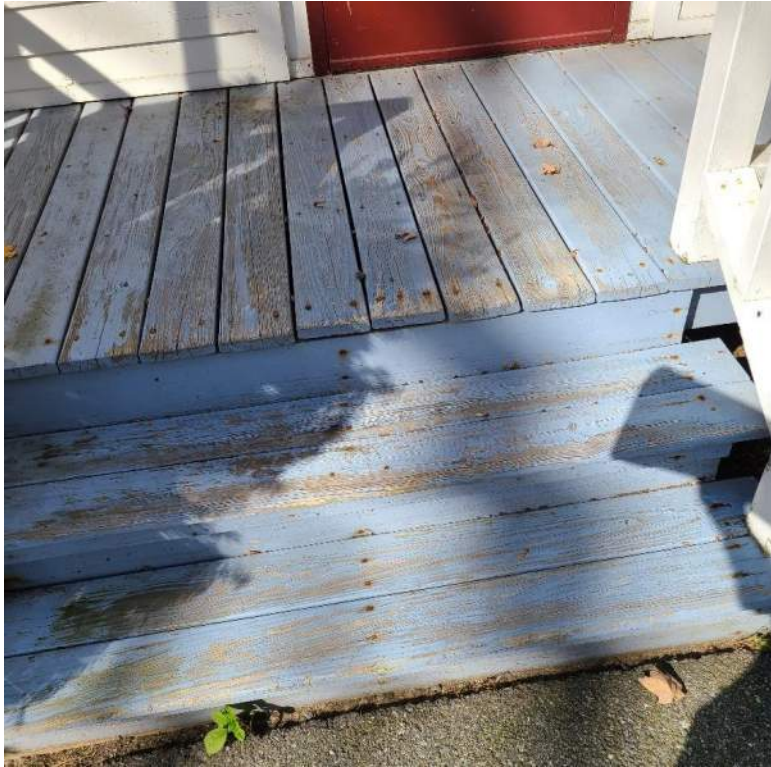
Photo S3: Secure and refinish side entrance deck and stairs.

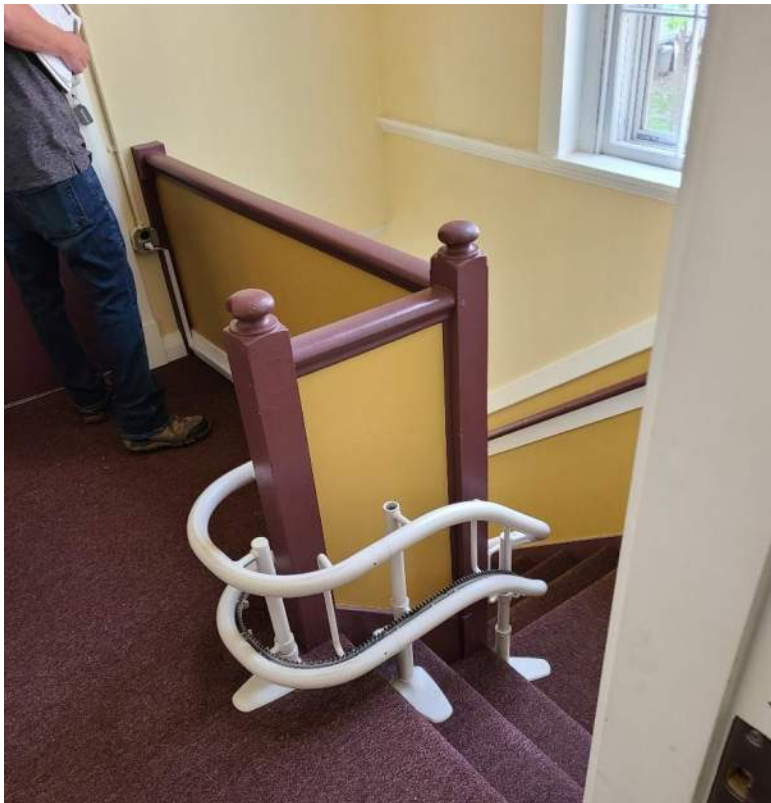
Photo S4: Half-wall is too low at top of stairs. Safety risk. Increase height.

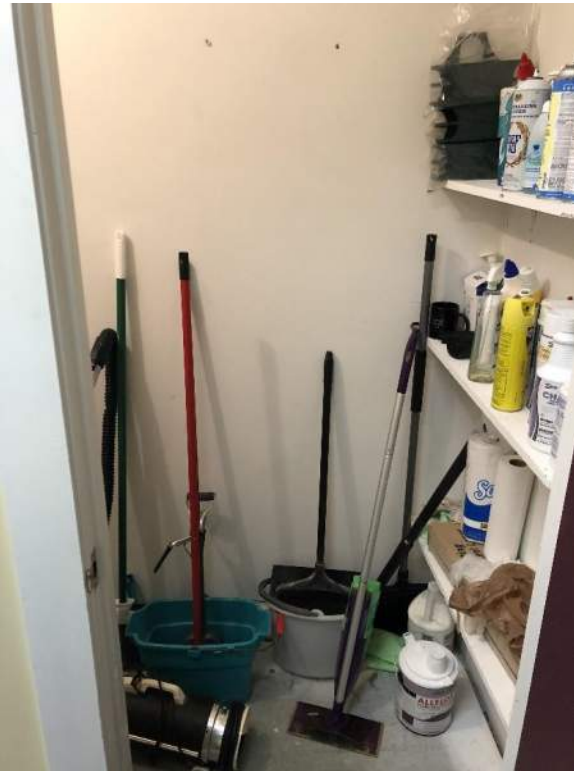
Photo H1: Installation of exhaust fan in janitor closet recommended.

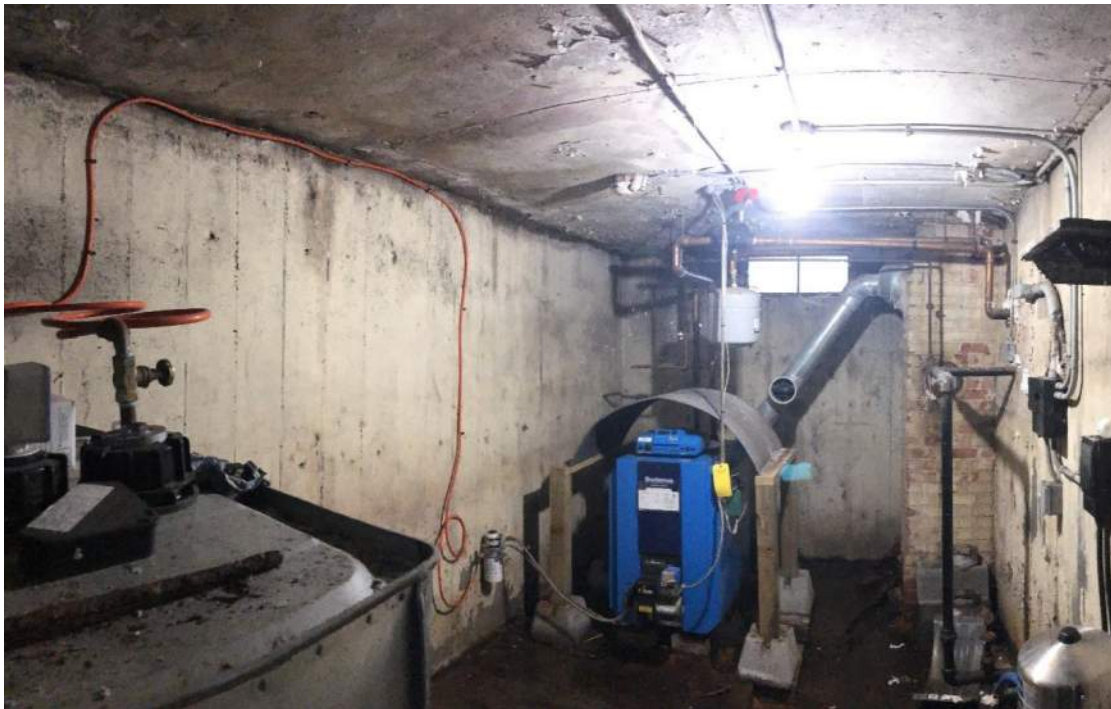
Photo H2: Boiler room subject to water inflow and resultant moisture issues. See Photo C1.

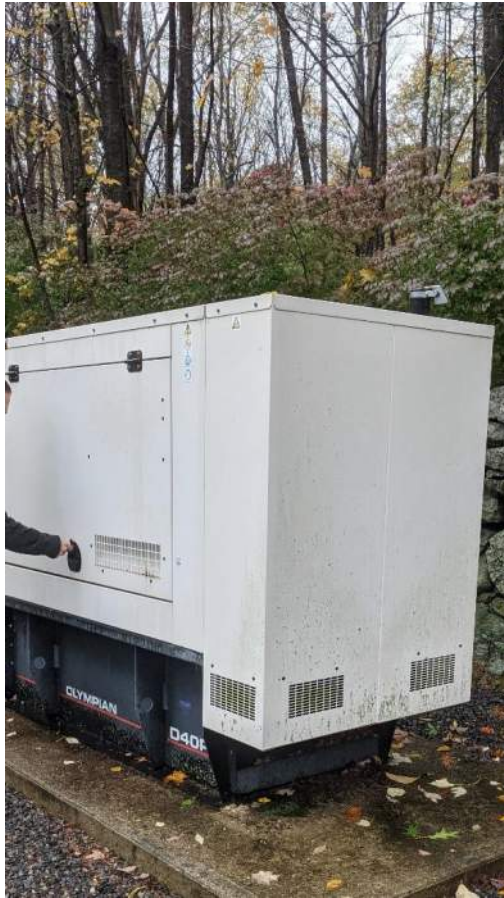
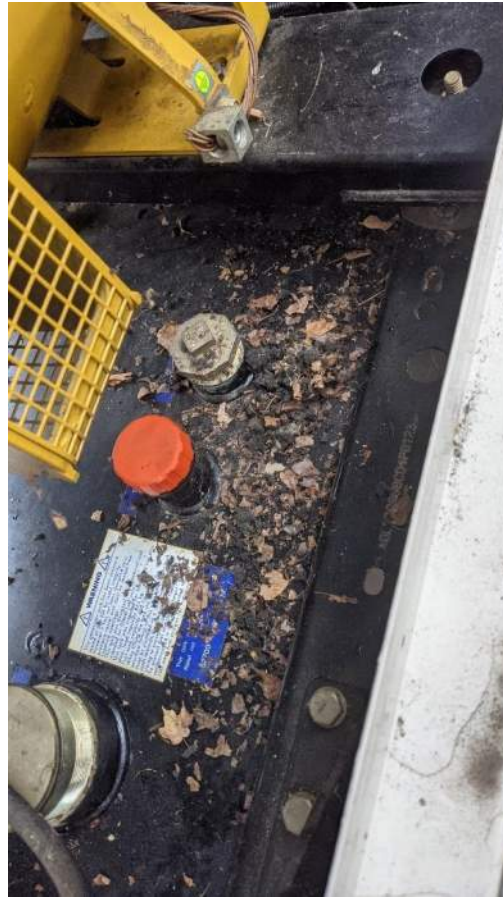
Photo E1,E2: Evidence of rodents in backup generator. Clean and make rodent-proof

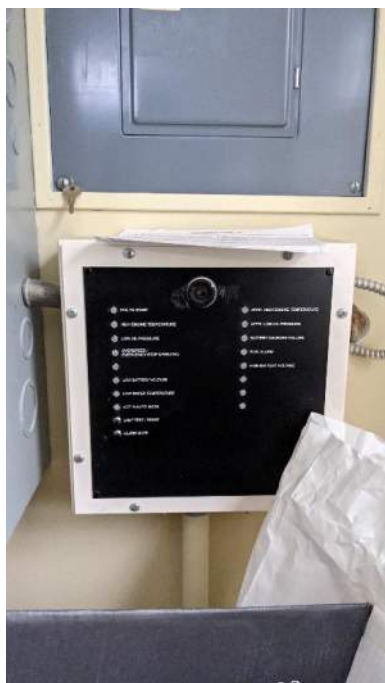
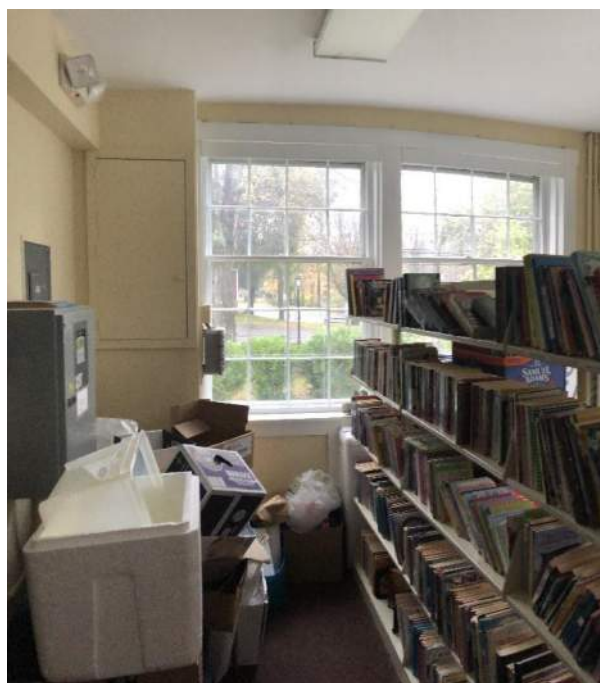
Photo E3,E4: Working space violation in front of panelboards. Remove stored items.

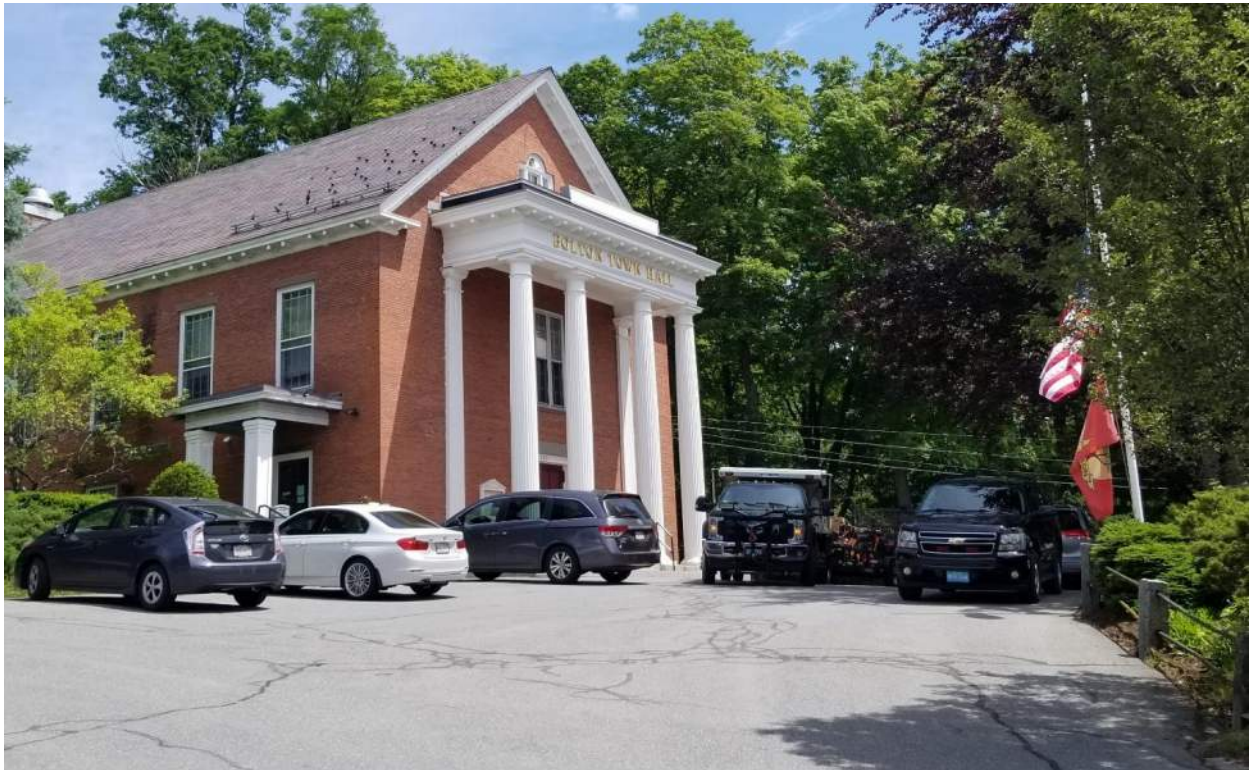
Photo C1: View of the front driveway. Guardrails compromised, need replacement. New curb required to prevent surface runoff down bank, behind retaining wall and onto street.

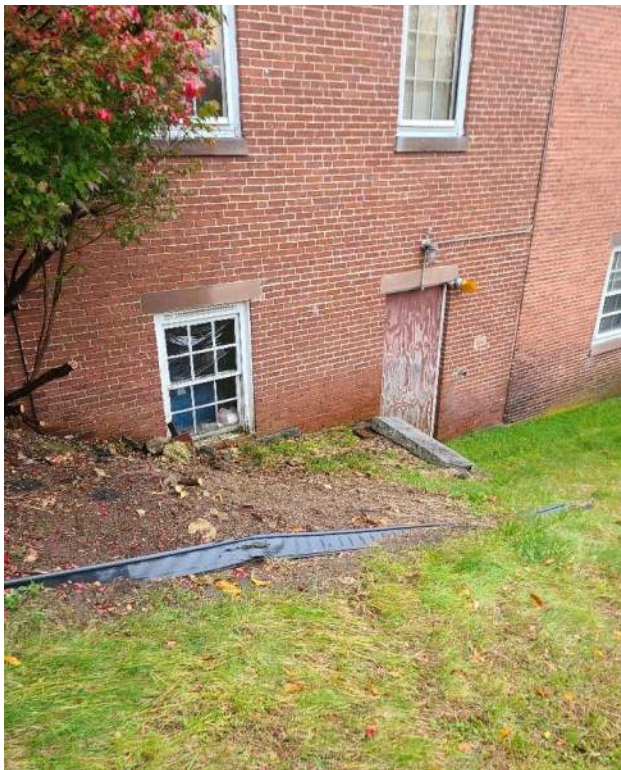
Photo C2: Surface runoff compromising SW corner of building. Regrade and install drainage.

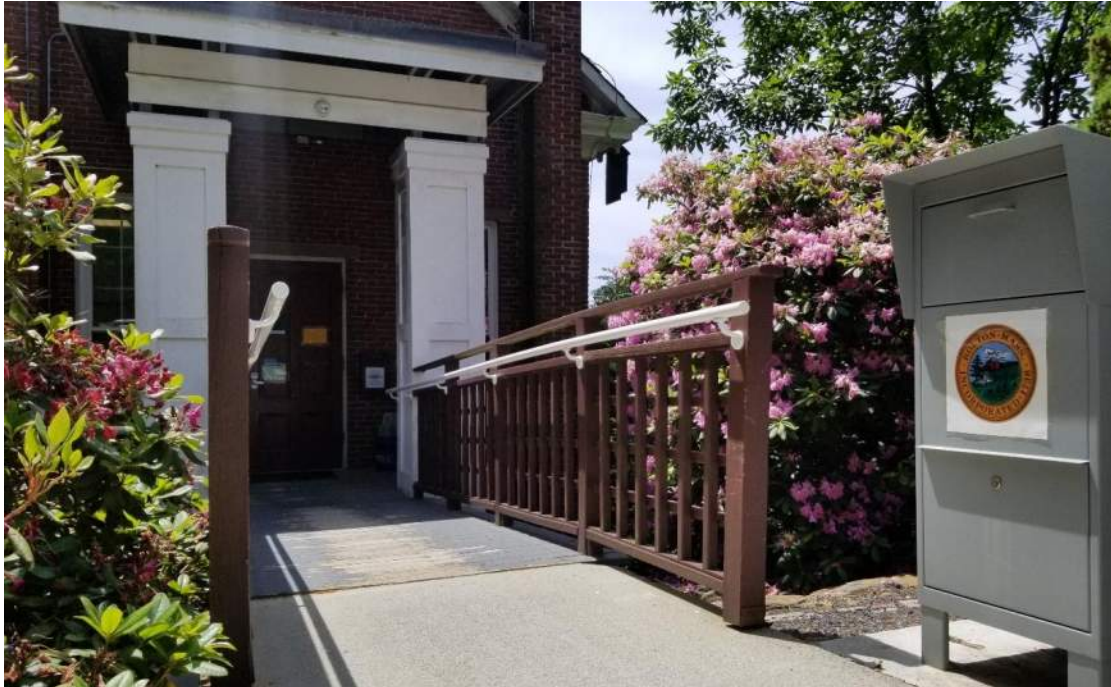
Photo S1: Rear entry ramp compromised and in need of replacement. Top view.

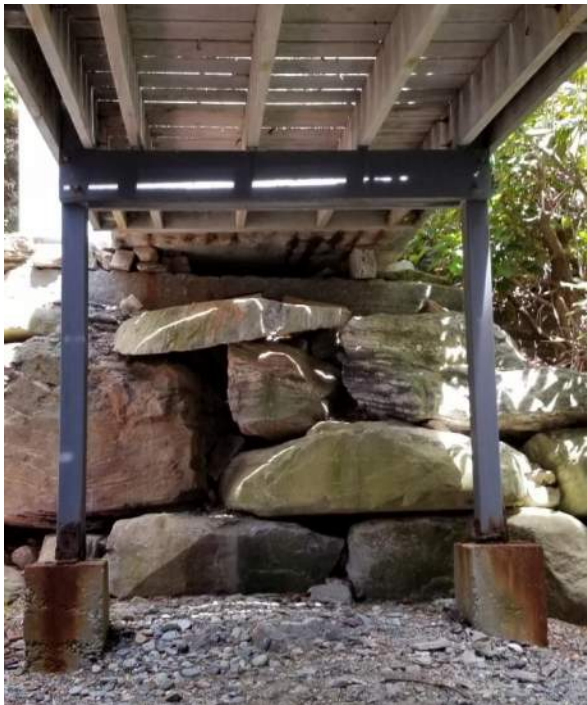
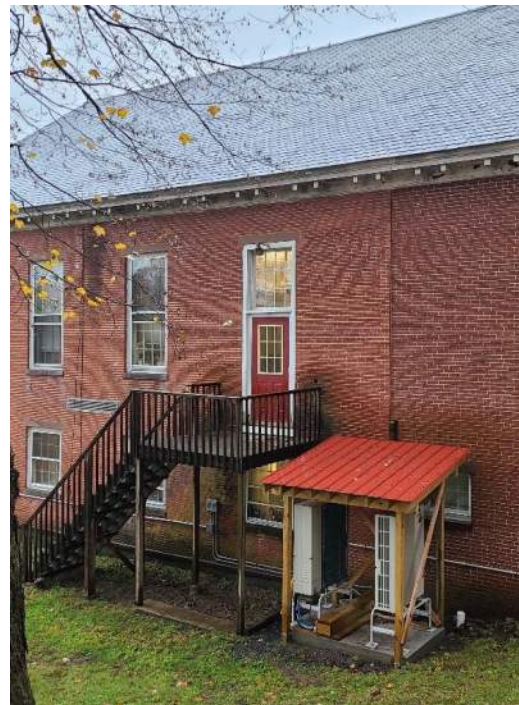
Photo S2: Rear entry ramp (underside view) and wood side stairway compromised.

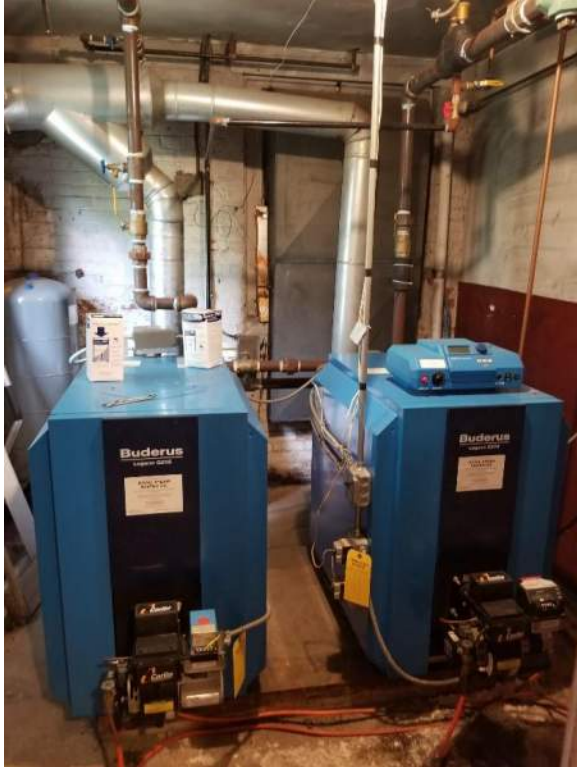
Photo H1/P1: Existing Boilers. Recommend water analysis and possible treatment to reduce hydronic system piping corrosion.

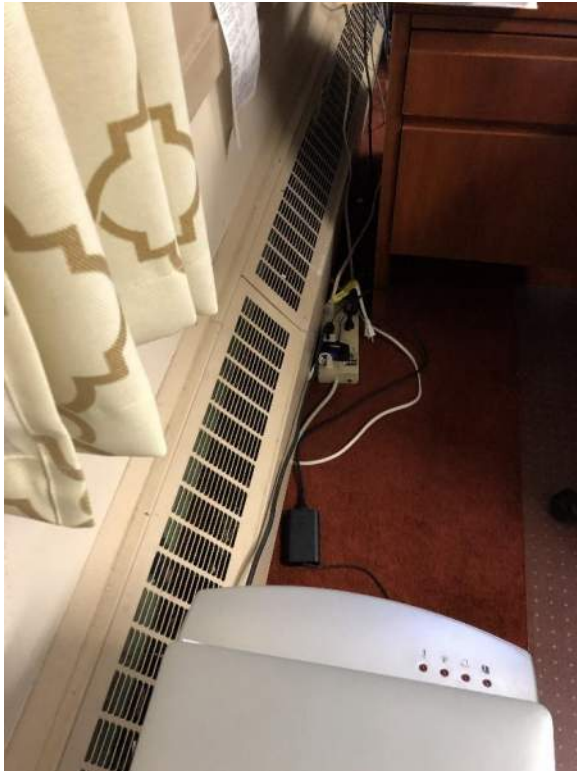
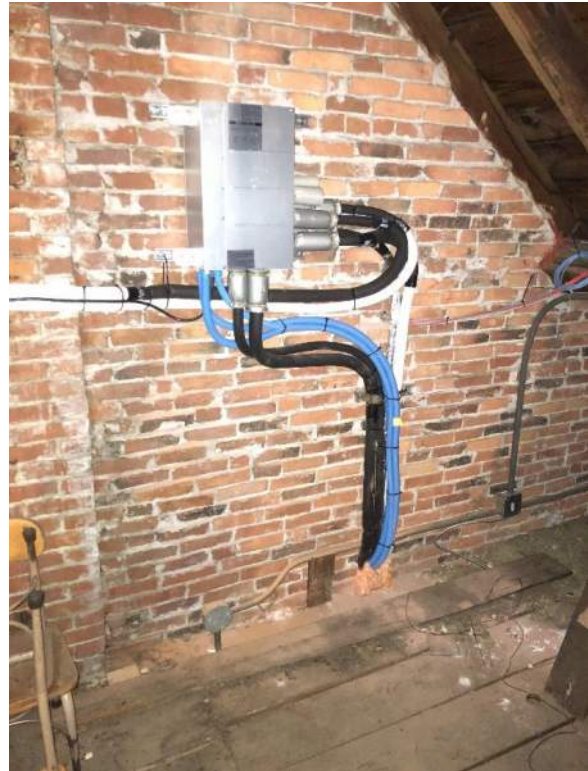
Photo H2,H3: There are air quality concerns in Town Hall; improved ventilation or air purification may be required. Photo of ductless mini-splits distribution box in attic.

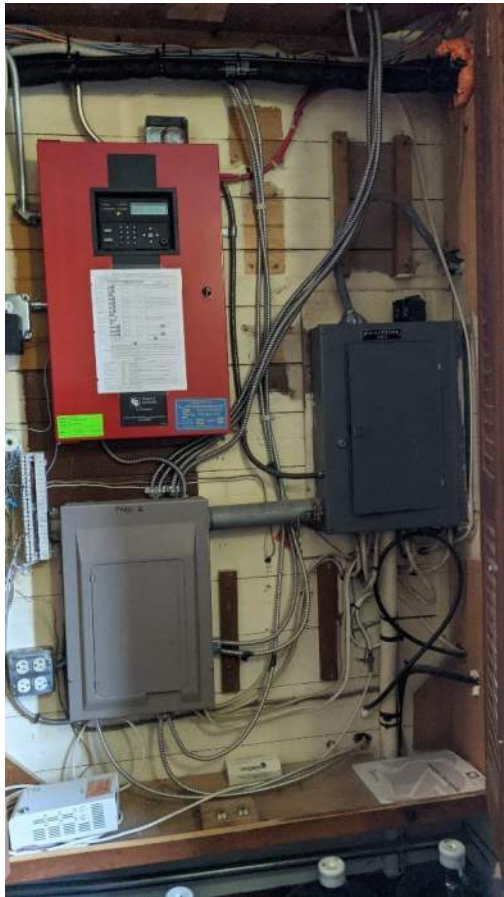
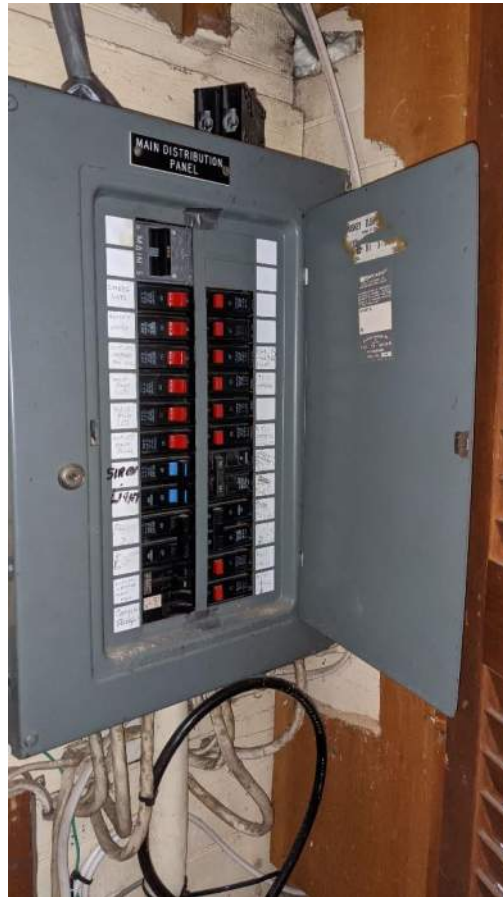
Photo E1,E2: View of the existing main distribution panel at end of useful life. Provide minimum 30-inch wide by 36-inch depth clear working space in front of electric panels.

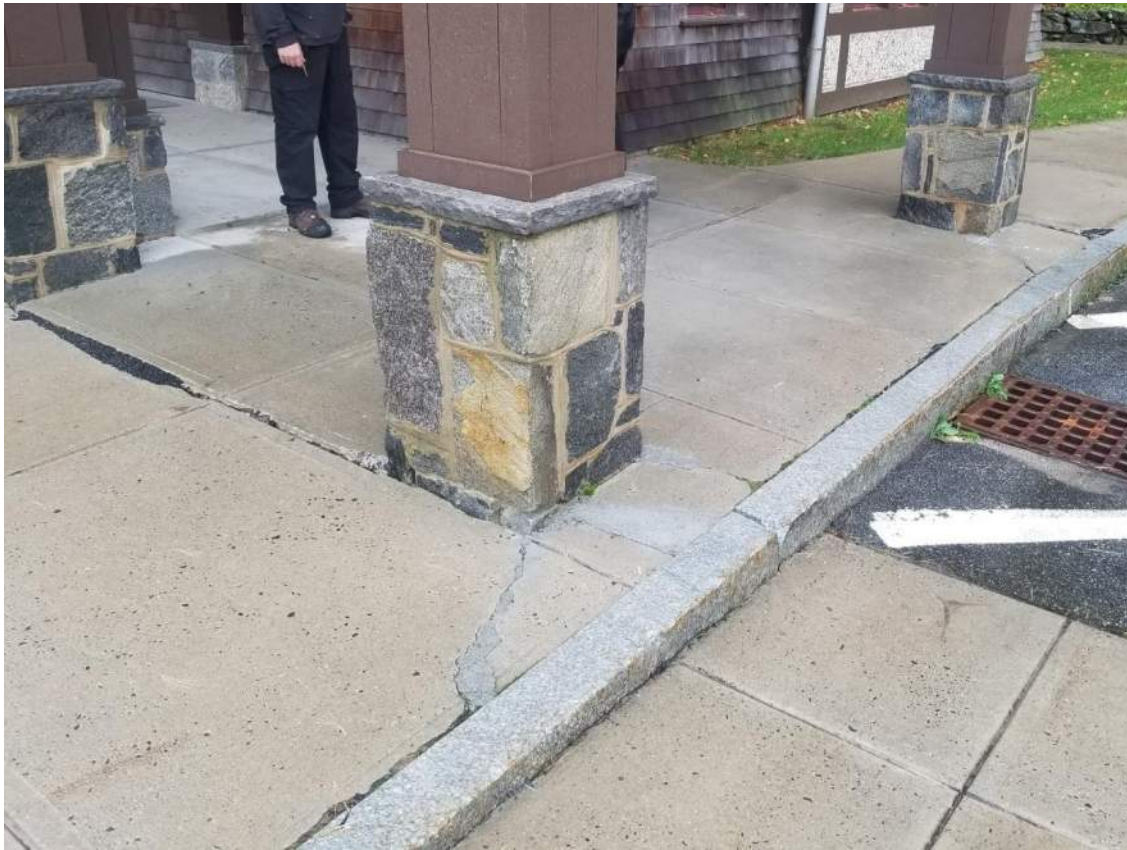
Photo C1: Sidewalk damage at main entrance. Granite curbing missing grout throughout.
