Bolton, Massachusetts

MUNICIPAL BUILDING CONDITIONS ASSESSMENT REPORT

Town of Bolton

June 2022

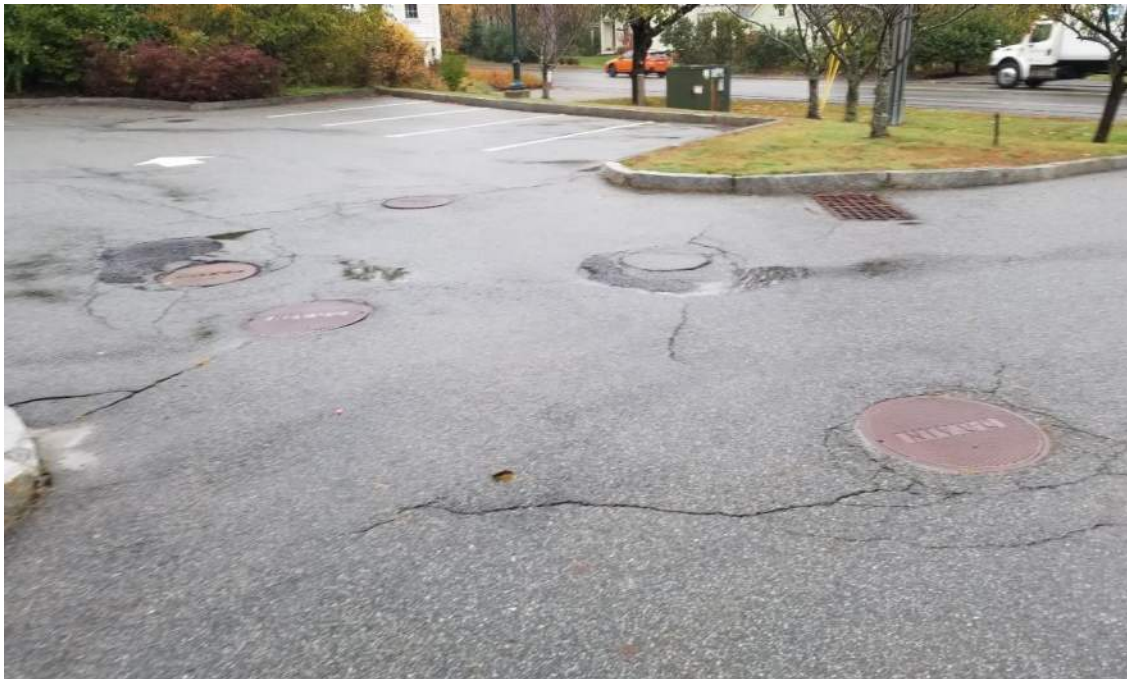
Photo C2: Bituminous concrete settling around manhole covers throughout driveway.

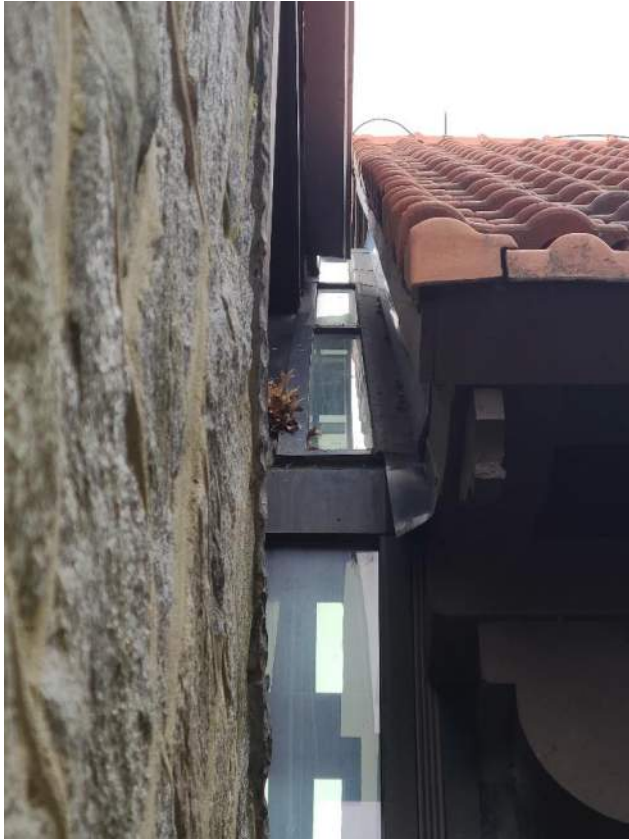
Photo S1: Expansion join between original building and addition is leaking.

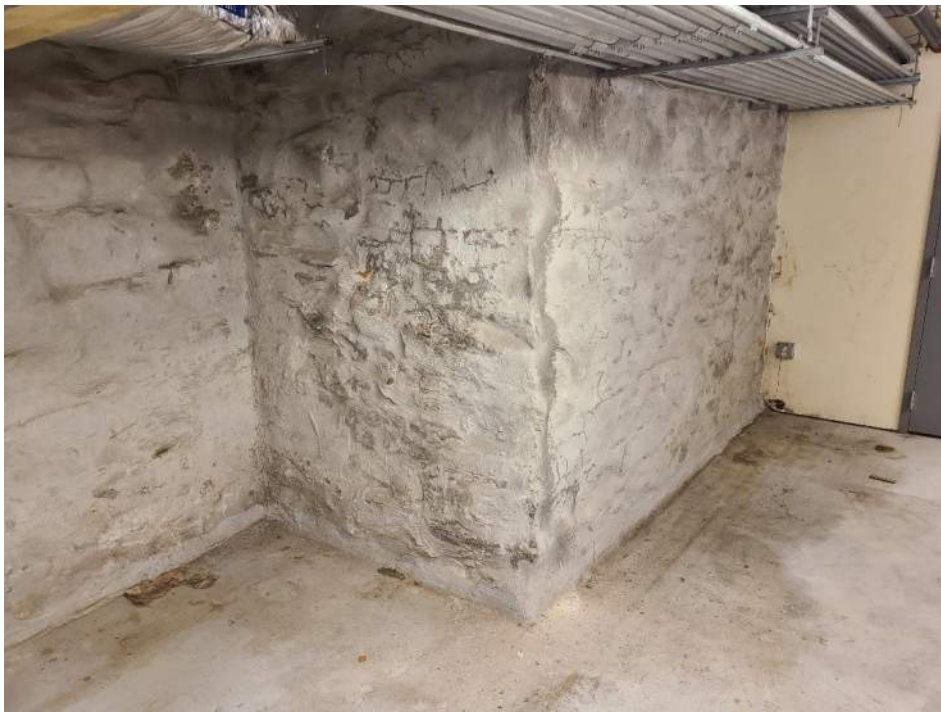
Photo S2: Foundation moisture in basement of original library should be monitored.

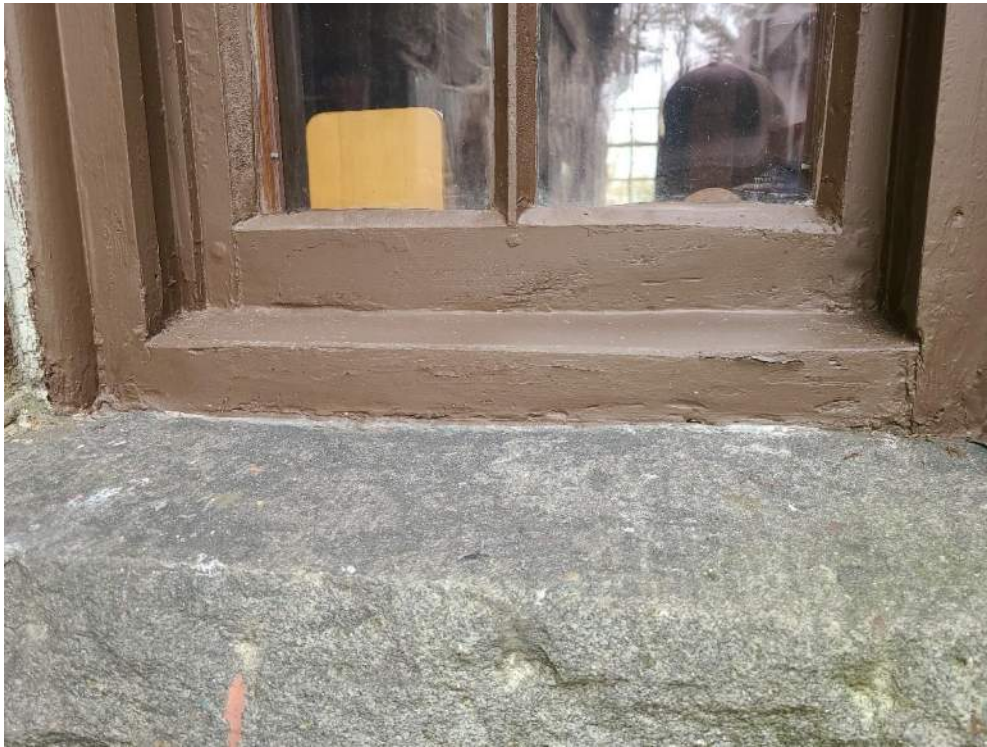
Photo S3: Rot on sills of small double hung windows. Sill rot throughout building.

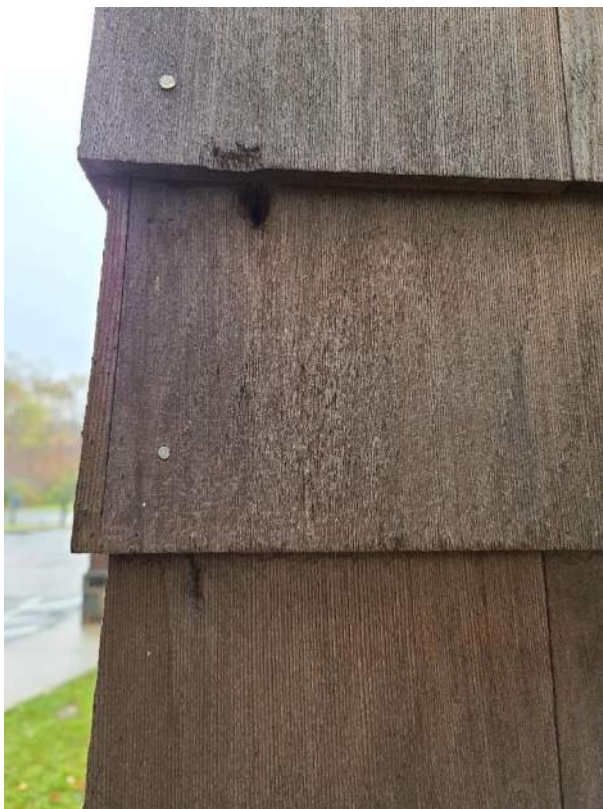
Photo S4: Holes in cedar siding from bugs or pests need to be sealed.

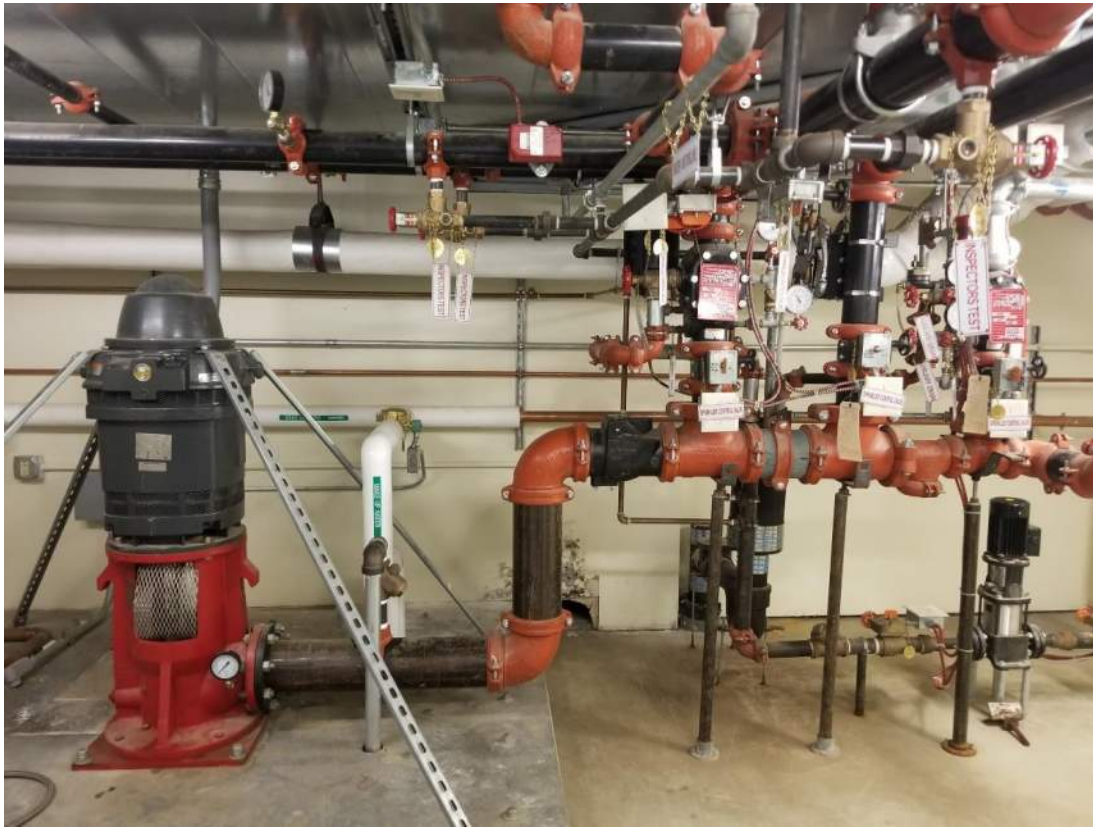
Photo P1: Fire pump room and suppression system. Fireproof insulation needs to be installed in rooms' penetrations. See item L-S-5 of Appendix A.

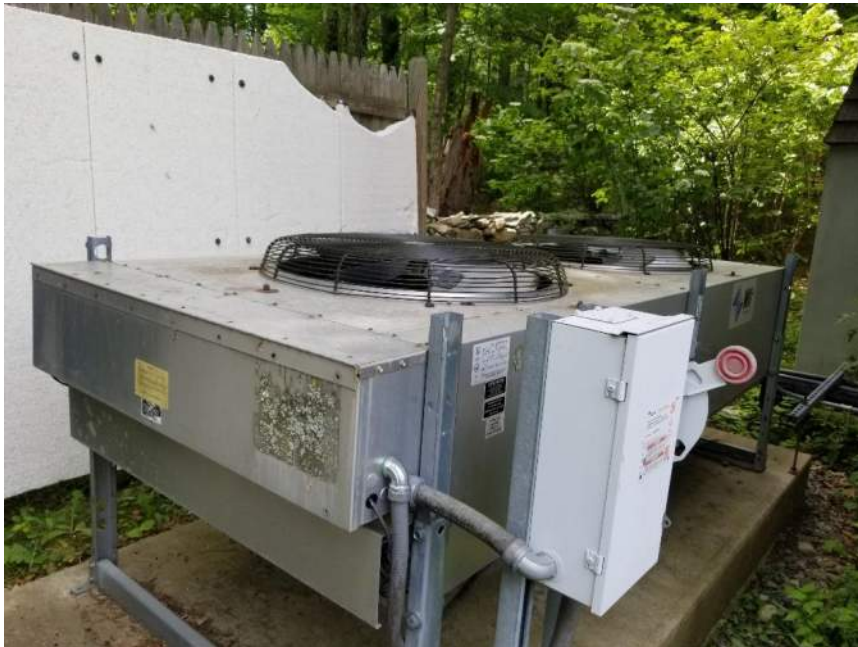
Photo H1: Condenser. Replace insulation and provide weather-proof UV resistant jacket.

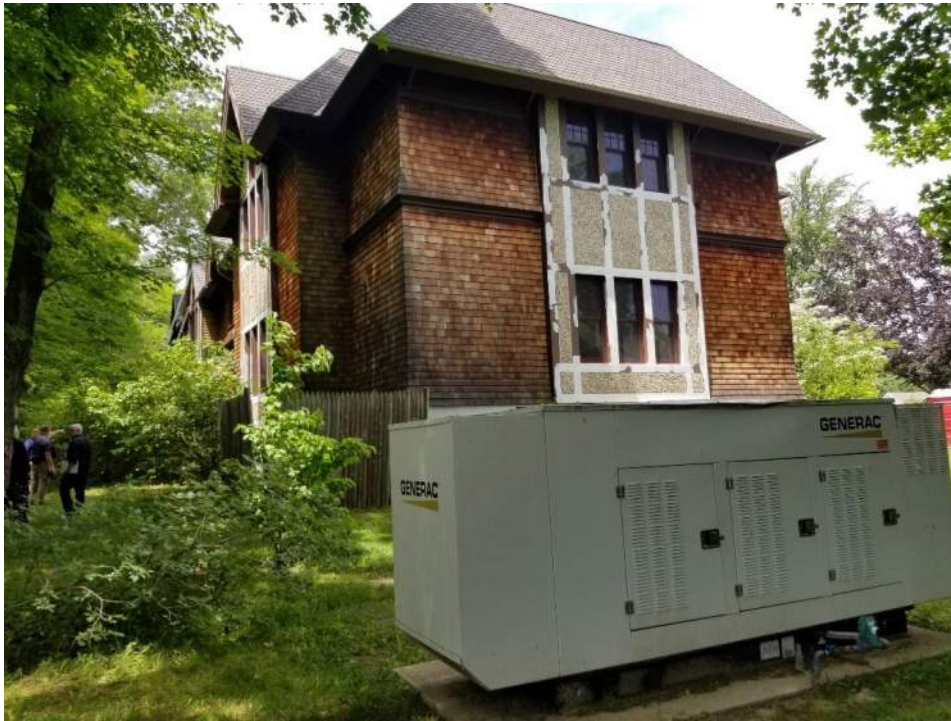
Photo E1: Backup generator. New motor recently installed after 10 years of operation.

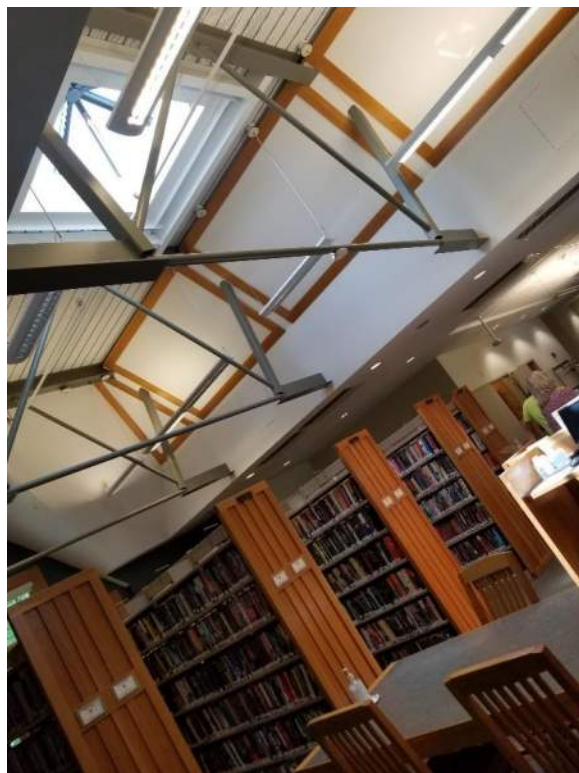
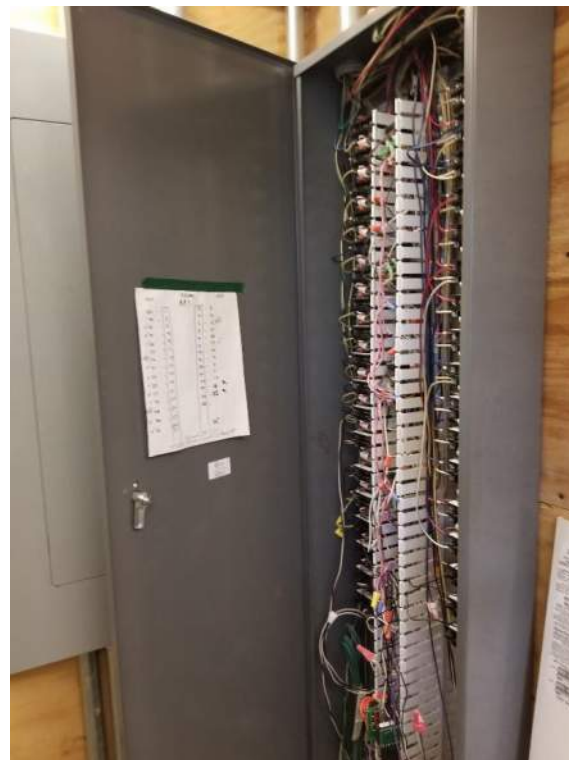
Photo E2,E3: Low voltage Payne Sparkman lighting control system is problematic. Electrical panels. System diagnosis by manufacturer required.

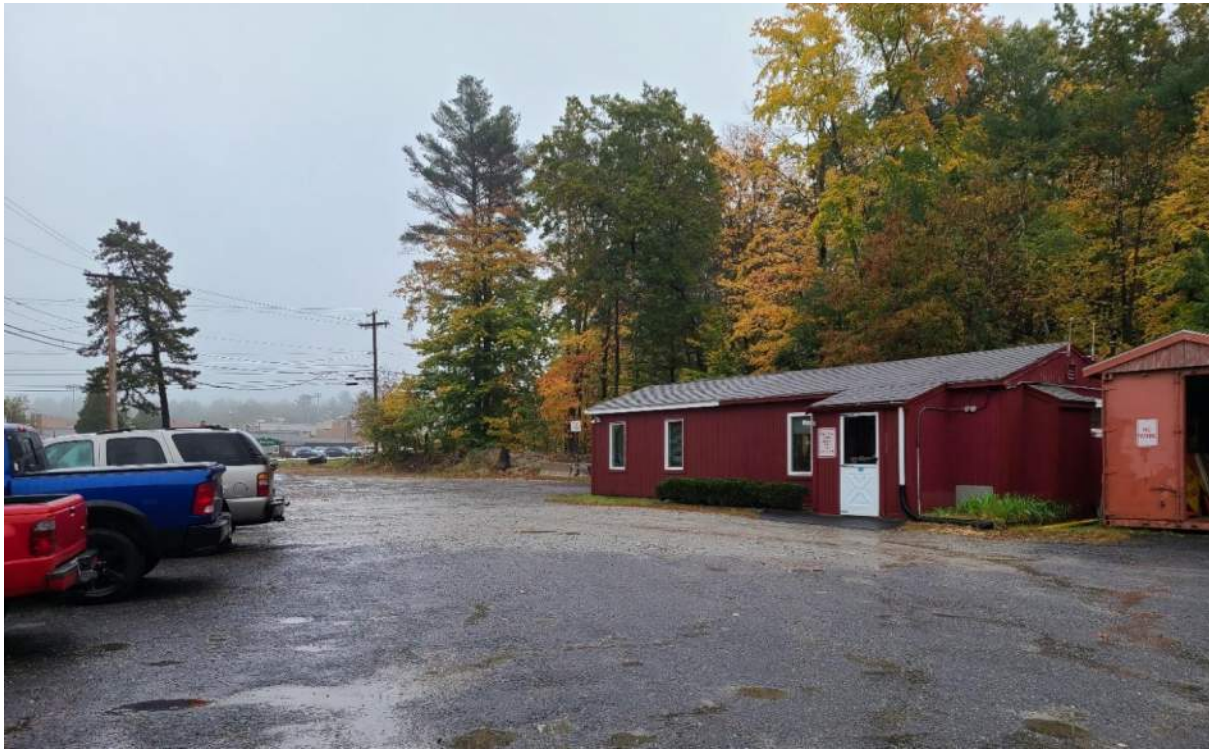
Photo C1: View of the existing conditions of DPW parking lot. No ADA to Admin Building.

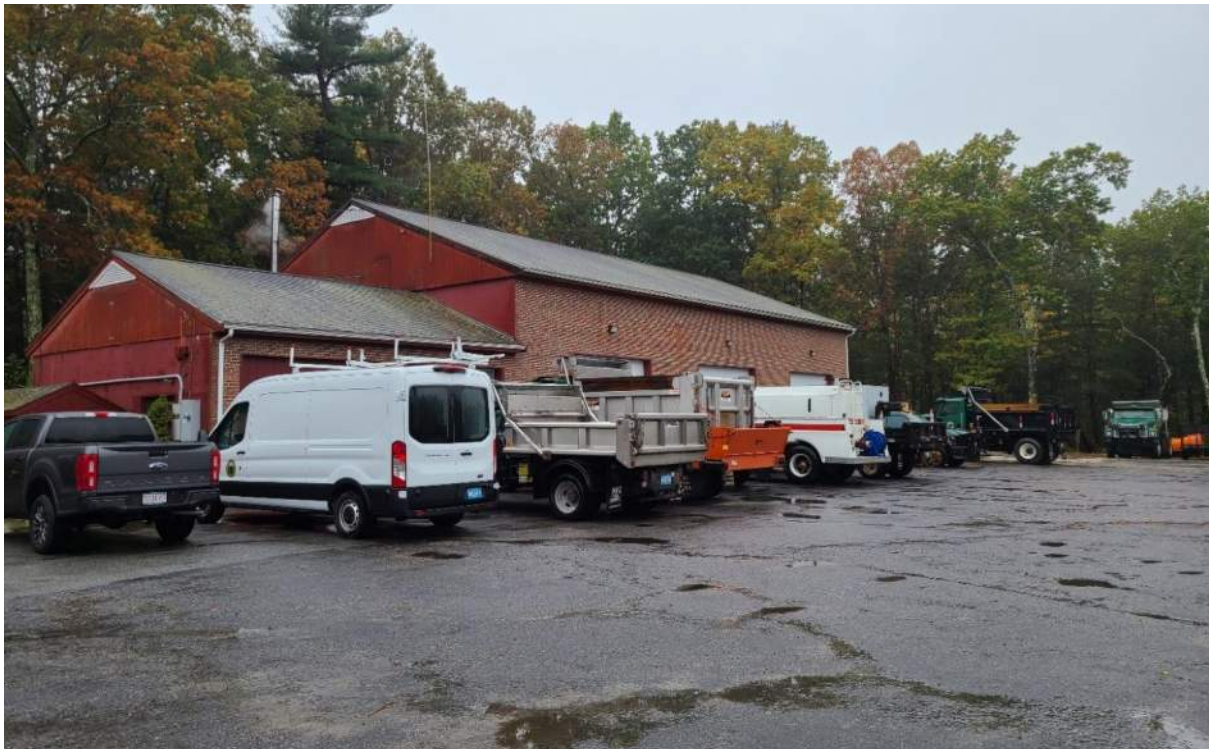
Photo C2: View of parking lot and vehicle storage at DPW Garage. Limited space. Moss on lower section of roof.

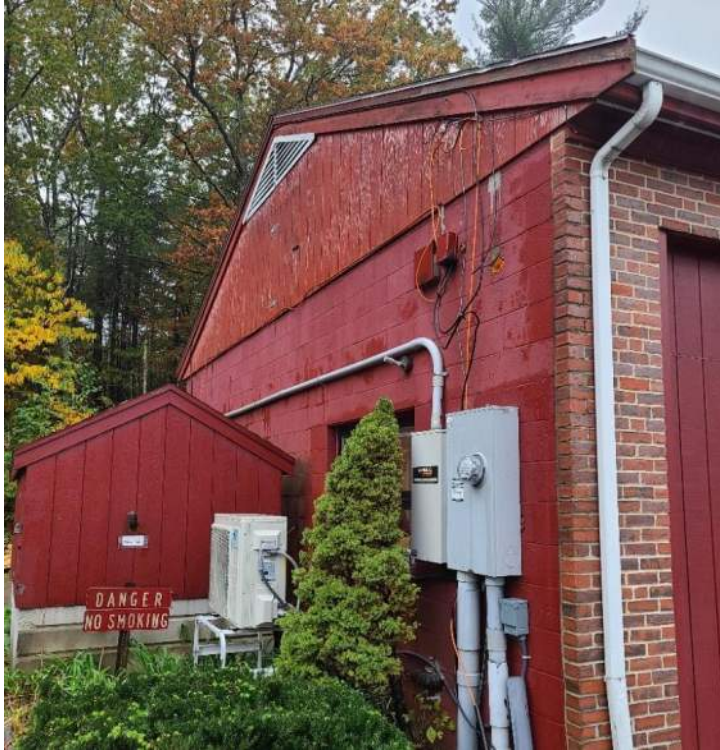
Photo S1: Exterior Paint Peeling on Garage. Typical of Admin Building too.

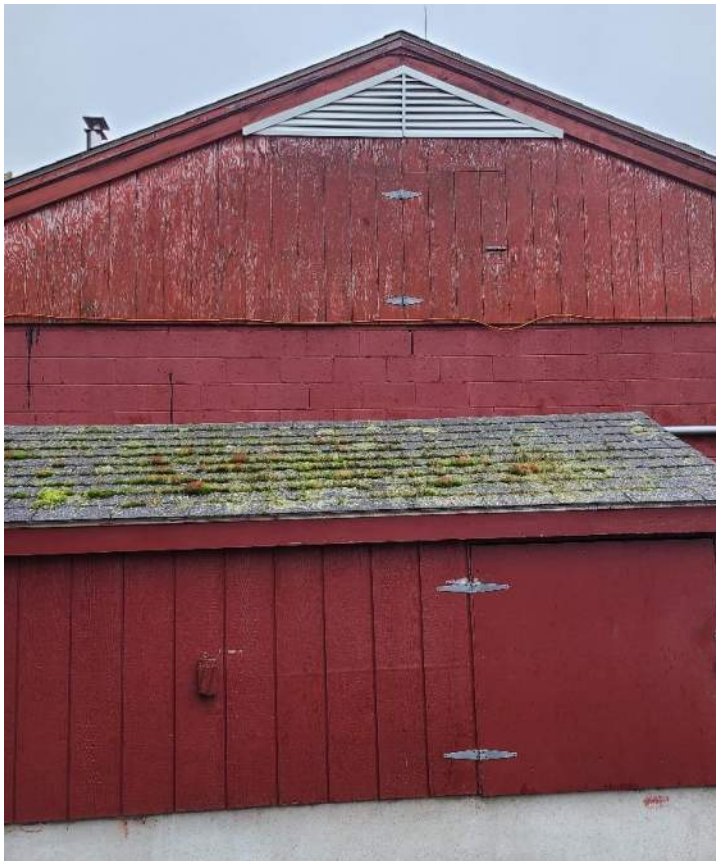
Photo S2: Oil tank shelter shingles covered in moss.

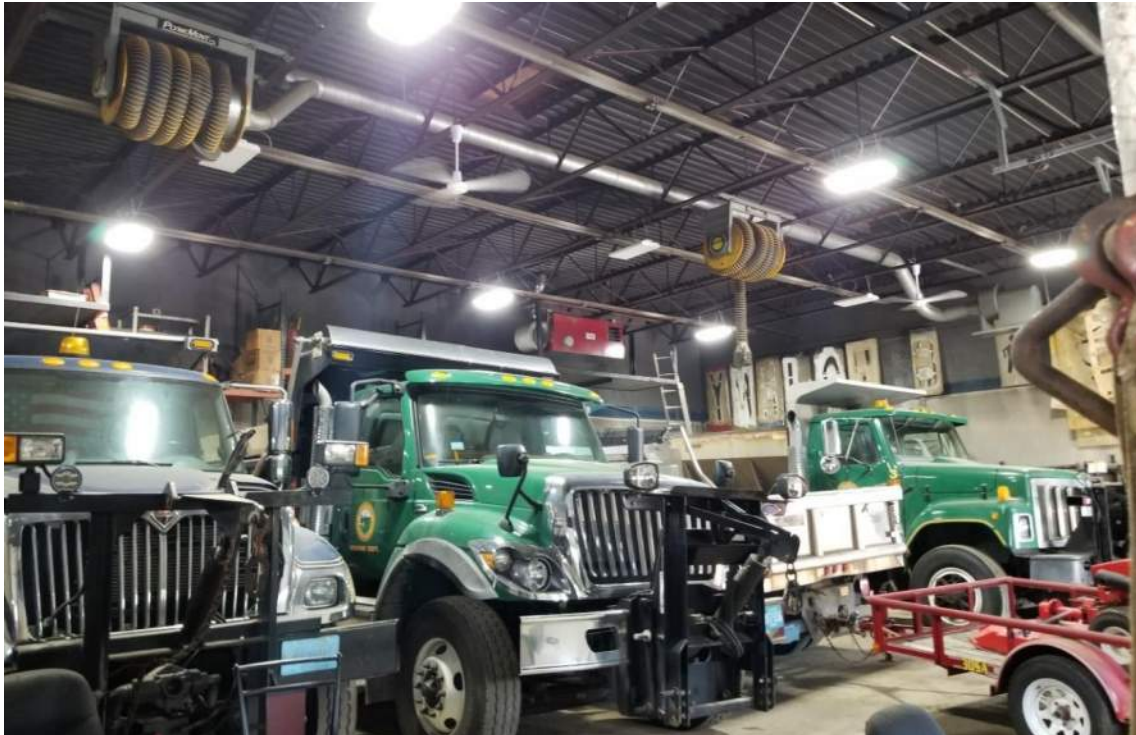
Photo H1: DPW Garage lacking automatic ventilation and gas detection is safety hazard. Need gray water tight tank, floor drains and an oil water separator. Lack of adequate spacing between vehicles for adequate operations and maintenance activities.

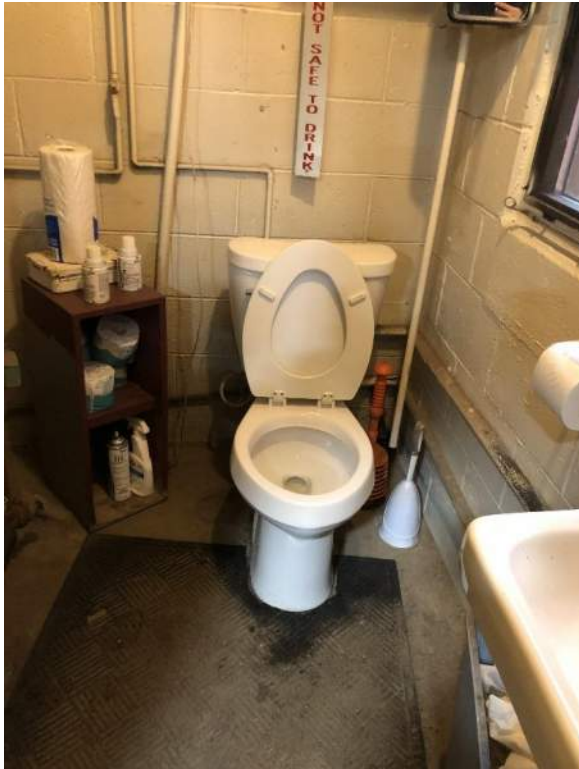
Photo P1: Garage bathroom needs exhaust fan. No showers for employees and no female-specific bathroom. Replace cesspool with tight tank.

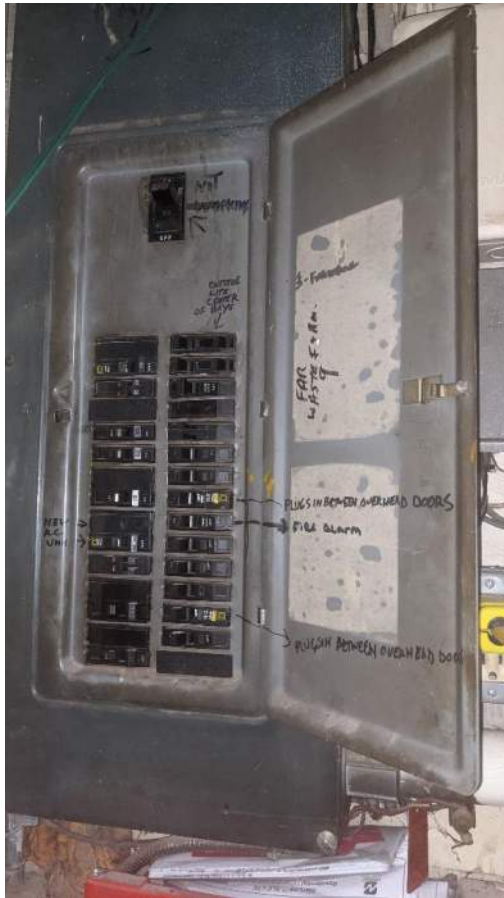
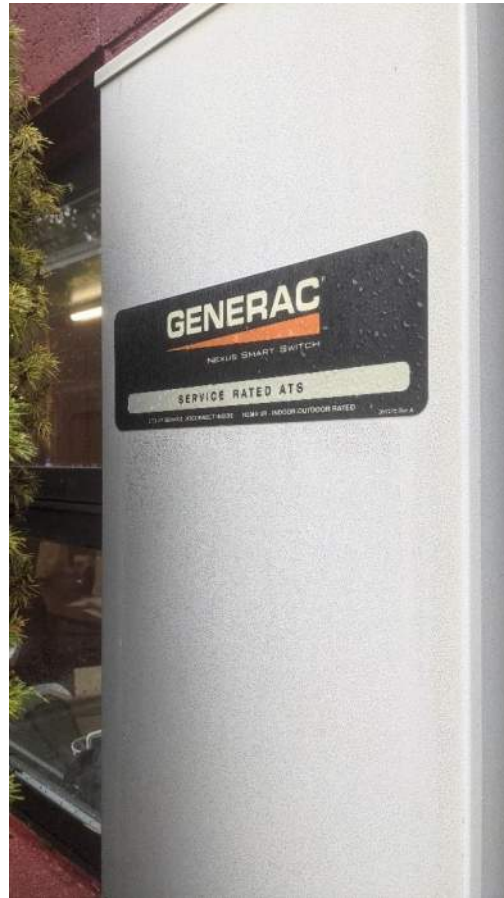
Photo E1,E2: View of the existing panelboard and ATS. Nearing end of useful life.

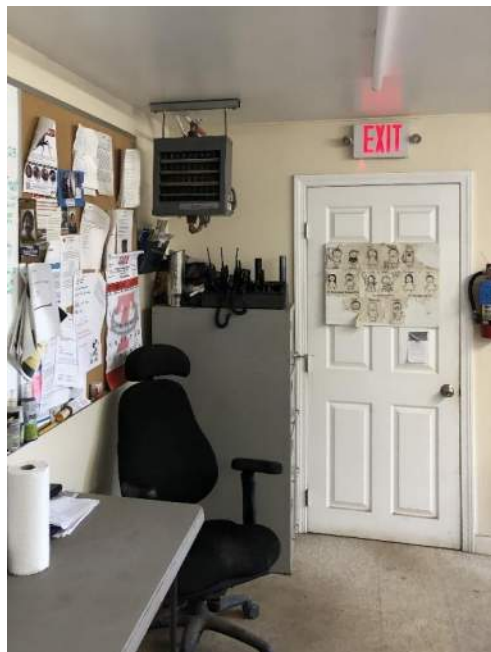
Photo E3: Install emergency lighting with battery backup (as shown in photo) where lacking throughout facility.
