Inter-Fluve, Inc.

Summary Report

TO: Town of Bolton Conservation Commission
FROM: Nick Nelson, Inter-Fluve, Inc.
DATE: November 1, 2010
REGARDING: Fyfeshire Dam Removal Feasibility Assessment

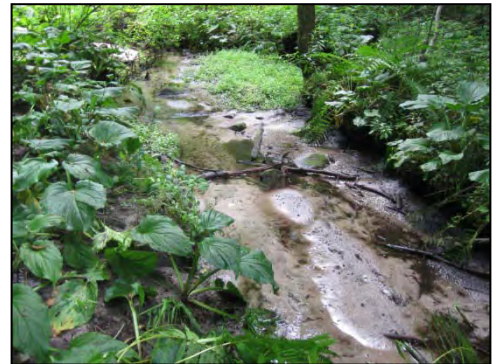
Figure 4: Sand deposition upstream of the Wattaquadock Hill Rd culvert.

The stream that flows into and out of Fyfeshire Pond is a small stream about 5-6 ft wide and 1-2 ft deep. The channel bed consists primarily of gravel and cobbles. The culverts through which the stream passes (Wattaquadock Hill Rd, Collins Rd, and Lancaster Rd) are undersized and result in backing water up during high flow conditions. These backwaters cause sediment to fall out of suspension resulting in the sand deposits found upstream of the culverts (Figure 4). Floodplains adjacent to the stream extend upstream of Wattaquadock Hill Rd for about 1000 ft. These floodplains consist of mature red maple trees, skunk cabbage, and other vegetation commonly found in red maple wetlands (Figure 5). The floodplains are typically 15-30 ft wide ending at a low-angle slope leading to upland habitat. The upland habitat is characterized by a pine tree canopy with ferns on the forest floor (Figure 6). Upstream of this forested habitat, the stream becomes less sinuous as it flows through agriculture fields. The lack of canopy cover in these fields results in decreased shade and likely increased water temperatures.

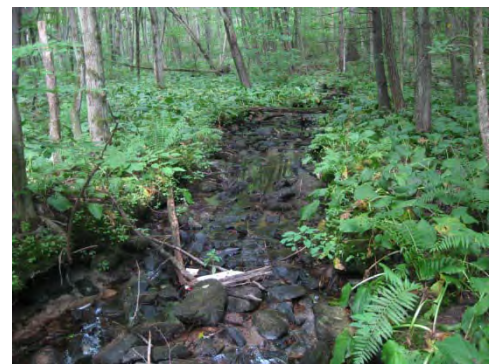
Figure 5: Channel and red maple floodplain upstream of Wattaquadock Hill Rd.

The natural riparian corridor from the fields to Fyfeshire Pond is productive and healthy for both aquatic and terrestrial species. The canopy trees provide shade that keeps water temperatures low; the trees also provide a source of woody debris recruitment that is important for in-stream habitat. The gravel and cobble substrate in the channel provides

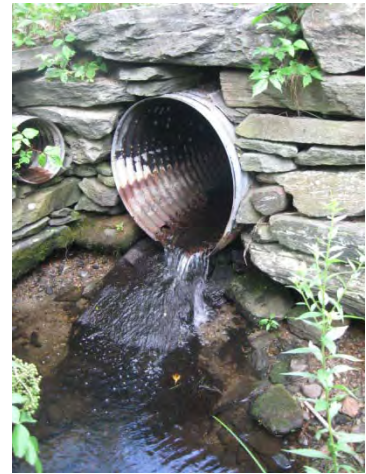
Figure 7: Perched culvert under Lancaster Rd.

Although small fish were observed during the fieldwork, there are a few concerns regarding fish passage and habitat following dam removal. Removal of Fyfeshire Dam will eliminate one fish passage barrier. However, other passage barriers remain in the form of undersized and perched culverts. Undersized culverts often reduce the ability of fish to pass through the culvert during high flows because the water velocity is too great. The Lancaster Rd culvert is perched about 1.5 ft above the channel bed on the downstream end, thus preventing fish from getting into the culvert during low to moderate flows (Figure 7). Finally, the dam just upstream of Fyfeshire Pond within the conservation area presents another fish passage barrier. During high water flow, the pond behind this dam is filled to capacity and with the help of some flash boards at a path crossing (Figure 8) water flows through a secondary channel that flows close to Wattaquaddock Hill Rd before flowing into Fyfeshire Pond (Figure 9). At such higher water flows, fish are able to swim up this channel, pass through a perched culvert under the walking path near the parking area, and continue upstream through the Wattaquaddock Hill Rd culvert. This was the case during our first site visit on April 24, 2010. By July 20, however, water flows were so low that no water was flowing into that secondary channel and only small amounts of water were seeping through the boards in the dam. So little water flowed, in fact, that the water collected in Fyfeshire Pond soaked into the ground quicker than it could be replenished, resulting in a dry stream bed downstream of Fyfeshire Pond Dam.

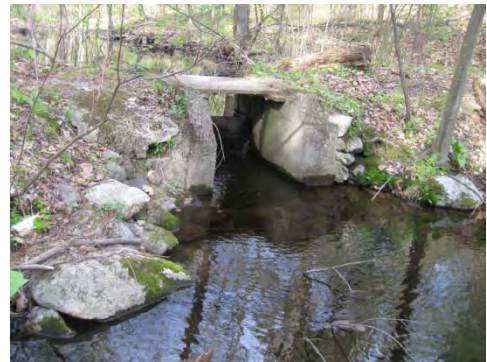
Figure 8: Flash boards in trail crossing upstream of upper dam.

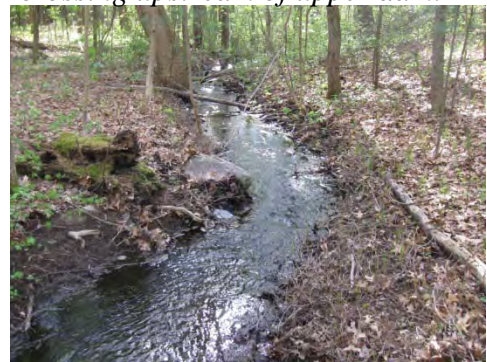
Figure 9: Secondary channel flowing along Wattaquaddock Hill Rd into Fyfeshire Pond.

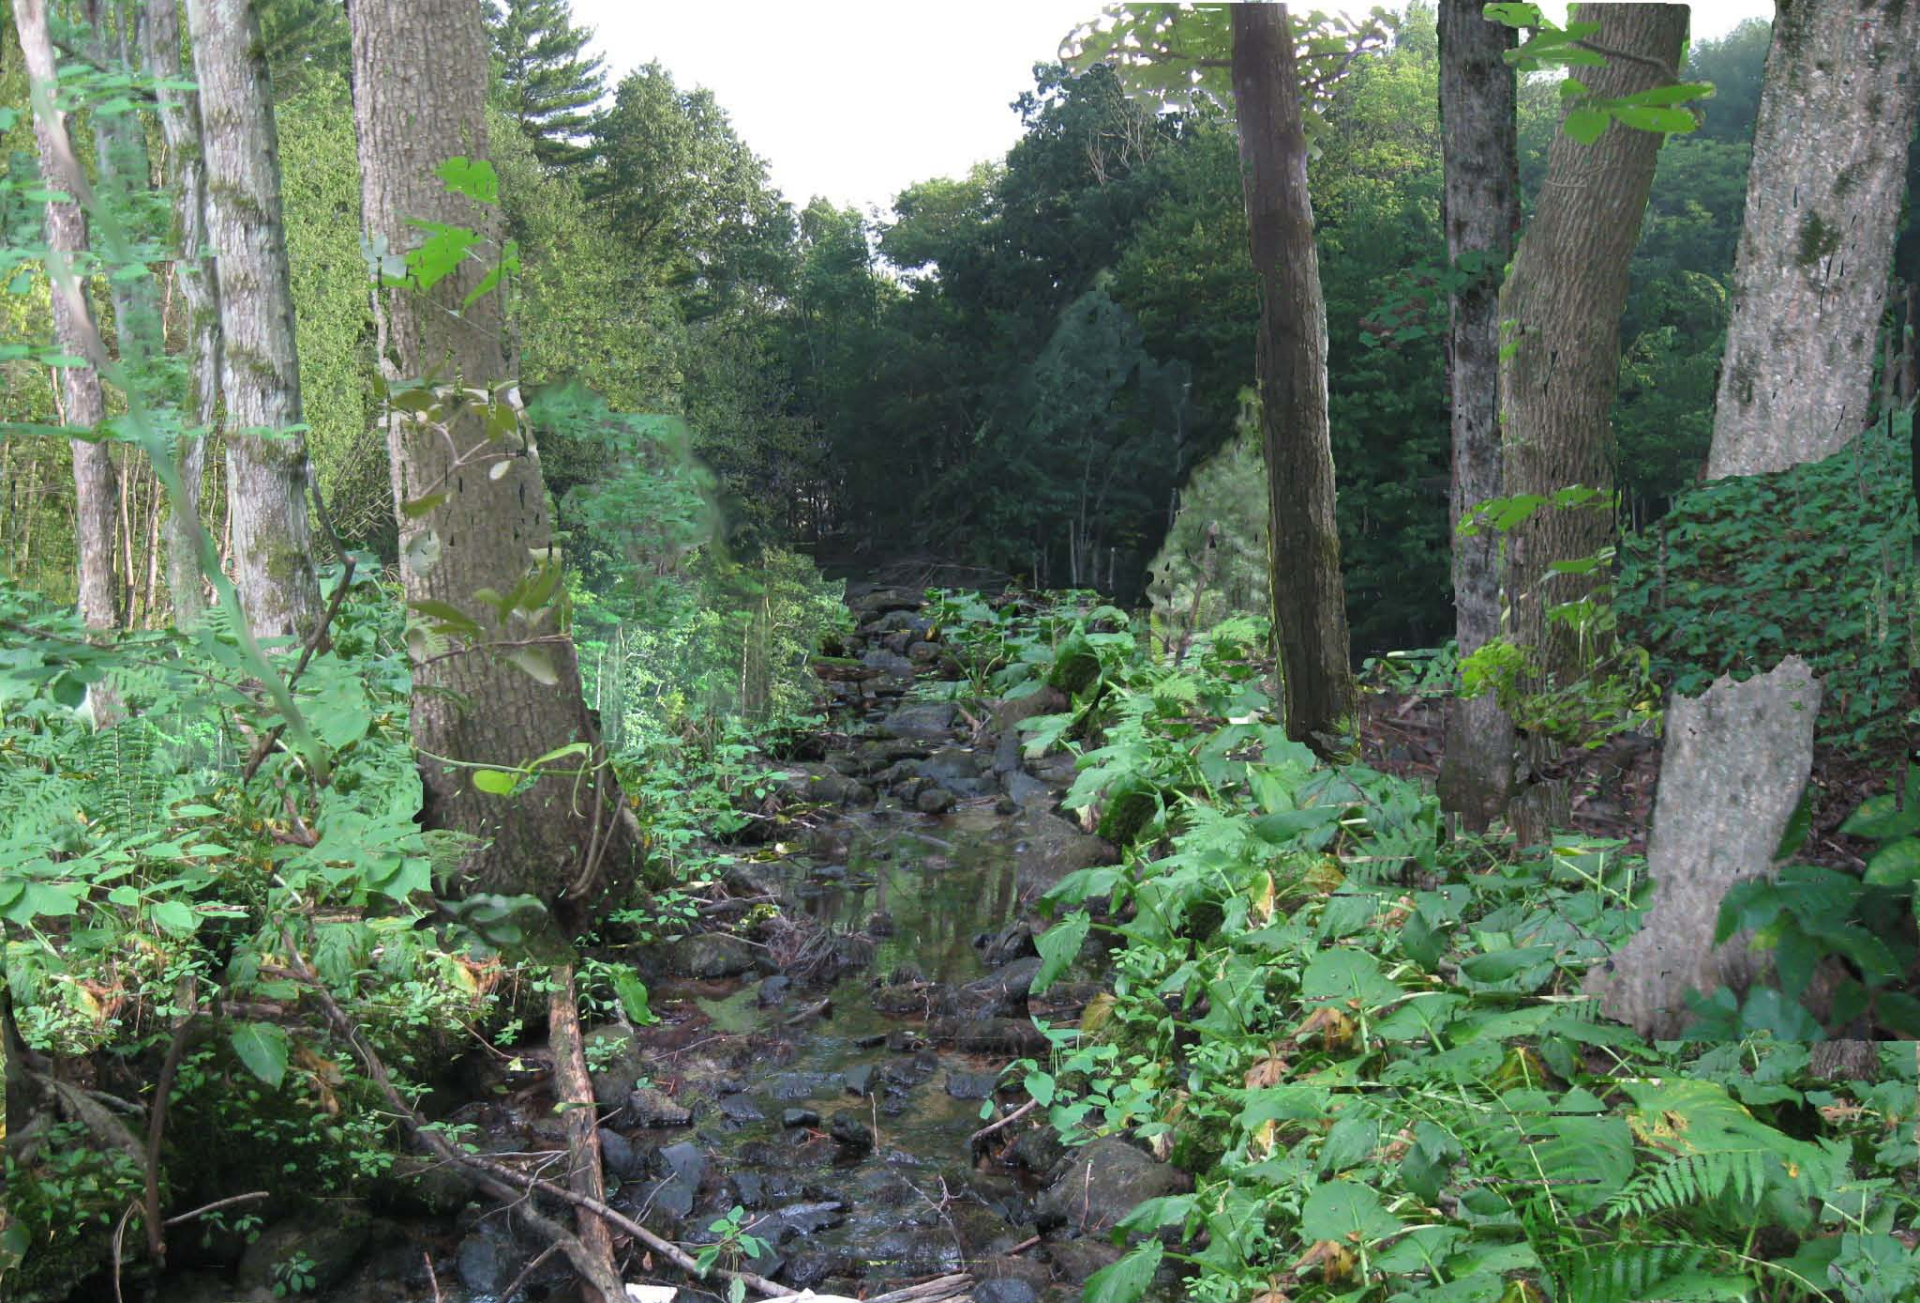
Exhibit 1B. Looking downstream towards former Fyfeshire Pond Dam: Proposed conditions

Conceptual rendering and Photoshop renderings - We have based our conceptual and Photoshop renderings on the depth of refusal survey and the analysis of upstream and downstream habitats (Appendix C and D). We suggest that the restored channel and land adjacent to the channel will resemble the channel and riparian corridor upstream of Wattaquodock Rd: a 5-6 ft channel with a red maple-dominated floodplain and pine tree upland (Exhibit 1B in Appendix D). Much of the area between the restored channel and the pool ('vernal pool' in the concept rendering) will likely be dominated by a canopy of red maple trees and an understory of shrubs, saplings, skunk cabbage, and ferns (see Exhibit 2B in Appendix D). It is possible that the high points, and thus drier areas, will sustain pine trees as well. As indicated on the conceptual rendering, this new riparian area would be a good location for a trail that would connect the two existing trails on either side of the pond.

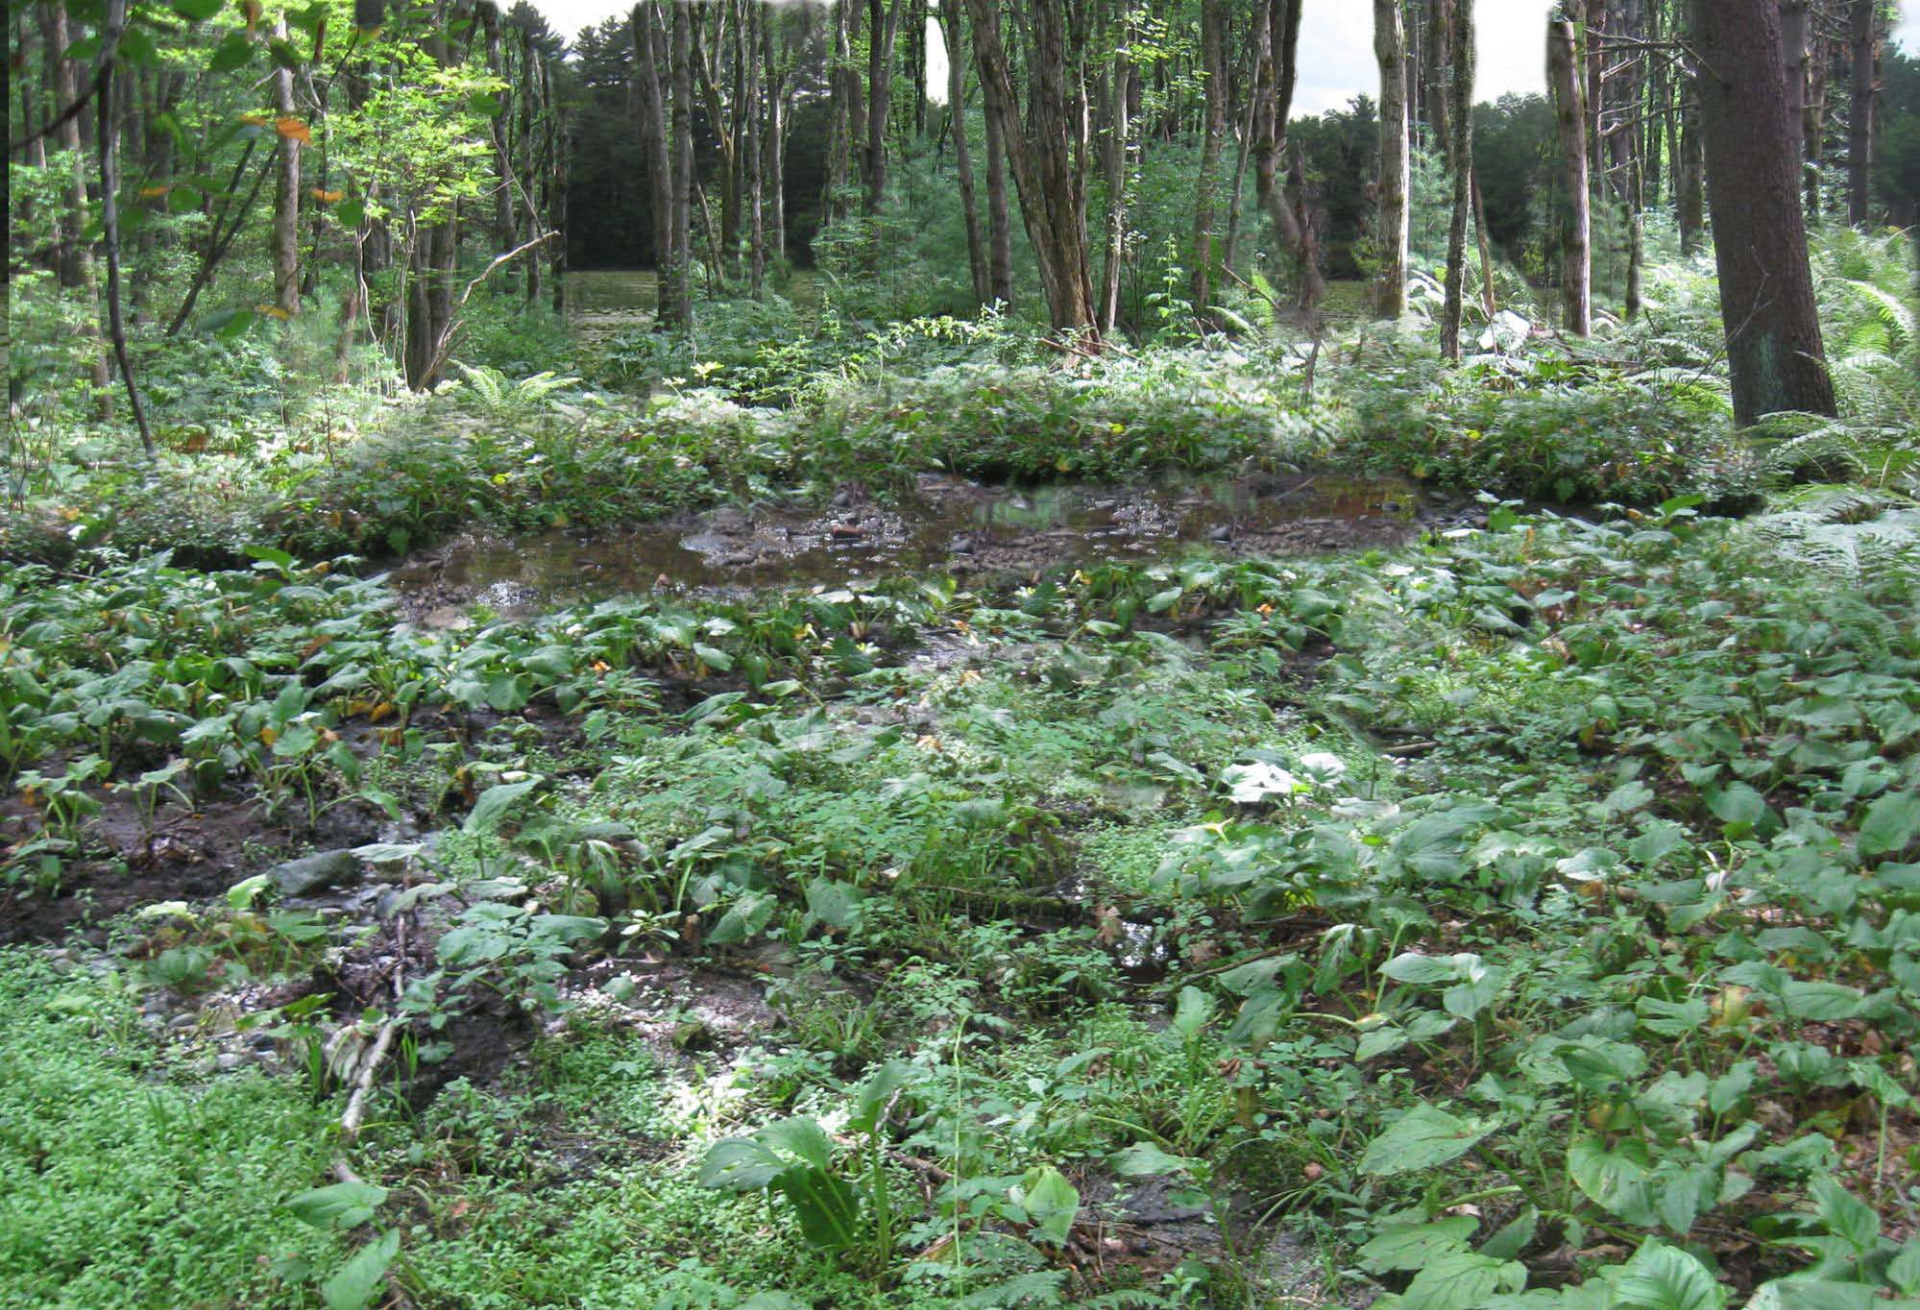
Exhibit 2B. Looking west across former Fyfeshire Pond: Proposed conditions with creek in the foreground and vernal pool in background.

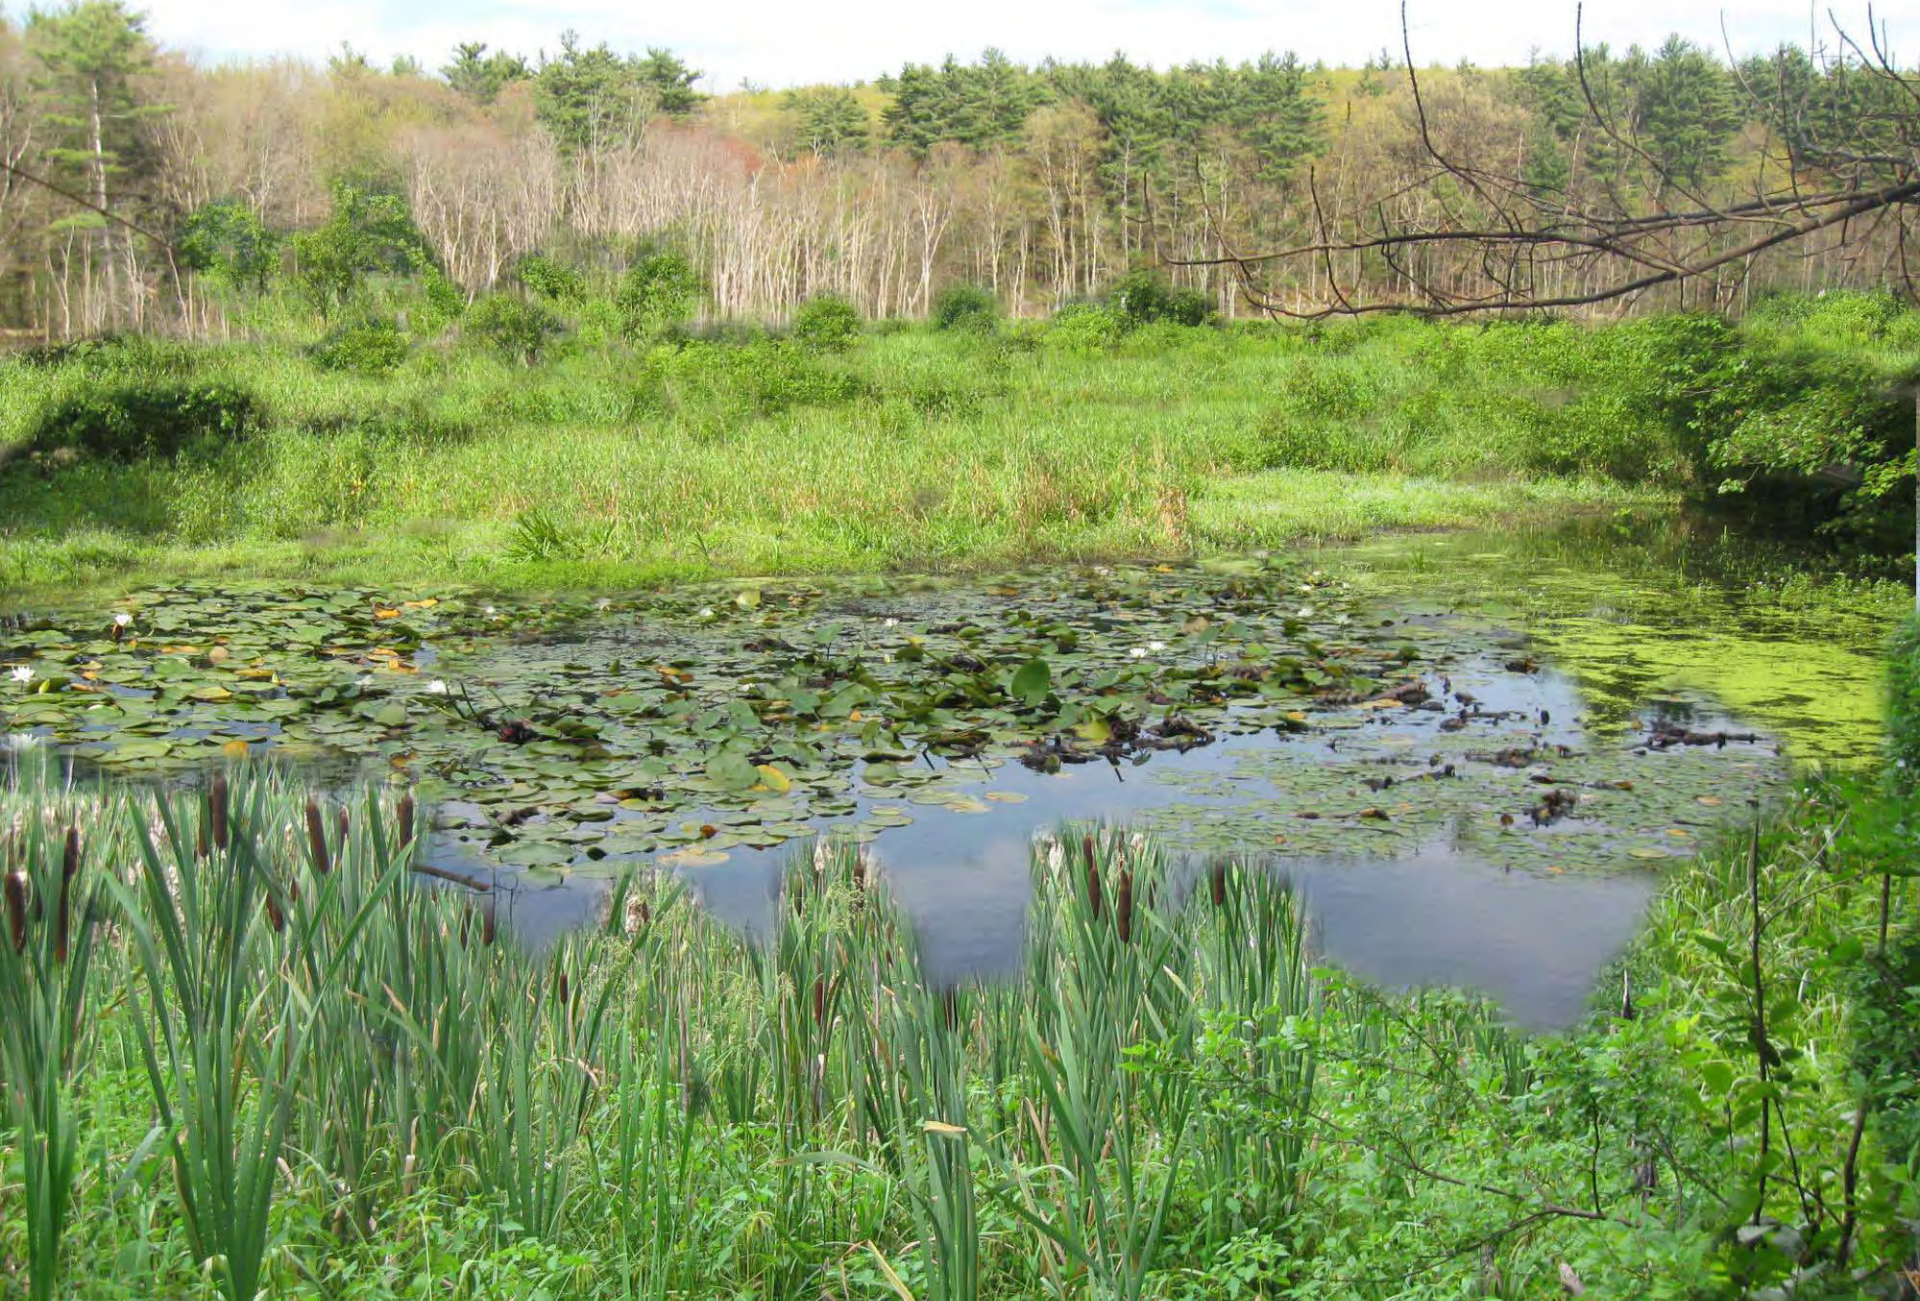
Exhibit 3B. Looking east across former Fyfeshire Pond: Proposed conditions with vernal pool in foreground

containing cattails and taller grasses (Exhibit 3B in Appendix D). Different vegetation will thrive as the water level varies, producing a succession of colorful flowering plants. Vernal pools rarely maintain fish populations but provide excellent habitat for amphibian and insect species. This pool will likely sustain many frog and toad species and may even provide breeding habitat for salamanders.
